THE WATERFORD MILL  
*Waterford, Virginia*

HISTORIC STRUCTURE REPORT

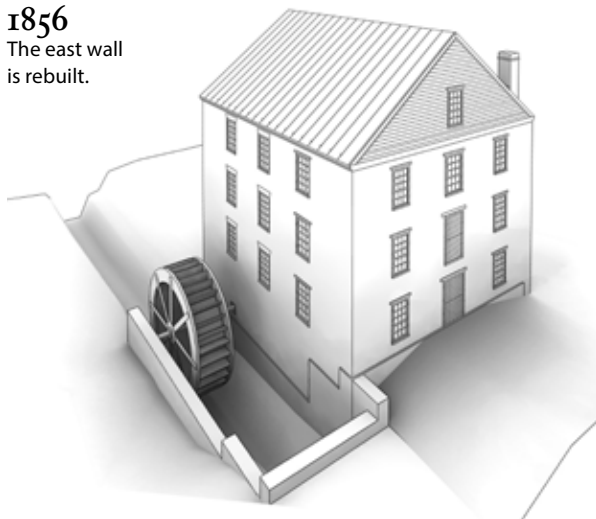
The east wall is rebuilt.

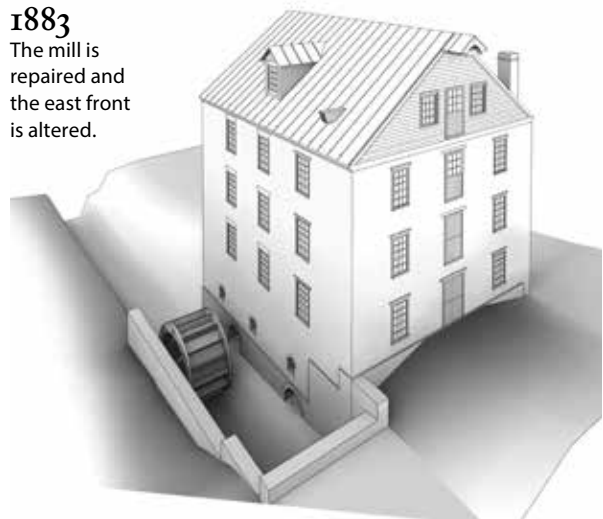
The mill is repaired and the east front is altered.

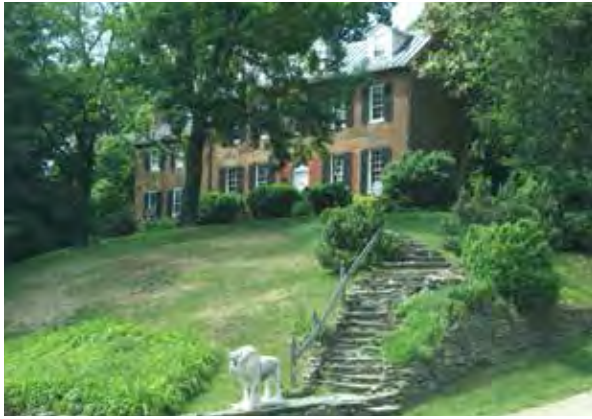
Emanuel Newcomer purchased the mill in 1814. He and his wife Catherine built the house nearby (known today as Mill End) between 1814 and 1817. They sold the combined property in 1817 [Waterford Foundation Walking Tour]. The house remained attached to the mill and served as the mill owner's house. In 1816, county tax records show that Newcomer owned two tracts, comprising one lot in Waterford and 53 acres near the town.

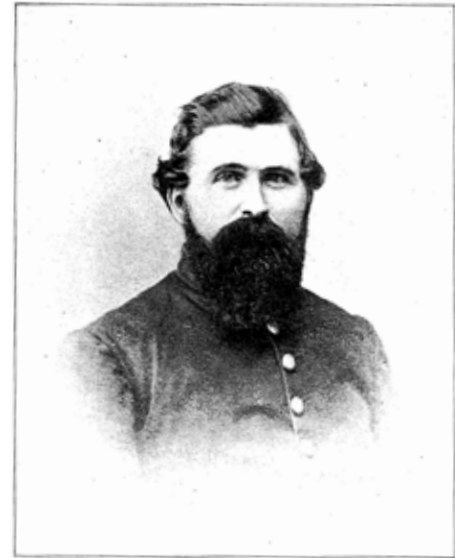
Capt. S. C. MEANS, Co. A.

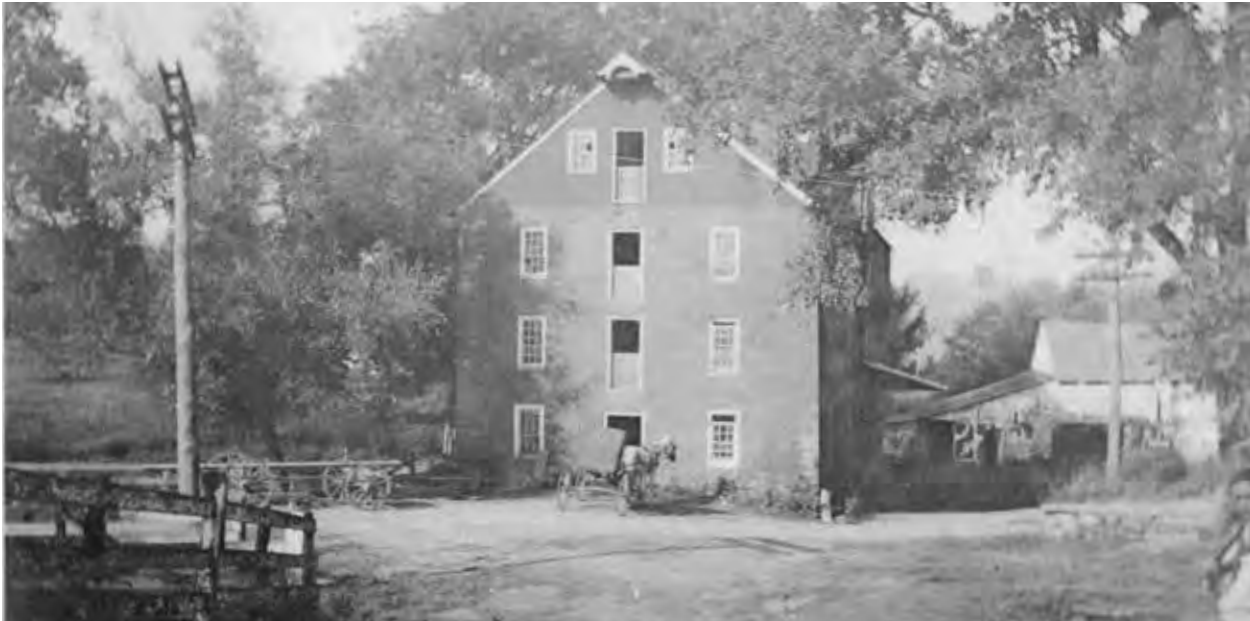
Above: Waterford Mill. East end. Postcard, early 20th century. Shows the stable beyond the mill and the cantilevered canopy over the receiving room in the hyphen between the mill and the west wing. Note the stone bollard still present at the northeast corner of the mill [WF].

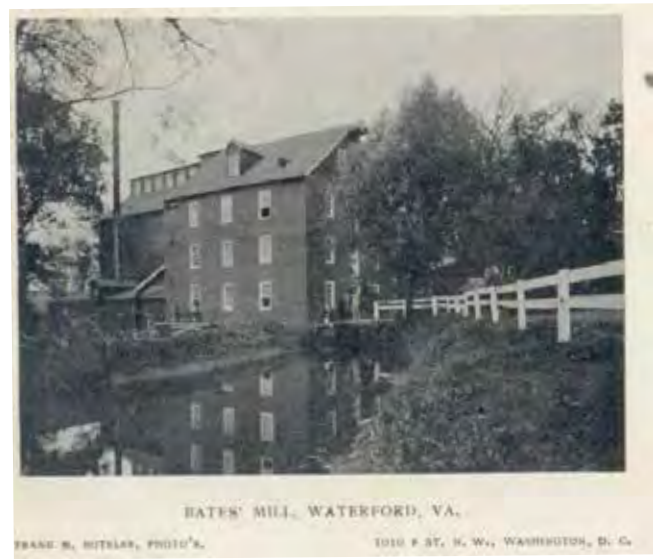
Right: Bates' Mill, Waterford, c 1903. Shows added steam plant along the south side of the west wing. The clerestory is not visible in the earlier view, but is likely an original feature of the west wing. The similarity in tone of the walls suggests that the west wing, clad with metal sheets stamped to resemble brick, was also painted to match the brick of the main building, giving the entire complex a cohesive appearance. The millrace is shown depleted of water, with the water level probably below the top of the water wheel. The wall can be seen at the end of the mill race and the metal flume beyond [WF].

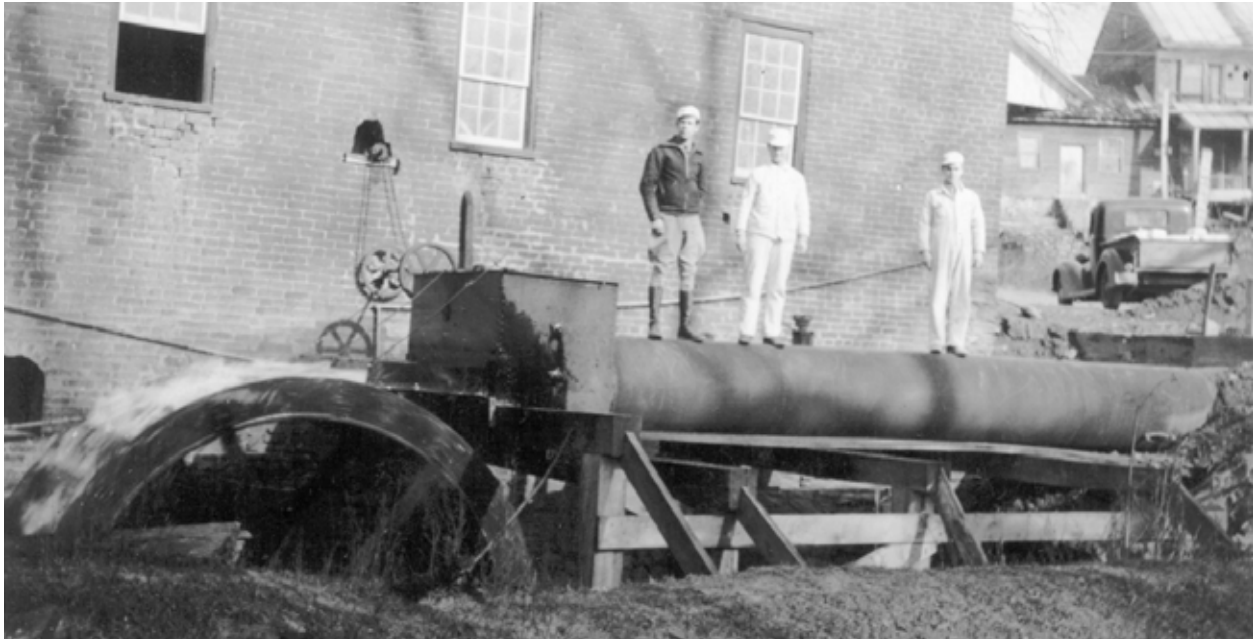
Waterford Mill, with Albert White and millers in 1937, showing the metal pipe and control gate in detail [WF]. It does not appear that at this time there was a turbine attached at any point to the pipe.

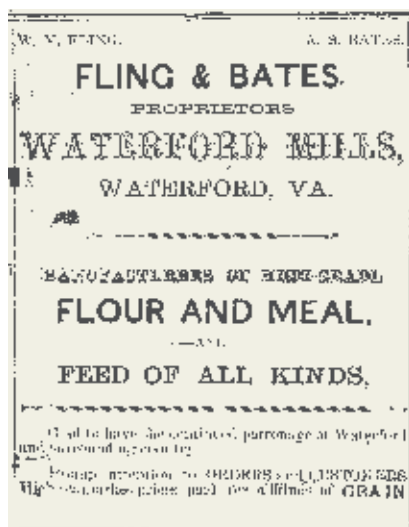
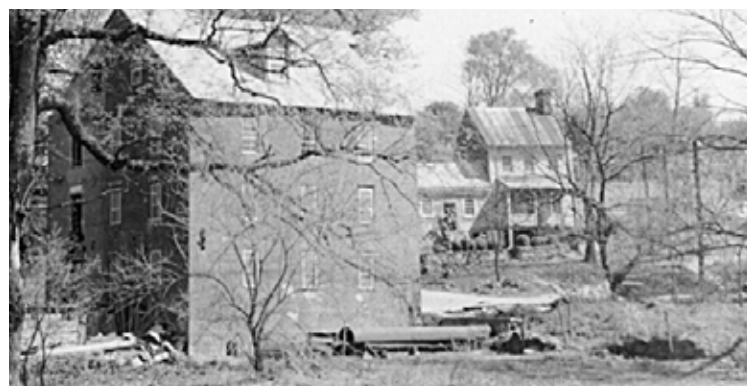
Above: Detail from c 1945 photo of the mill shortly after acquisition by the Waterford Foundation. The metal flume, the top of the wheel, and the concrete dam at the end of the mill race as it was built by A.S. Bates can all be seen [WF].

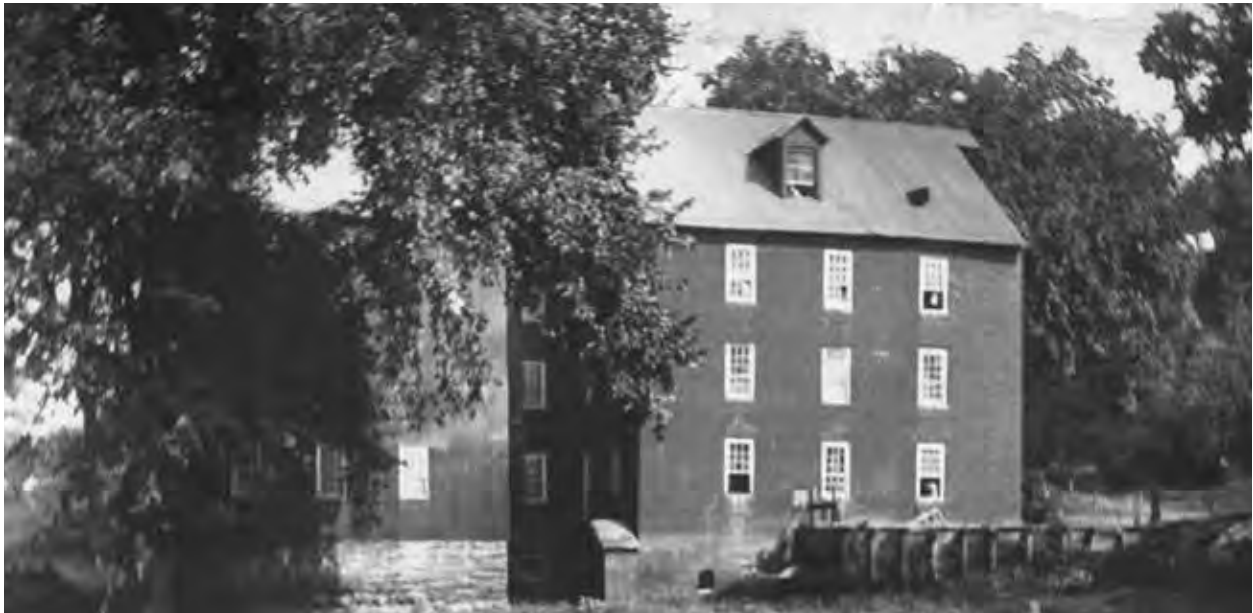
Waterford Mill, c. 1900. Shows the new west wing of c 1886 and a wooden flume and control gate as well as the wood plate at the end of the lowest of the iron tie rods at the west end [WF].

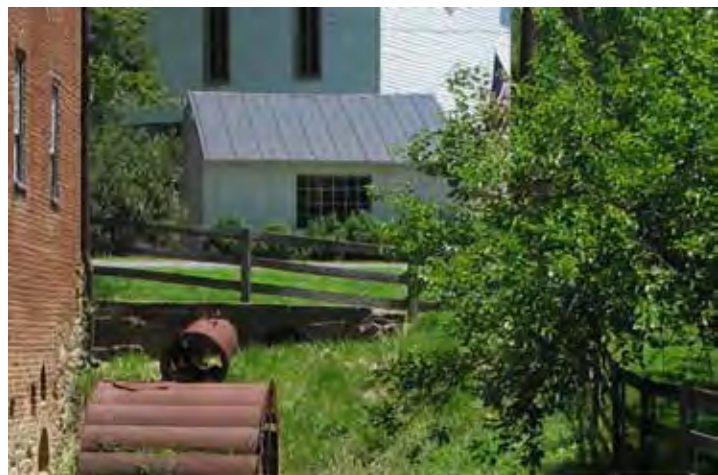
The Scale House that originally contained the scales mentioned in the 1914 announcement still stands today across the street from the mill.

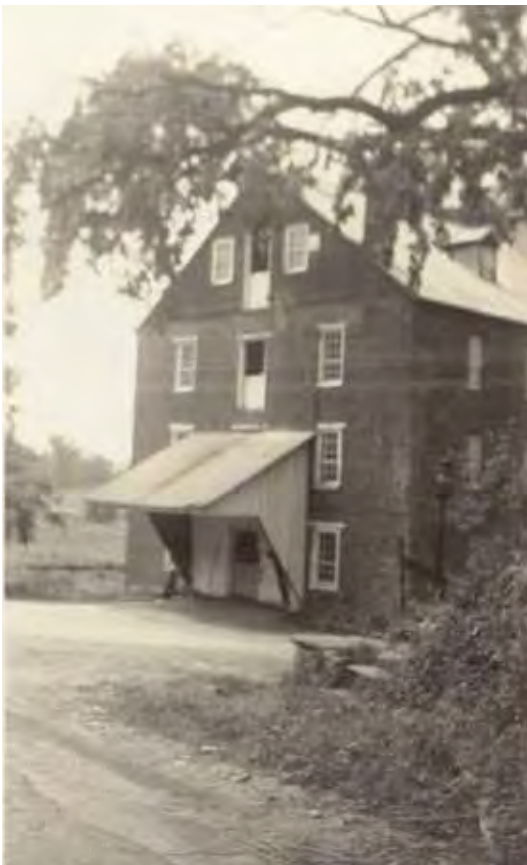
East front of the Waterford Mill, probably 1930s. Shows an added cantilevered canopy covering the mill's main door for loading of flour, dating from the early twentieth century [WF].

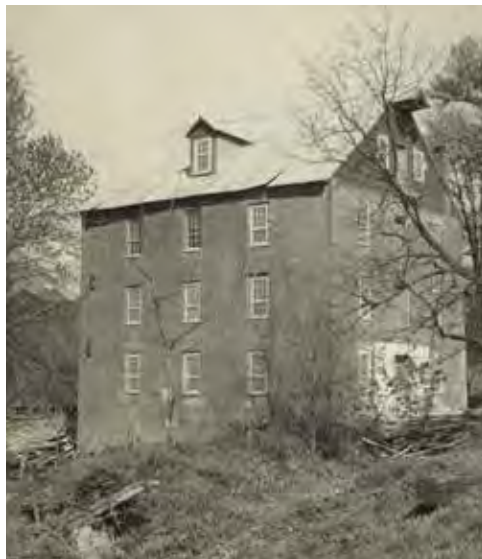
Waterford Mill soon after acquisition by Waterford Foundation in 1944 and after the west wing had been demolished. The corrugated metal roof appears loosely attached [WF].

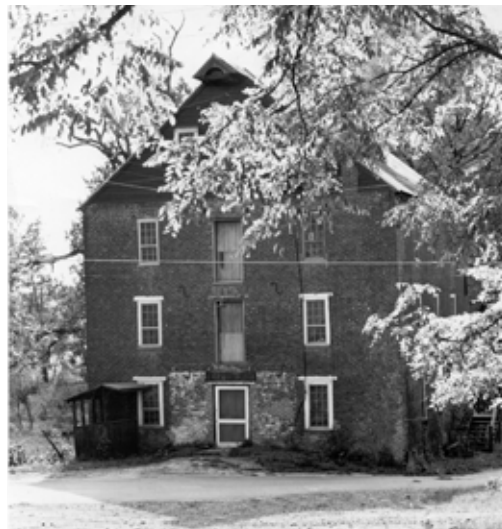
Waterford Mill, c. 1952. This shows the east wall after the canopy had been removed around the front door and the brick around door had been replaced. These bricks were replaced again and the sign above the door removed in 1983–4. The white-painted wooden screens were added to enhance ventilation of the building during regular use as a craft center [WF].

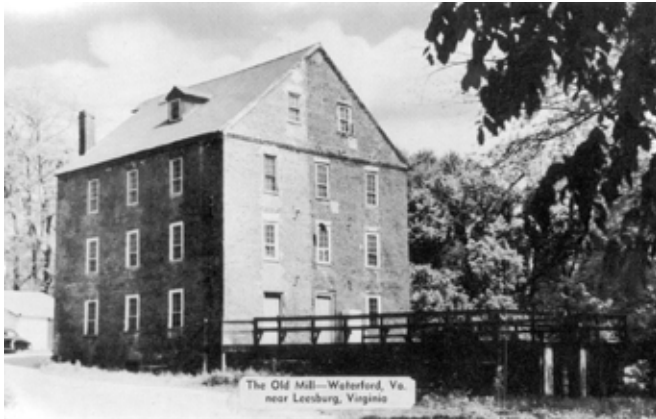
Above: Waterford Mill, c 1948. Shows wood platform installed over stone foundation of the west wing, which has been removed, leaving clear difference in brick color on the west wall [WF]

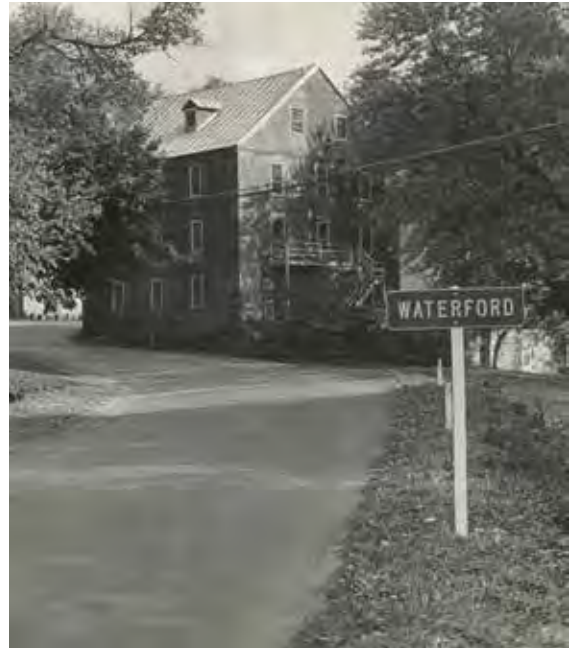
Right: Waterford Mill, west end, 1968. Shows the completed west terrace, fire stair, and small brick toilet room under the stair [WF].

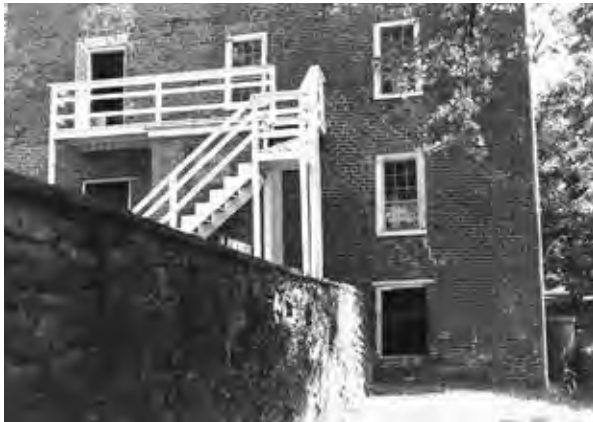
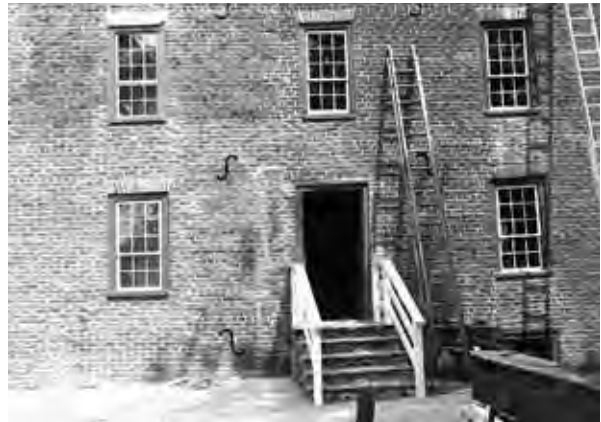
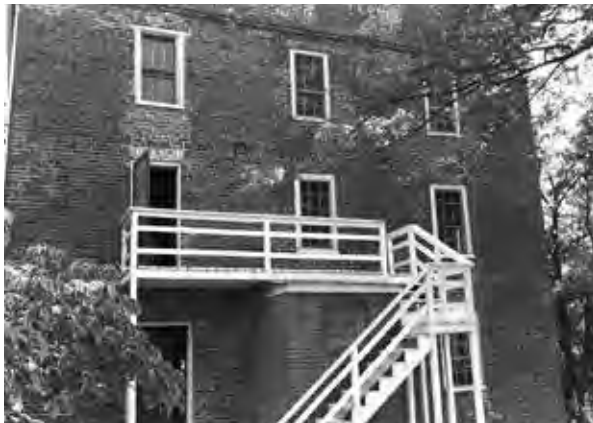
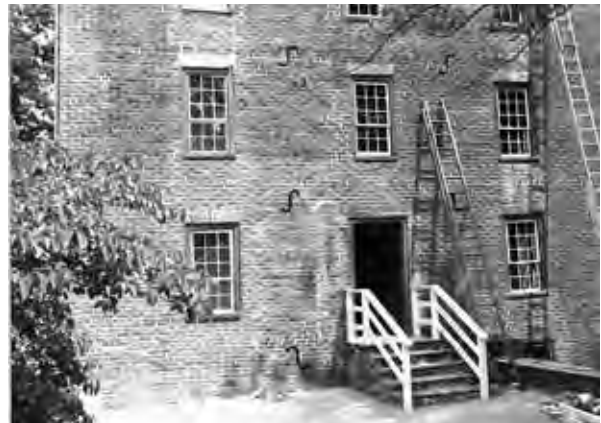
Documentary Photos from 1984 show the appearance of the west wall before and after the restoration [WF].

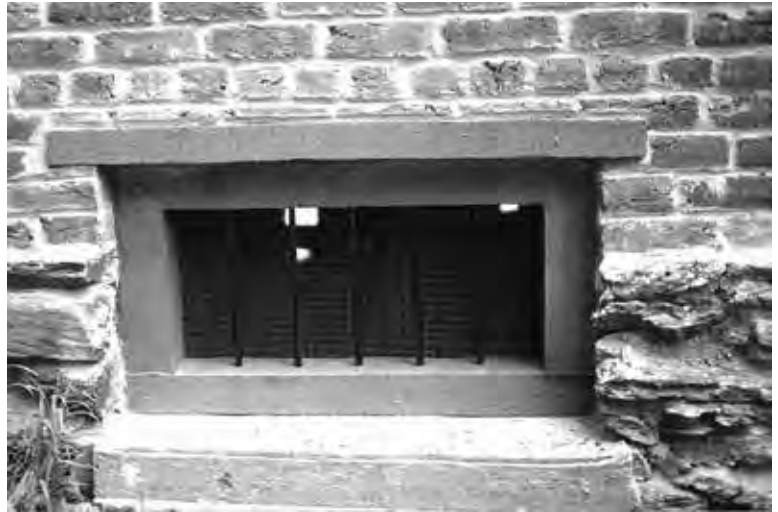
New basement vent in center of north wall.

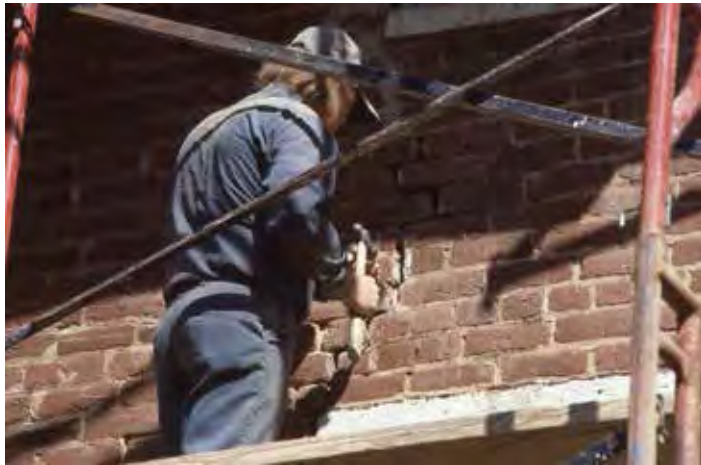
Removing portland cement repairs, south wall, April 1984 [WF slide collection]

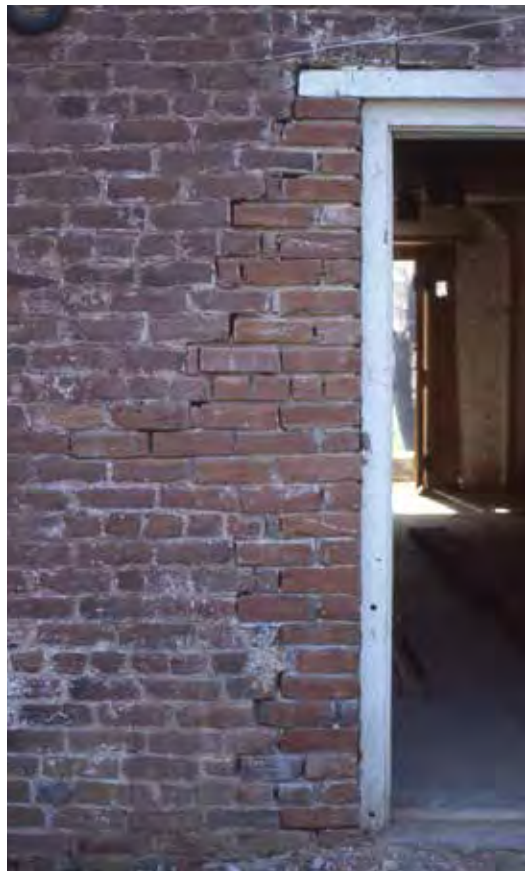
East entry door brick during repair, April 1984 [WF slide collection]

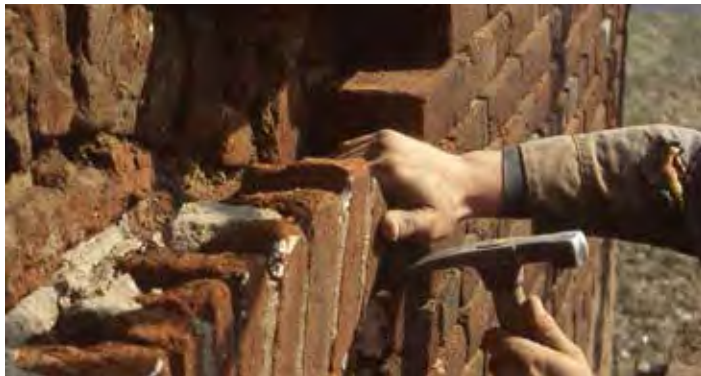
Third-floor jack arch under repair, March 1984 [WF slide collection]

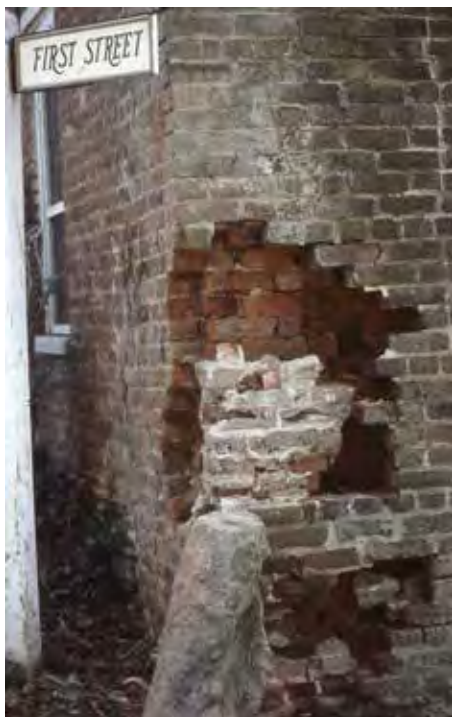
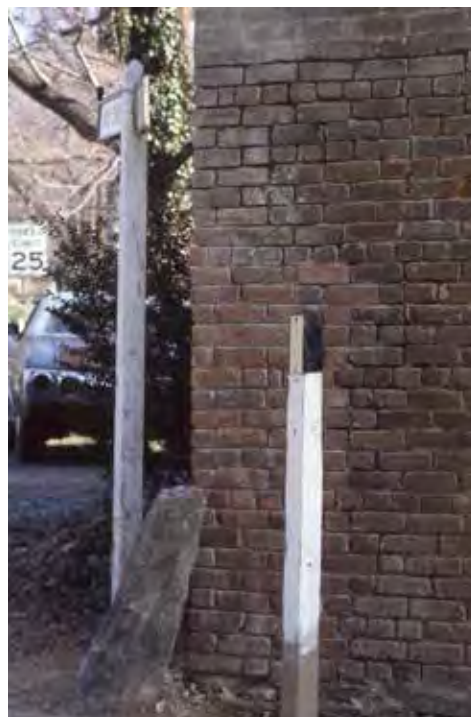
Northeast corner during and after repair, March 1984 [WF slide collection]

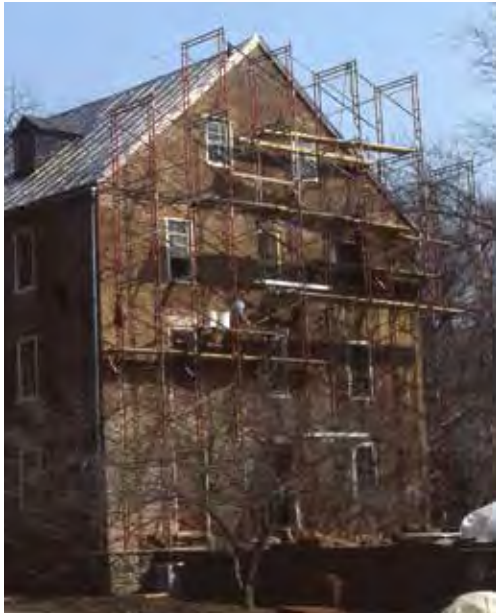
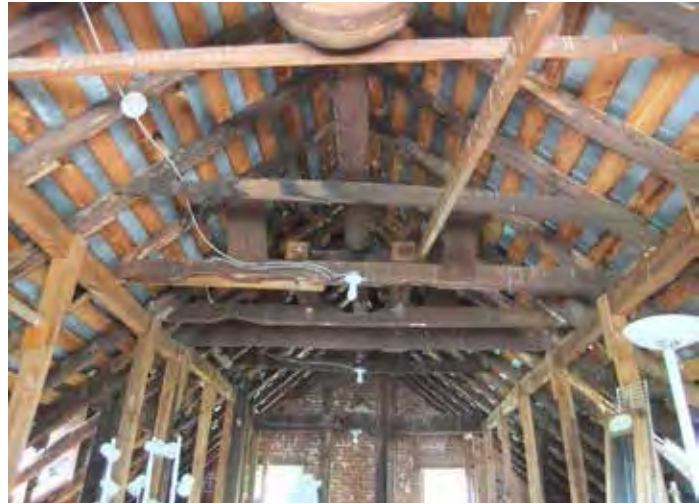
Above: Roof framing with rafters, collars and purlins on stud posts.

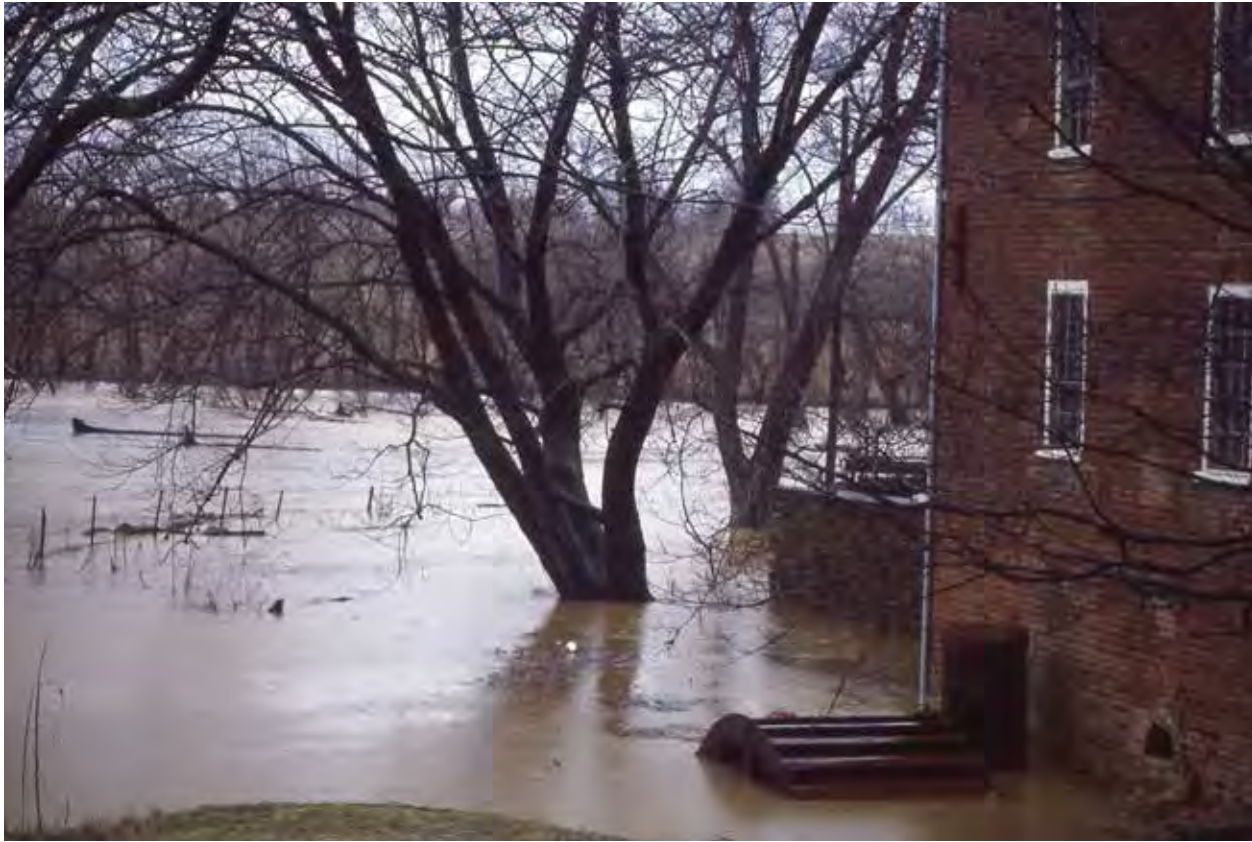
Left: Flood in March of 1984 [WF slide collection]

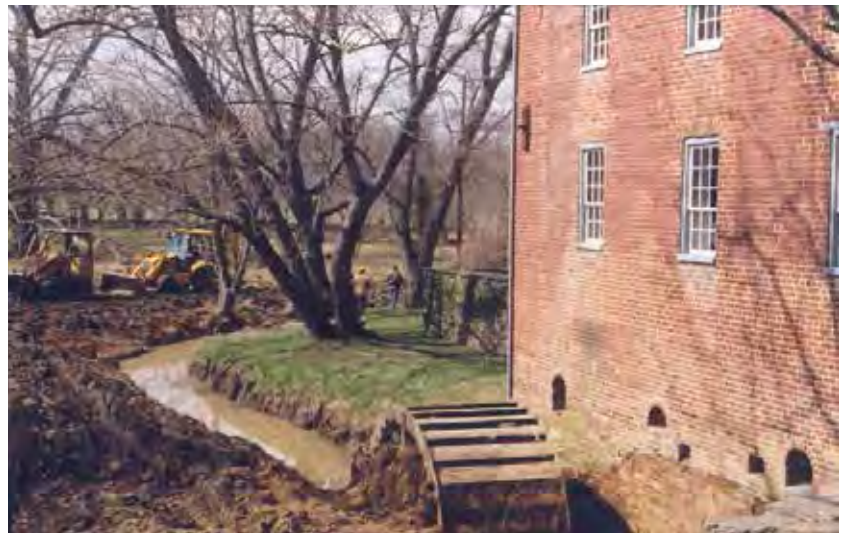
Waterford Mill, excavation of mill race, 1998 [WF].

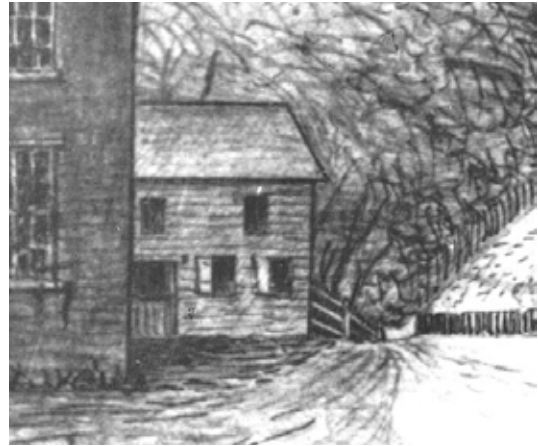
Detail of an 1882 sketch also shows a three-board fence running along the edge of the mill property [WF].

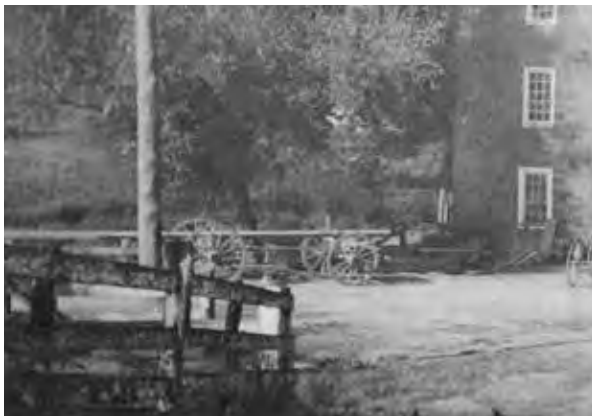
Detail of early 20th century mill and buggy postcard. This shows a three-board fence that is more similar to the fence installed in 1998.

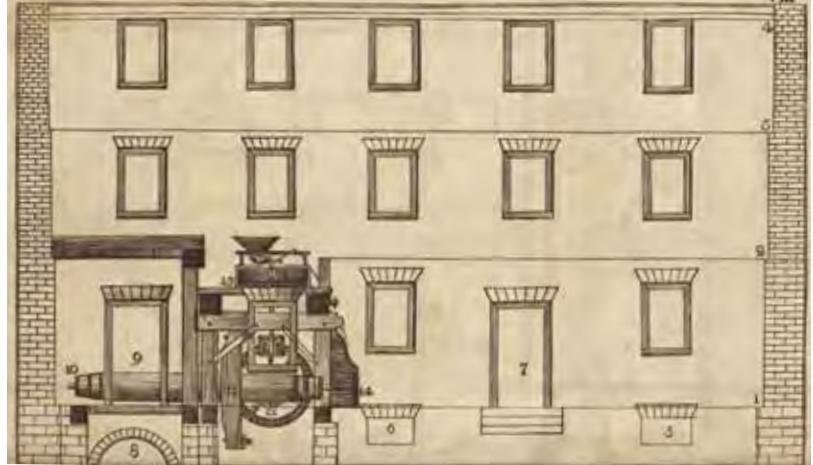
Above: Hurst frame end elevation. Below: Hurst frame side elevation [Oliver Evans, *The Young Mill-wright and Millers' Guide* (1795)]

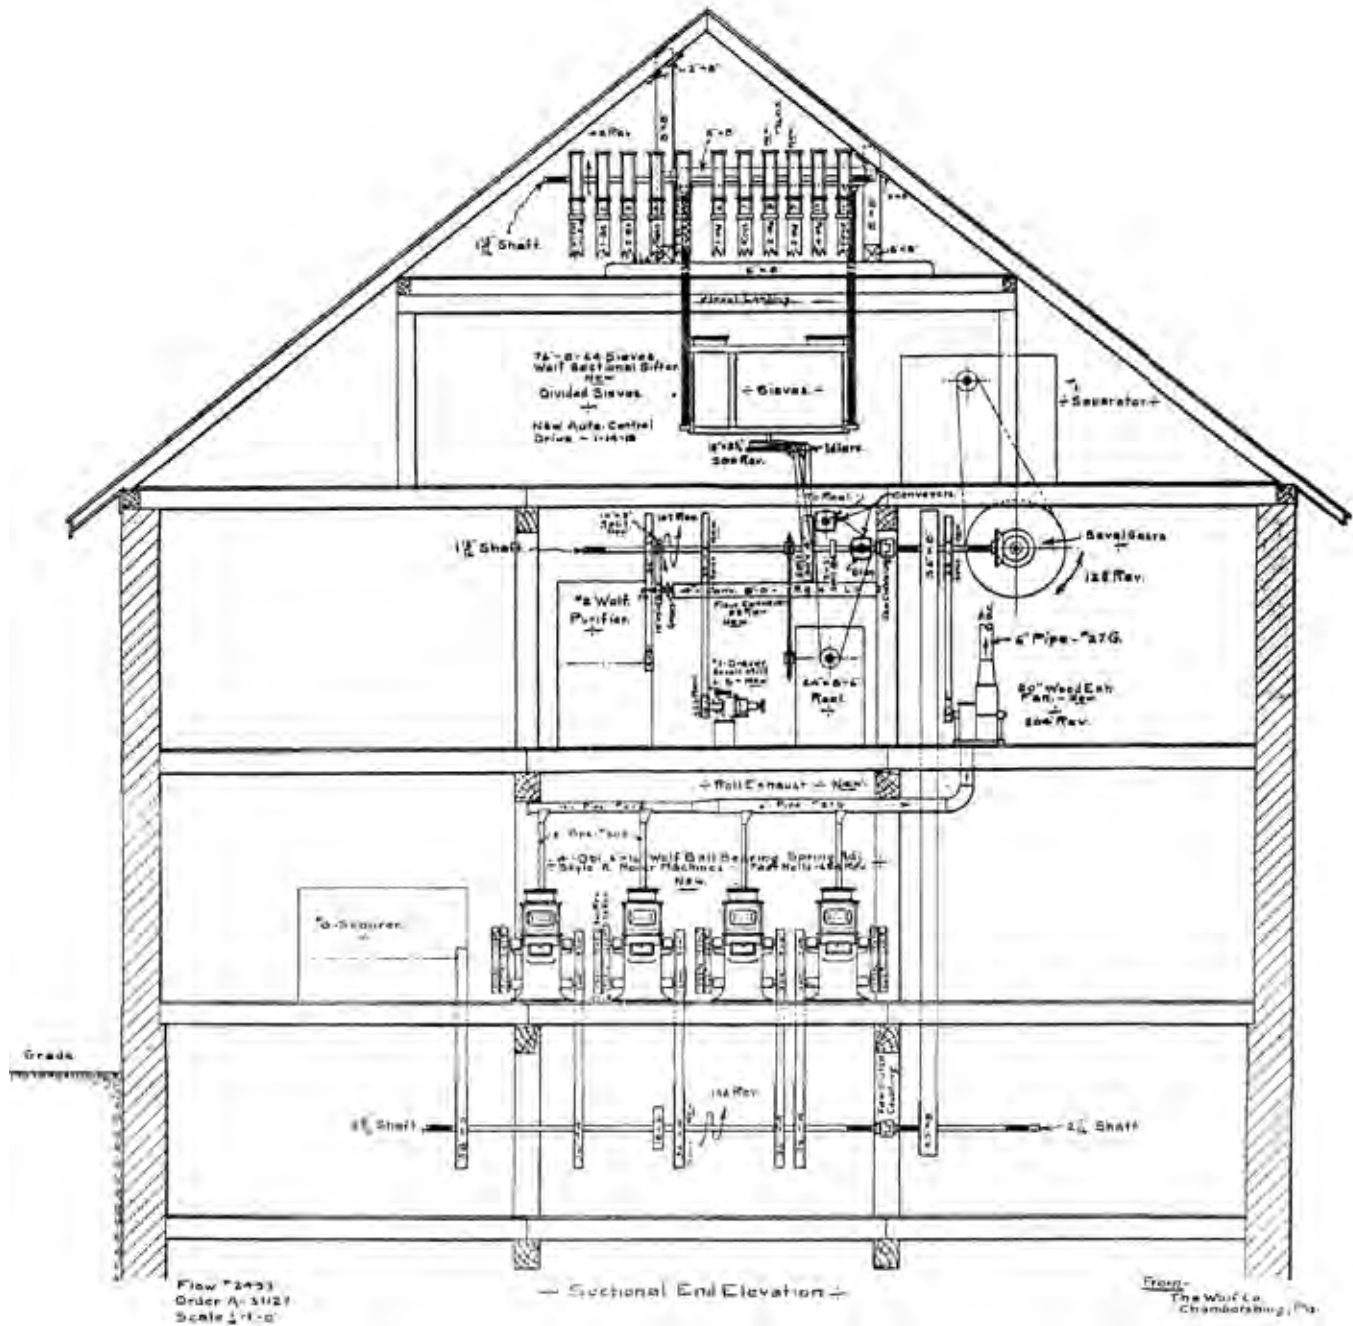
Flow Diagram, Roller milling equipment, Aldie Mill, Aldie, Virginia.  
The Wolf Co. Chambersburg, PA, 1911. [Courtesy of Derek Ogden.]

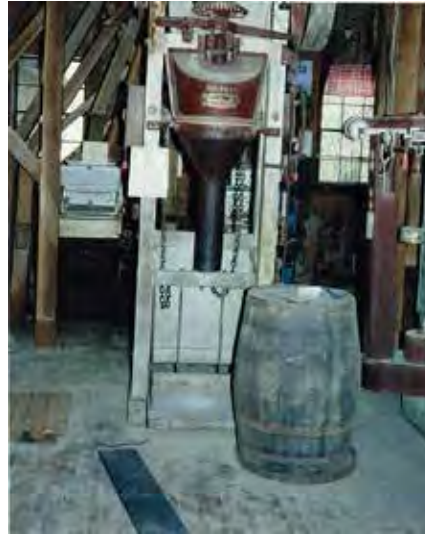
1. Wheat (and corn) was delivered in wagons to the receiving room in the hyphen between the mill and the west wing. The grain was weighed and dumped into a bin below the floor. The farmer was either paid for the grain at market price, or the miller “exchanged” flour or meal for the grain at a specified rate per bushel.
2. Just as in the Oliver Evans process, the grain was first passed through a ‘fanning mill’ to blow off the chaff and through screens to remove foreign material. The grain then was stored in large bins in the west wing until needed.

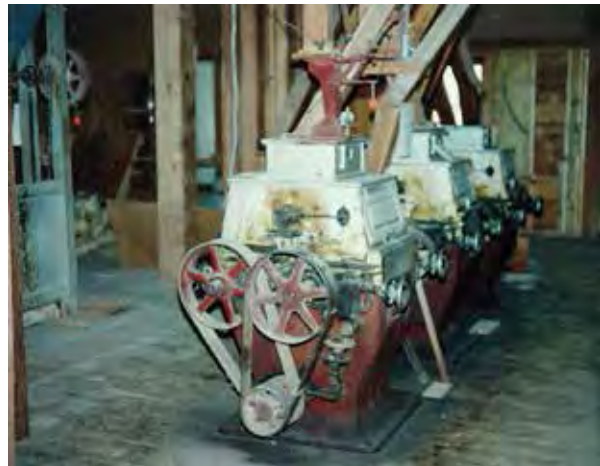
Gradual reduction milling. Olive Mill equipment before relocation to Waterford Mill in 1998 [WF].

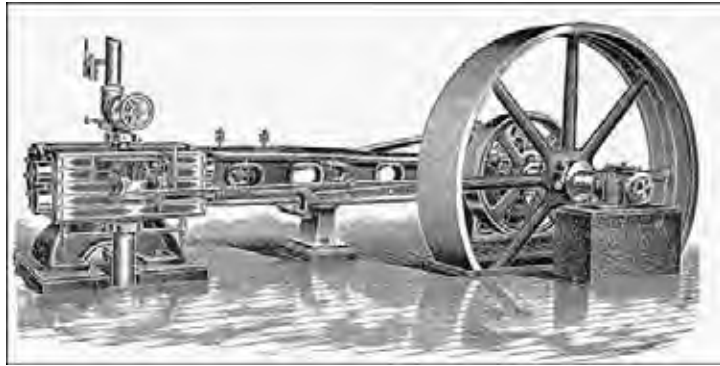
Above: Fitchburg Steam Engine. A typical mill engine in the 1903 catalog of the Fitchburg Steam Engine Company, one of several manufacturers. The boiler was separate. <http://home.iprimus.com.au/metzke/Engines.sketch.html>

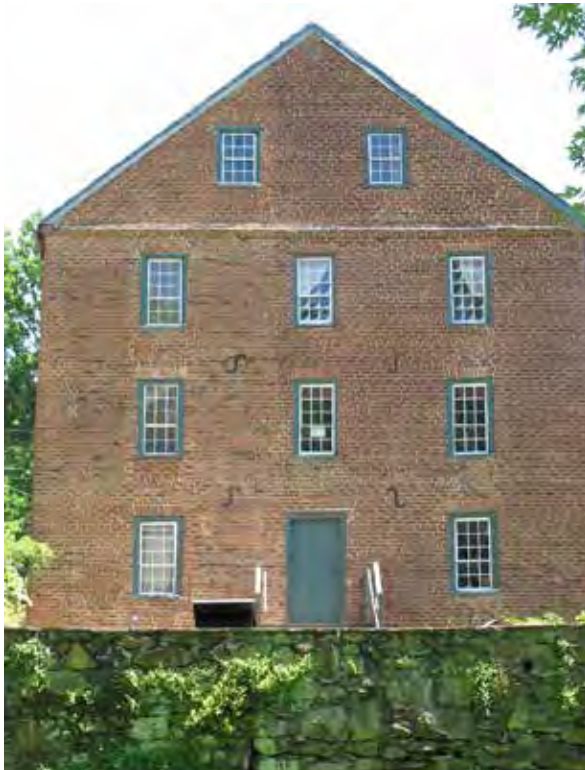
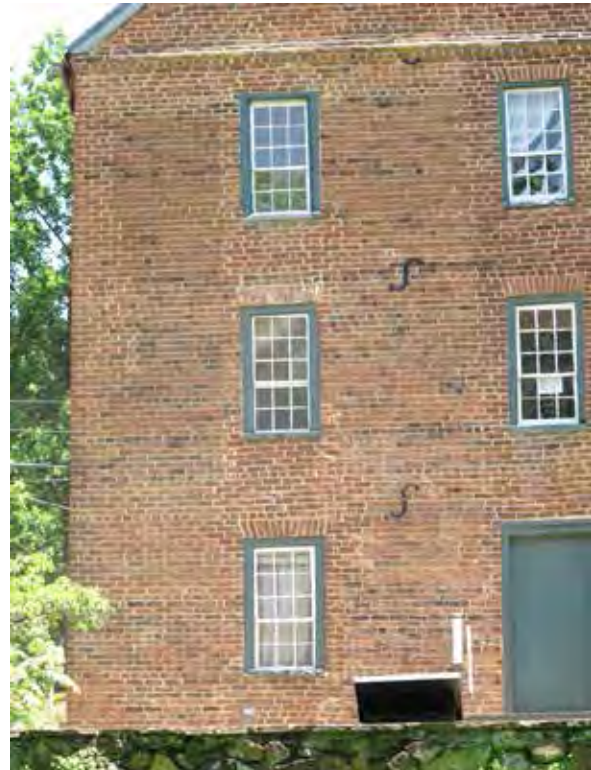
West End, Waterford Mill, 2012. A double row of projecting bricks can be seen above the third-floor windows.

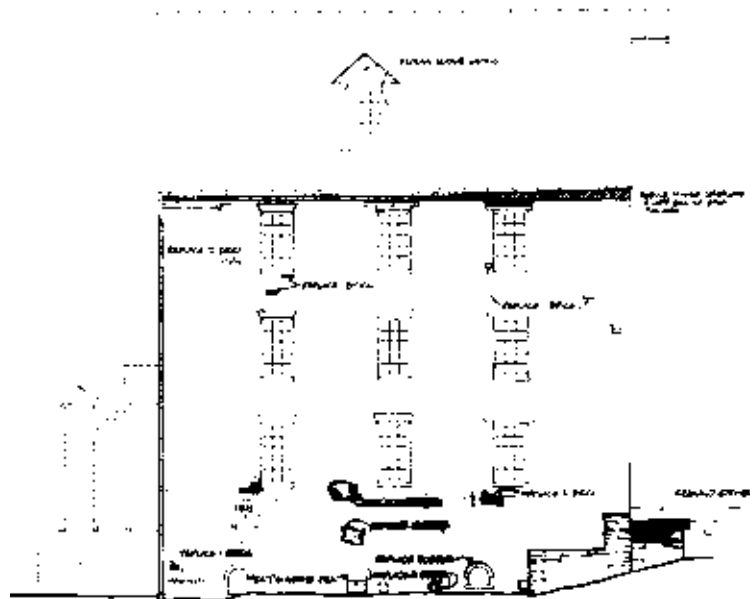
South side, Waterford Mill, Drawings, The Ehrenkrantz Group, 1985.

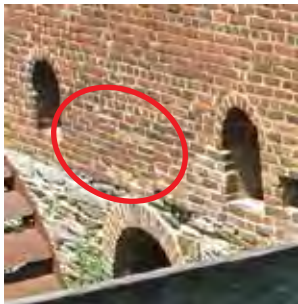
Left: View of western archway from northeast, 2012. The wall is patched just above and to the west of the large arch where the wheel shaft would have entered the building (circled).

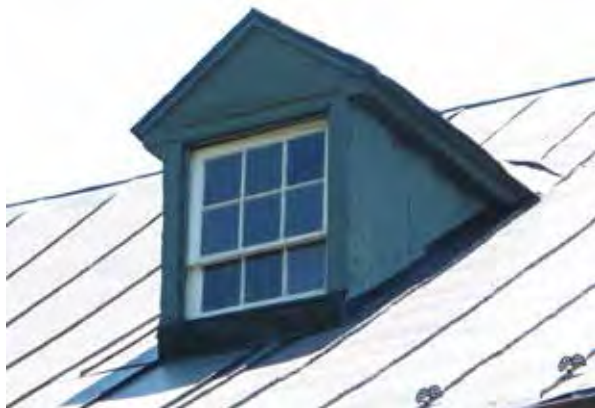
Close-up view of dormer

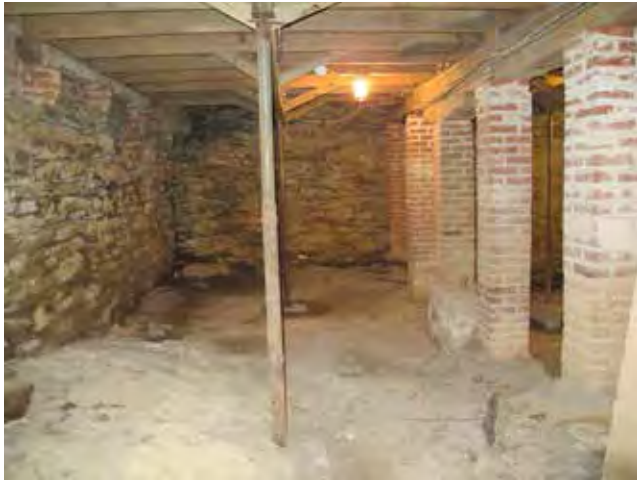
The north bay of the basement looking east

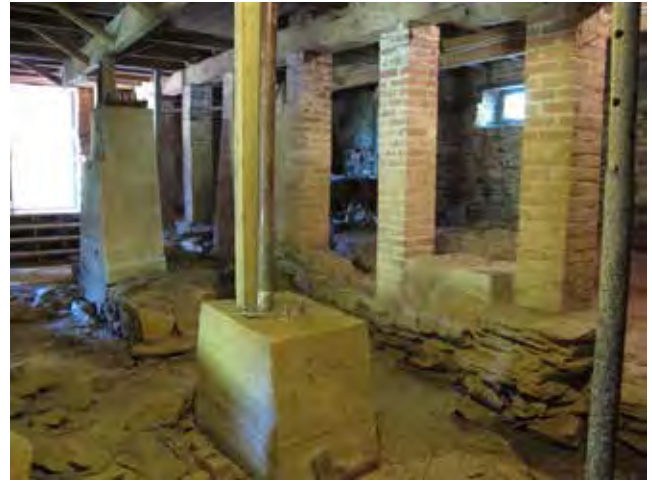
The central bay of the basement looking west.

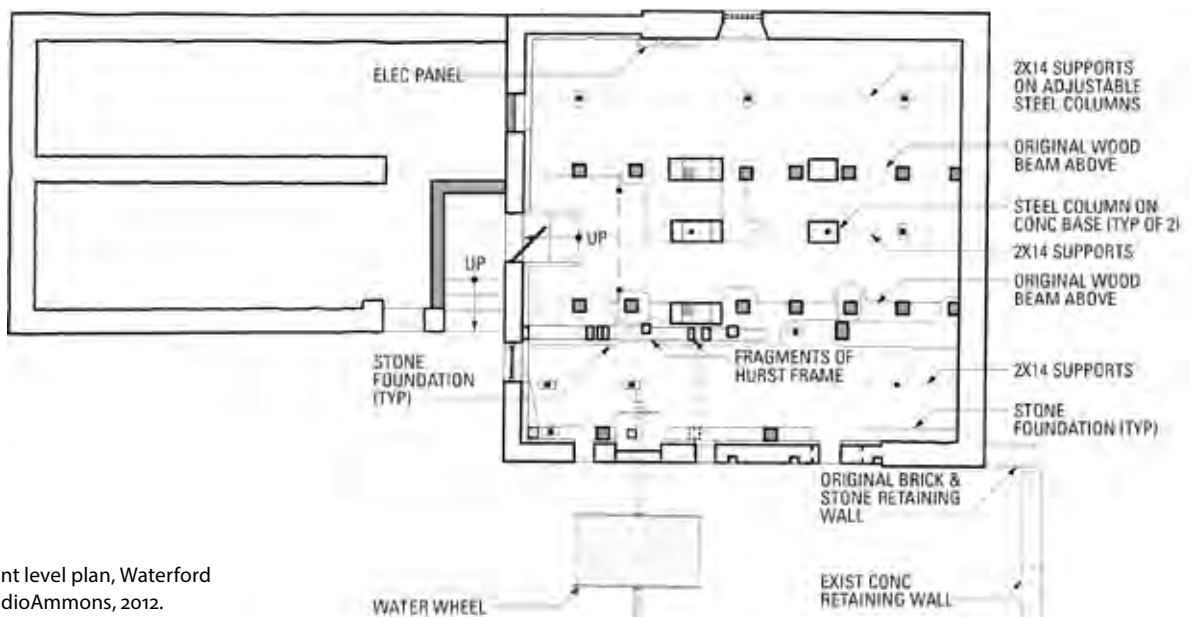
Basement level plan, Waterford Mill, StudioAmmons, 2012.

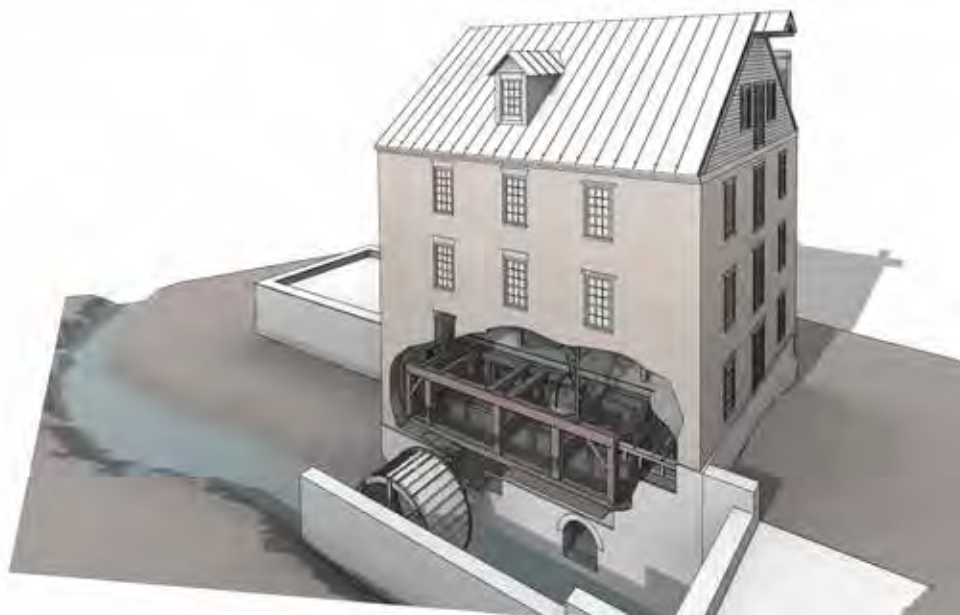
Conjectured restoration of the 1818 hurst frame with existing stone set in the present-day Waterford Mill. S. Bay Koulabdara for Studioammons, 2012

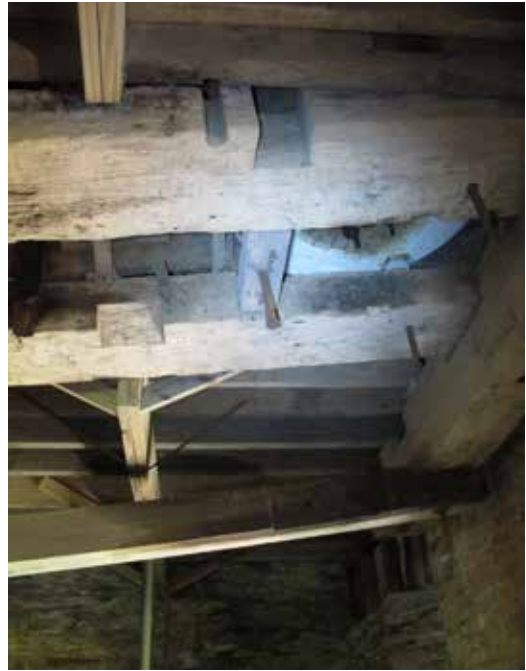
Right: Eastern millstones shifted to the south on original stone bearers.

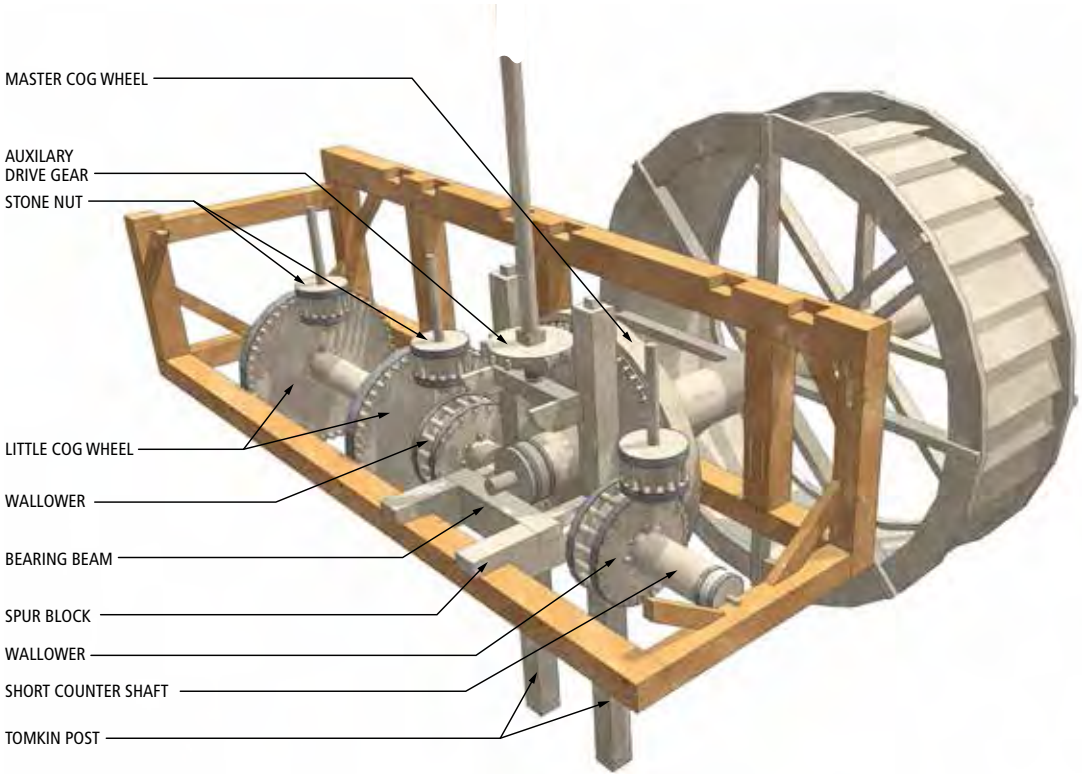
## THE WATERFORD MILL, WATERFORD, VIRGINIA

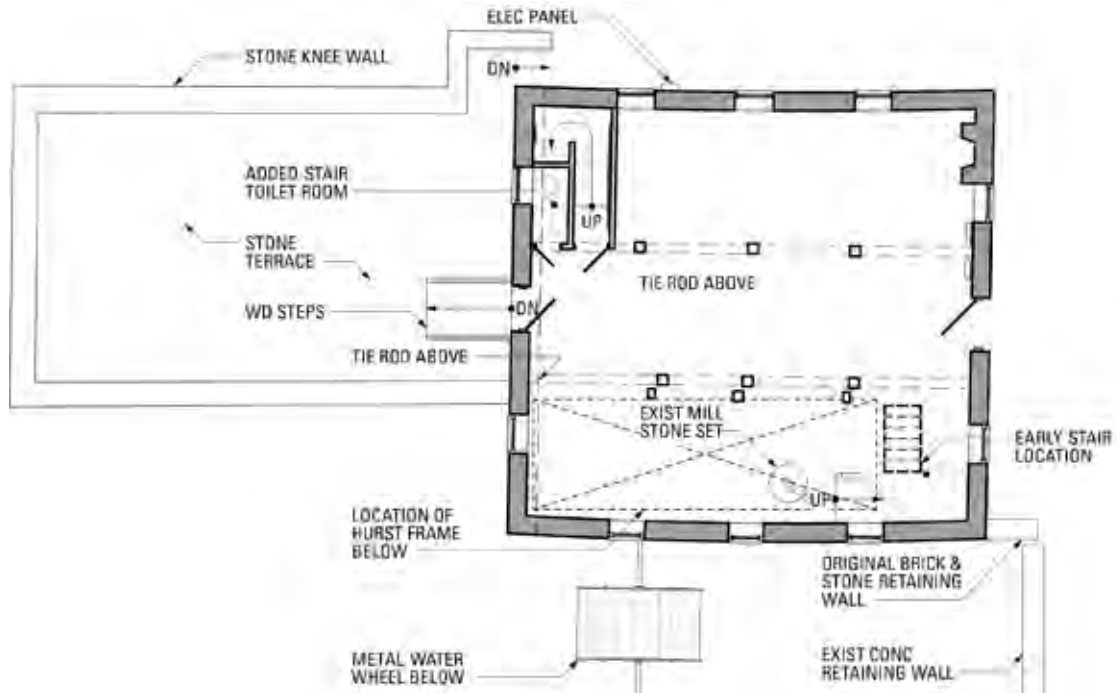
First floor plan, Waterford Mill, StudioAmmons, 2012.

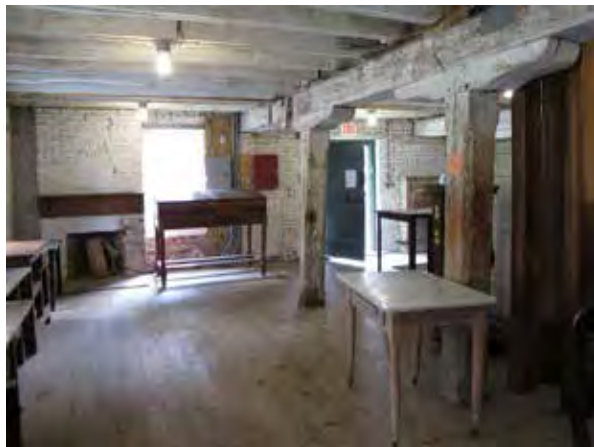
First floor looking east in north structural bay

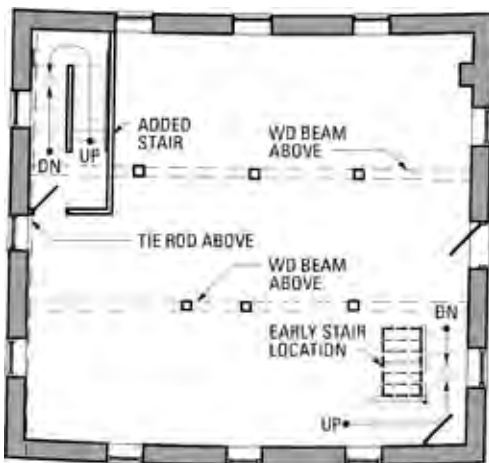
Second floor plan, Waterford Mill, StudioAmmons, 2012.
