THE WATERFORD MILL  
*Waterford, Virginia*

HISTORIC STRUCTURE REPORT

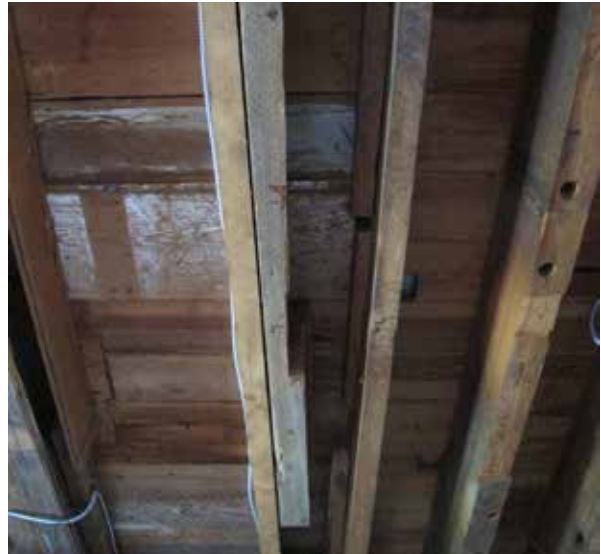
Above: The two sets of peg holes on the right (located near the west end of the center structural bay) are probably the location of a support for a central longitudinal second-floor power shaft. Looking north at Joist 18, Zone B, Sheet A-15 on the 1983 record drawings. The floor to the left is mostly old and to the right is replaced.

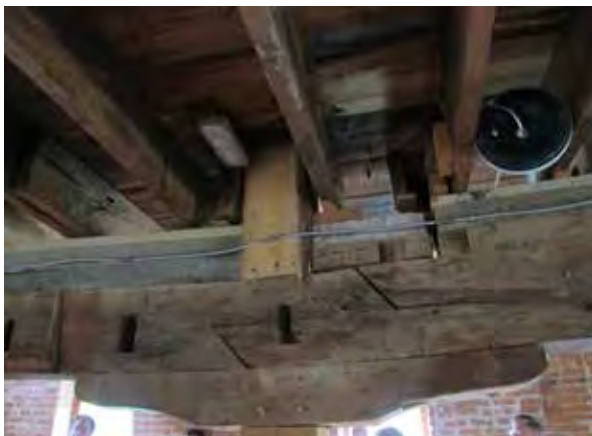
Typical scarf joint, center of northern beam on second floor.

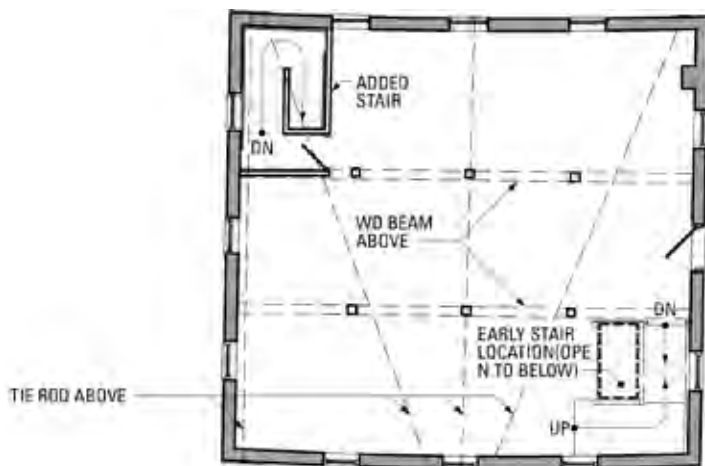
Third floor plan, Waterford Mill, StudioAmmons, 2012.

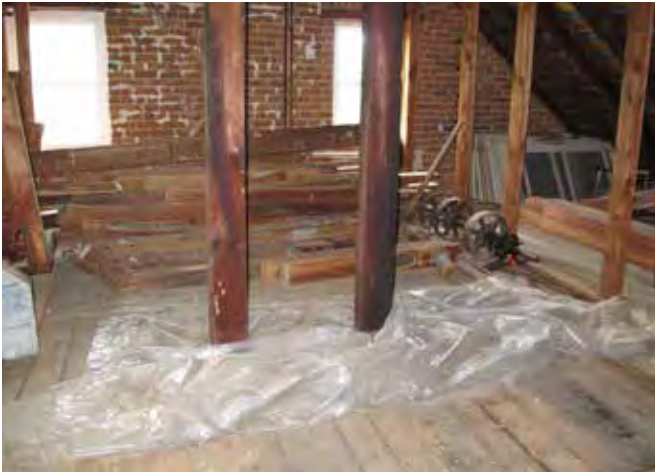
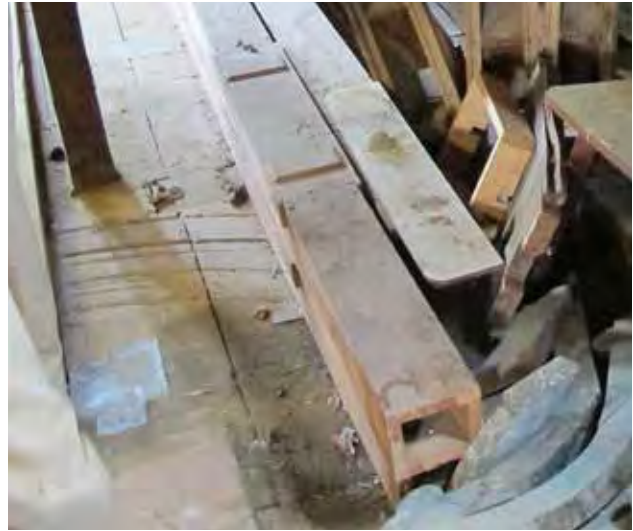
Above: The attic looking west.  
Right: Traces of a hopper boy flight arm on the attic floor

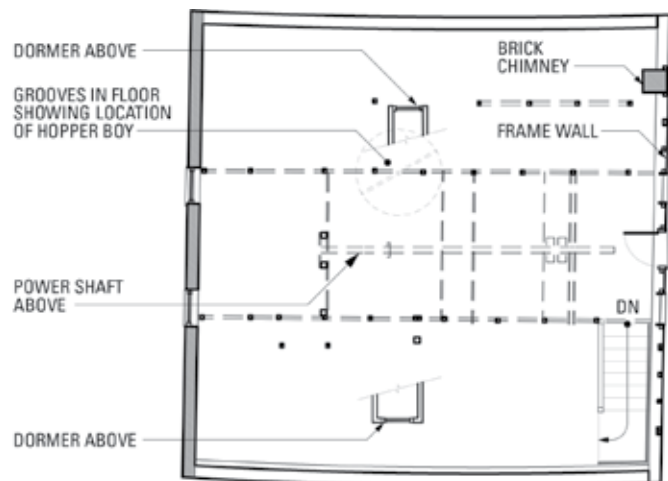
Attic floor plan, Waterford Mill, StudioAmmons, 2012.

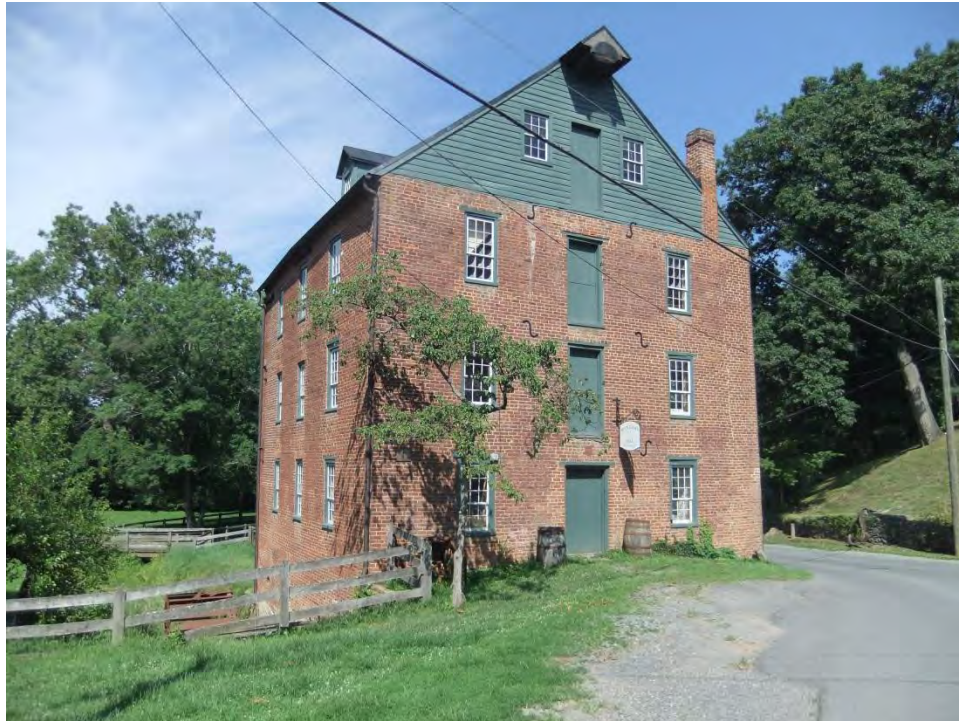
**Figure 1:** East elevation of Waterford Mill

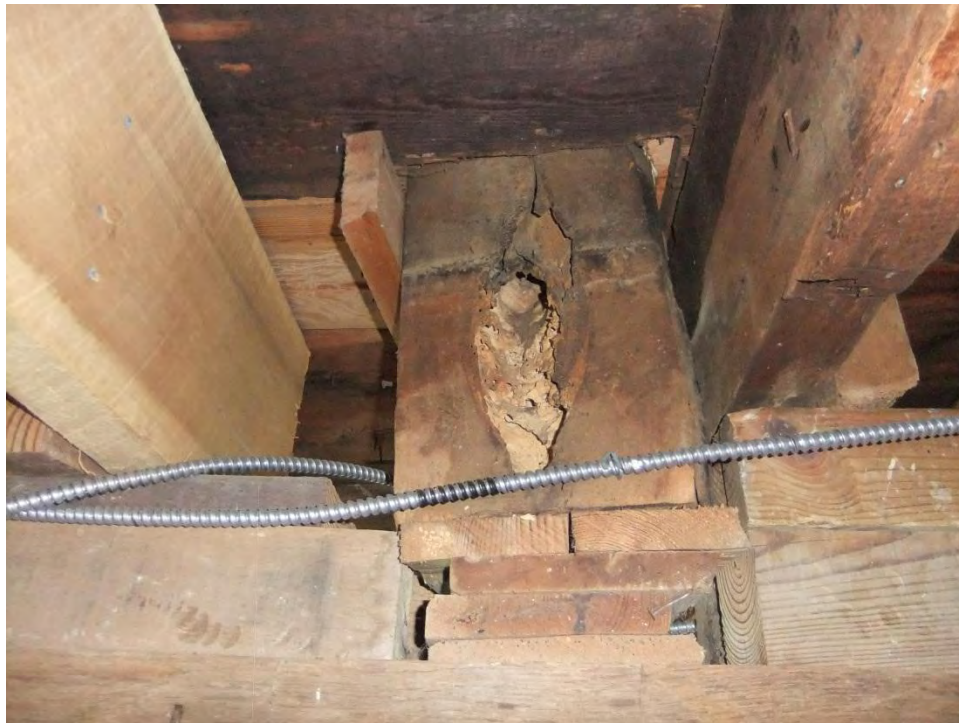
**Figure 20:** Third floor post deterioration

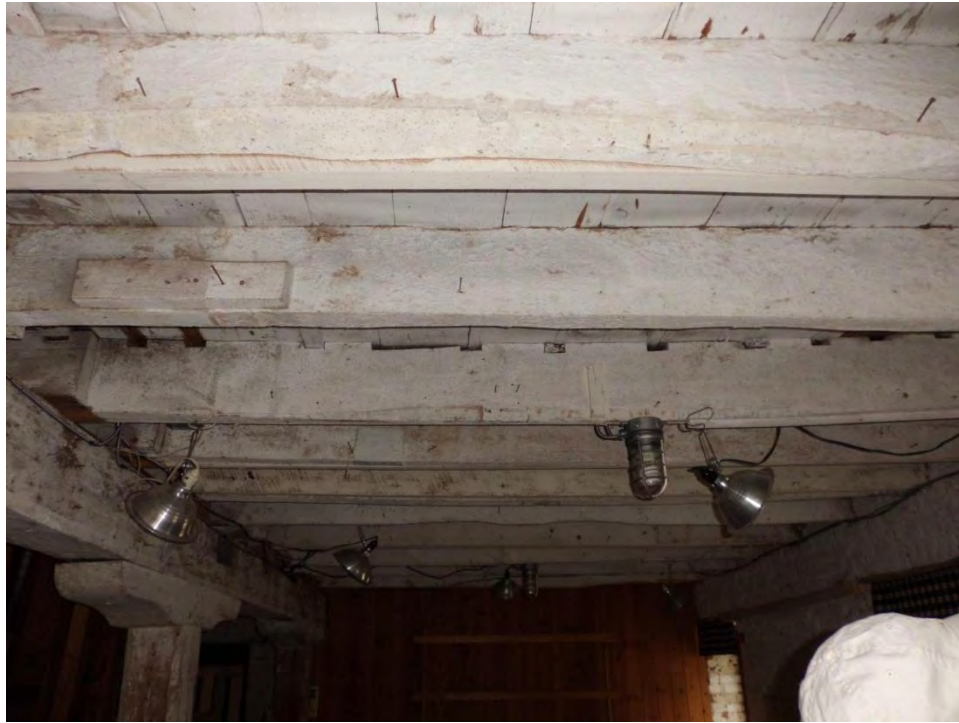
**Figure 21:** Second floor joist framing

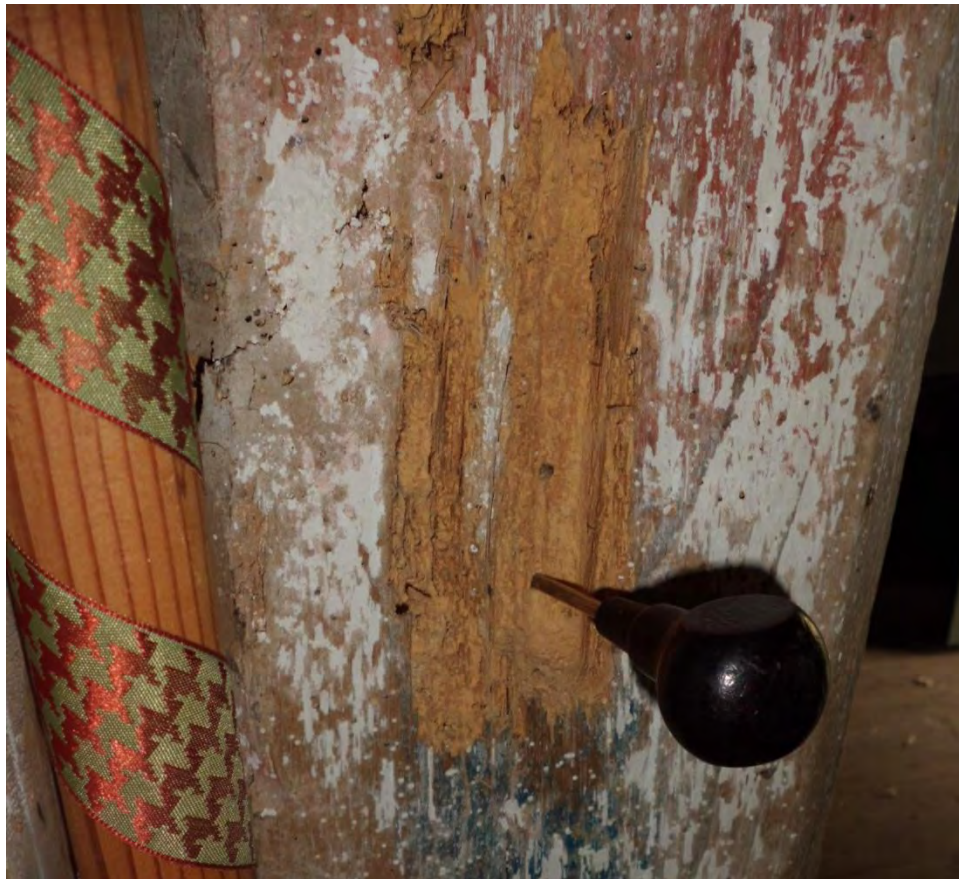
**Figure 26:** Second floor southeast corner column deterioration

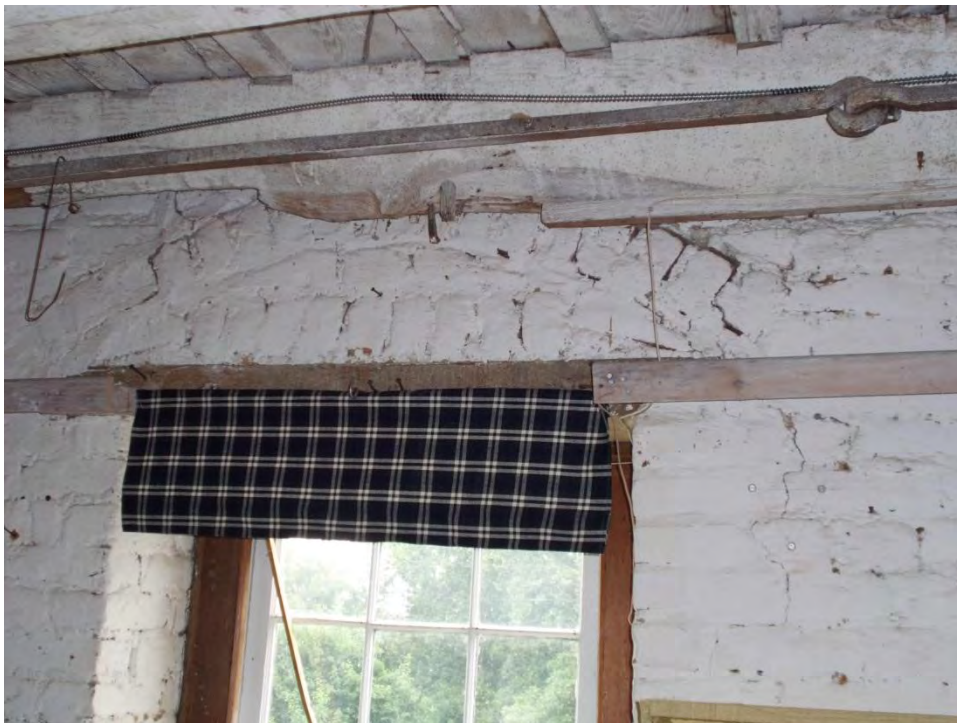
**Figure 28:** Cracking in masonry above first floor window along west wall

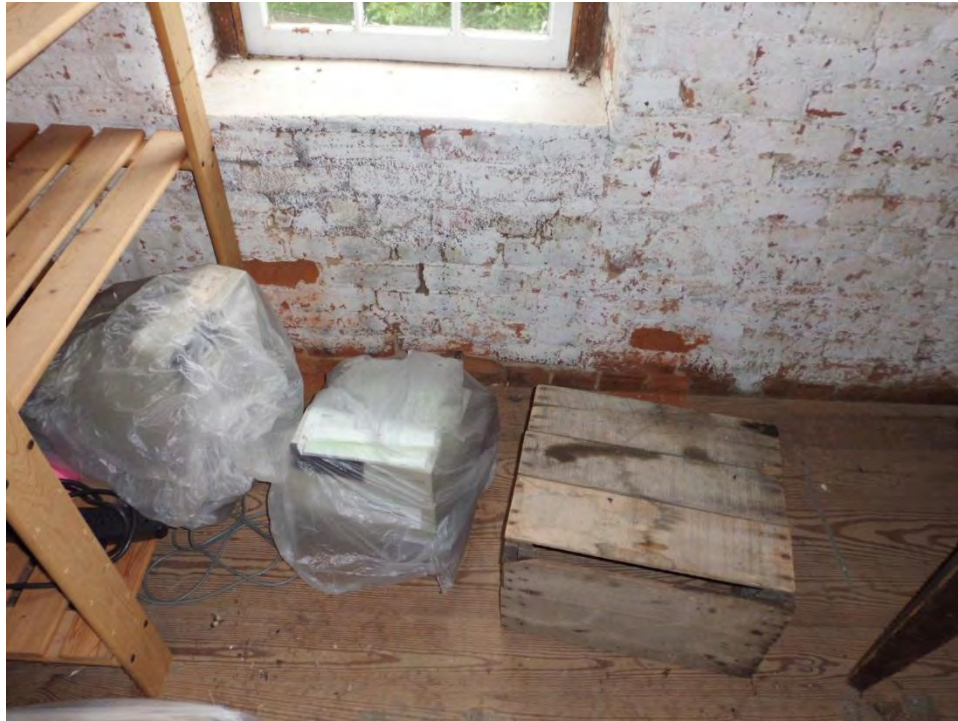
**Figure 29:** Spalling of masonry below first floor window opening along south wall

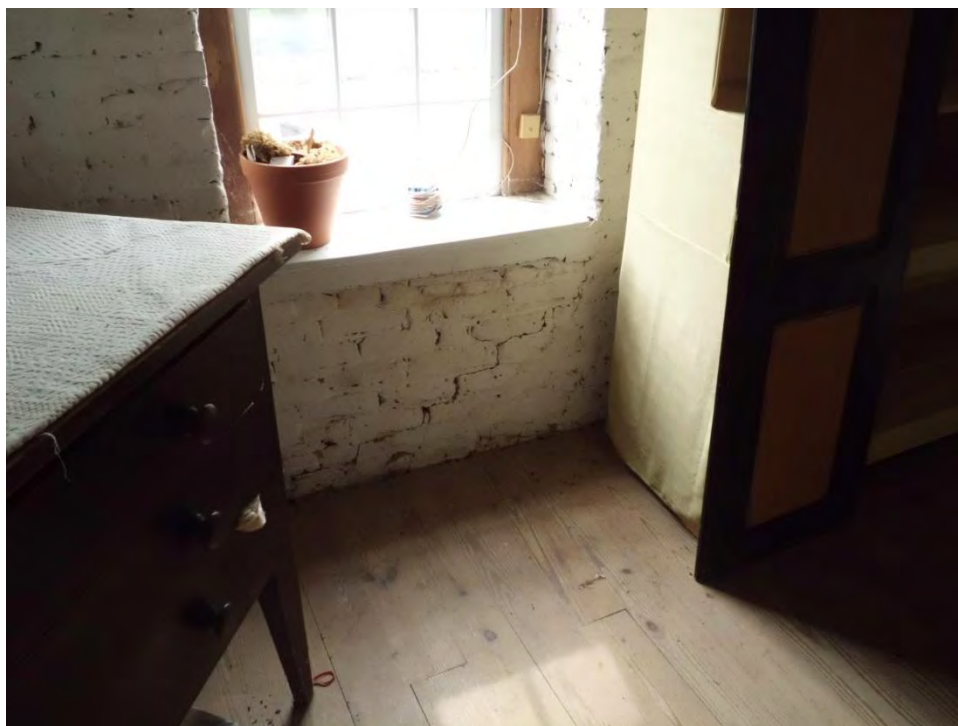
**Figure 30:** Diagonal cracking within mortar joints below first floor window opening along west wall

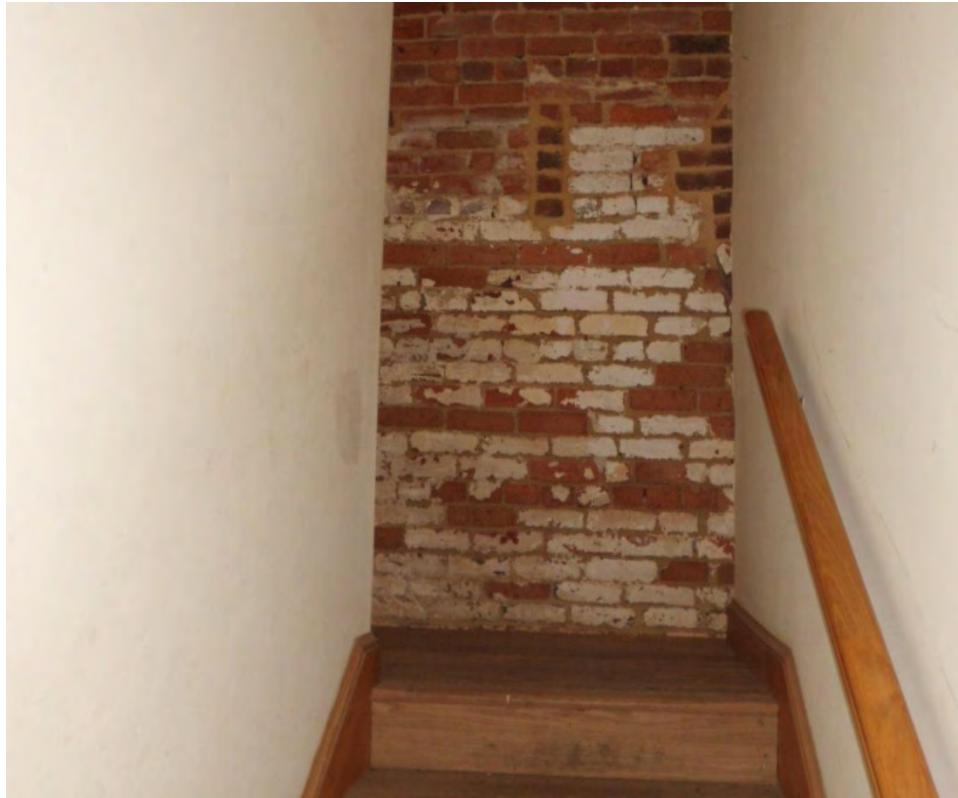
**Figure 31:** Brick spalling within northwest stairwell landing

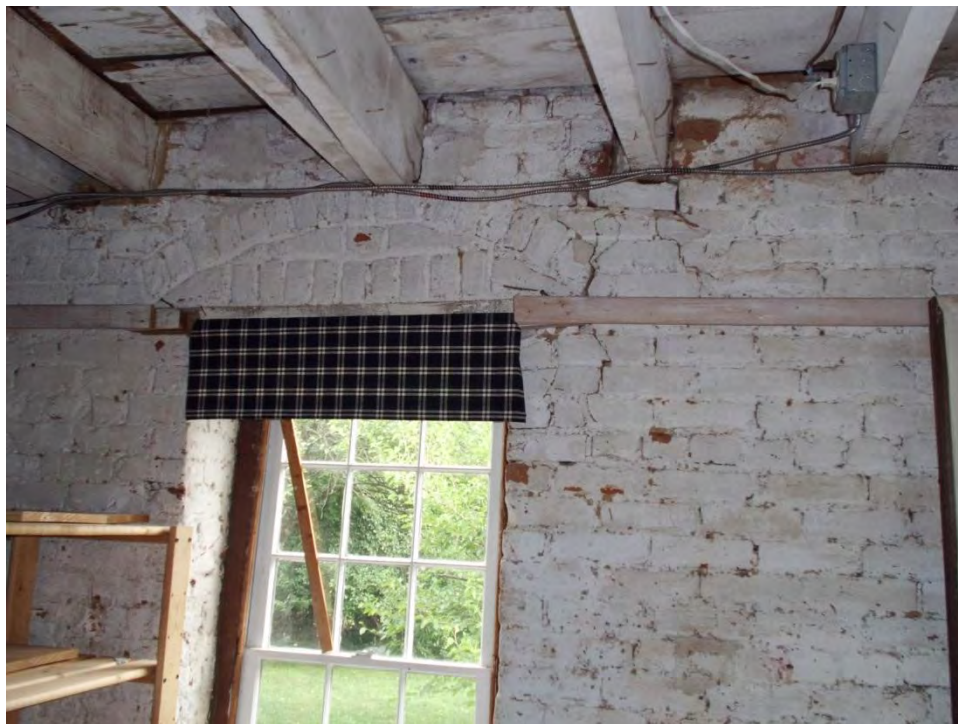
**Figure 32:** Second floor joist bearing deterioration at exterior masonry pocket

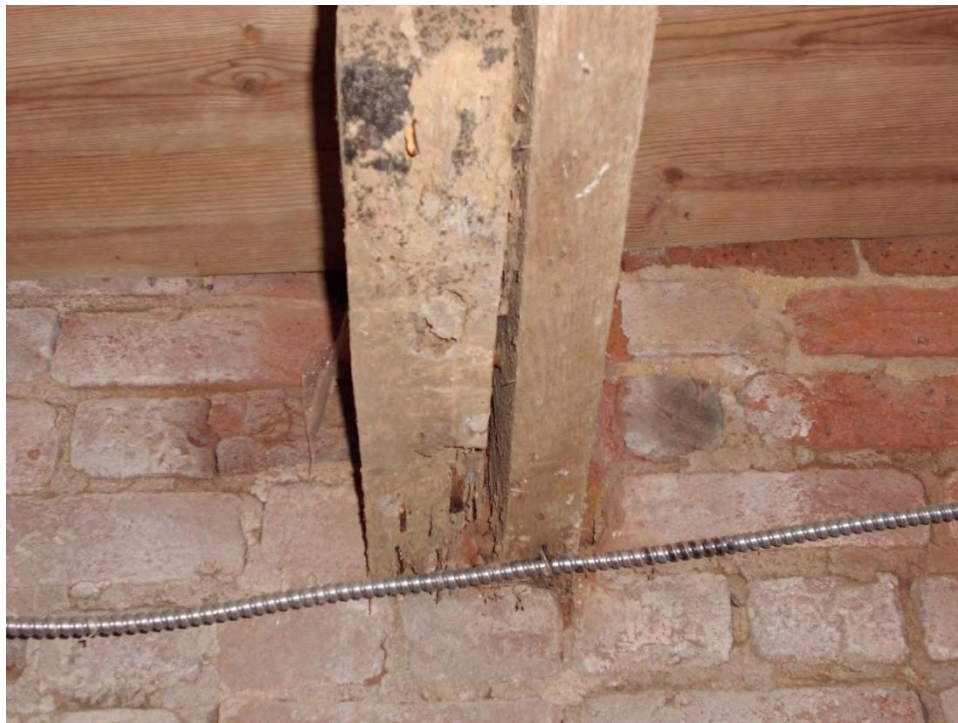
**Figure 36:** First floor joist bearing deterioration at northern masonry wall

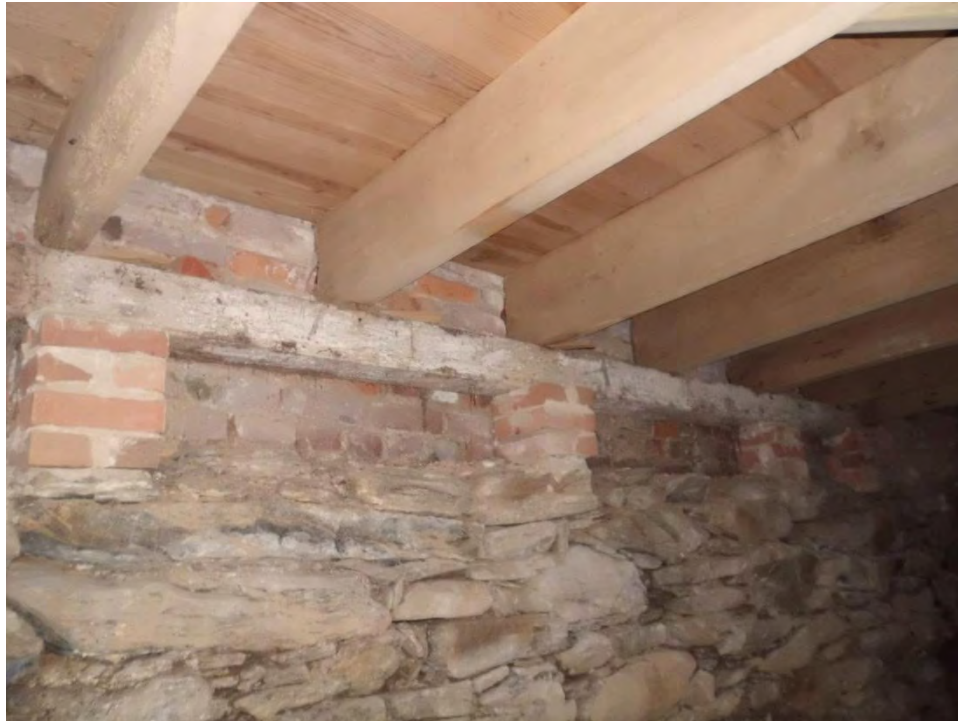
**Figure 37:** First floor northern joist masonry pier support

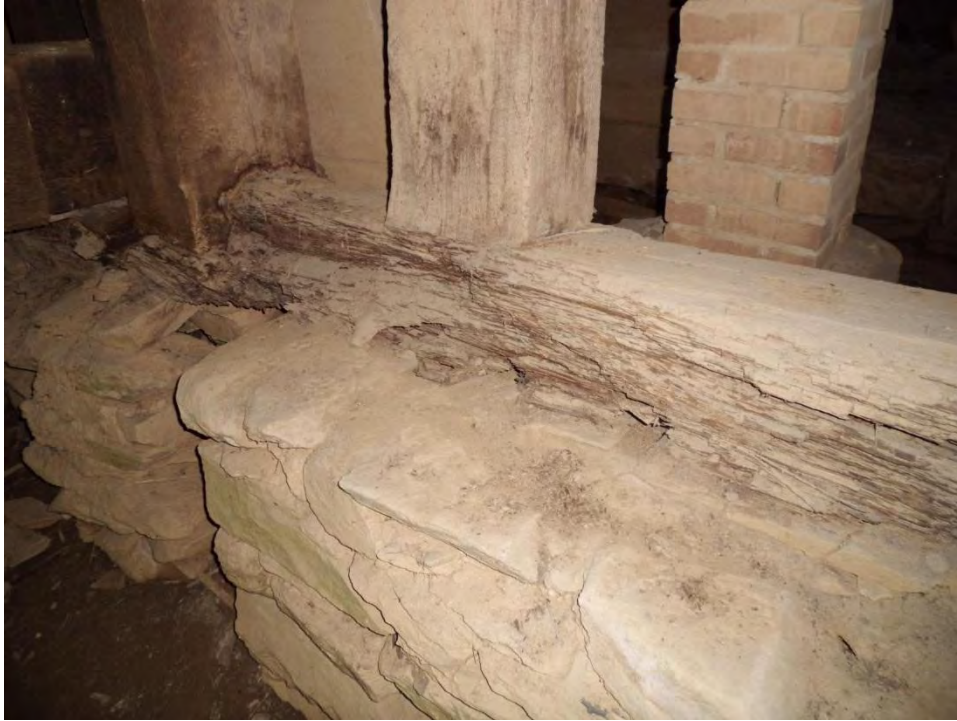
**Figure 41:** Canted brace with deteriorated Hurst frame support

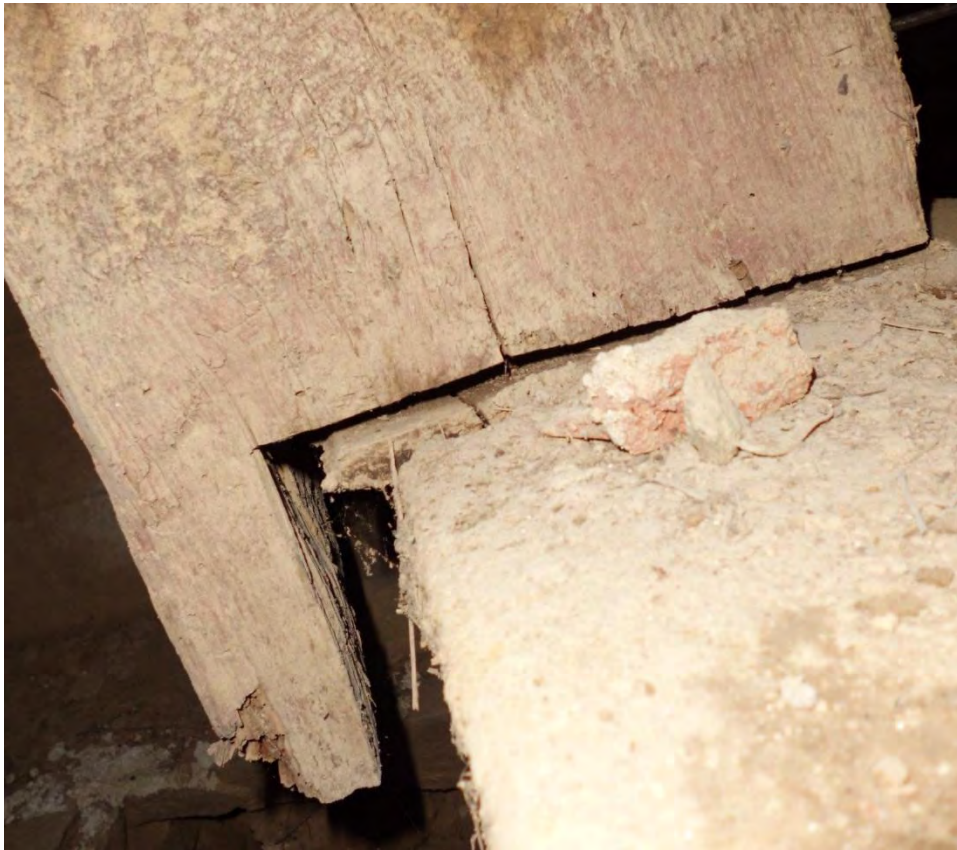
**Figure 42:** Canted brace bearing deterioration on Hurst frame

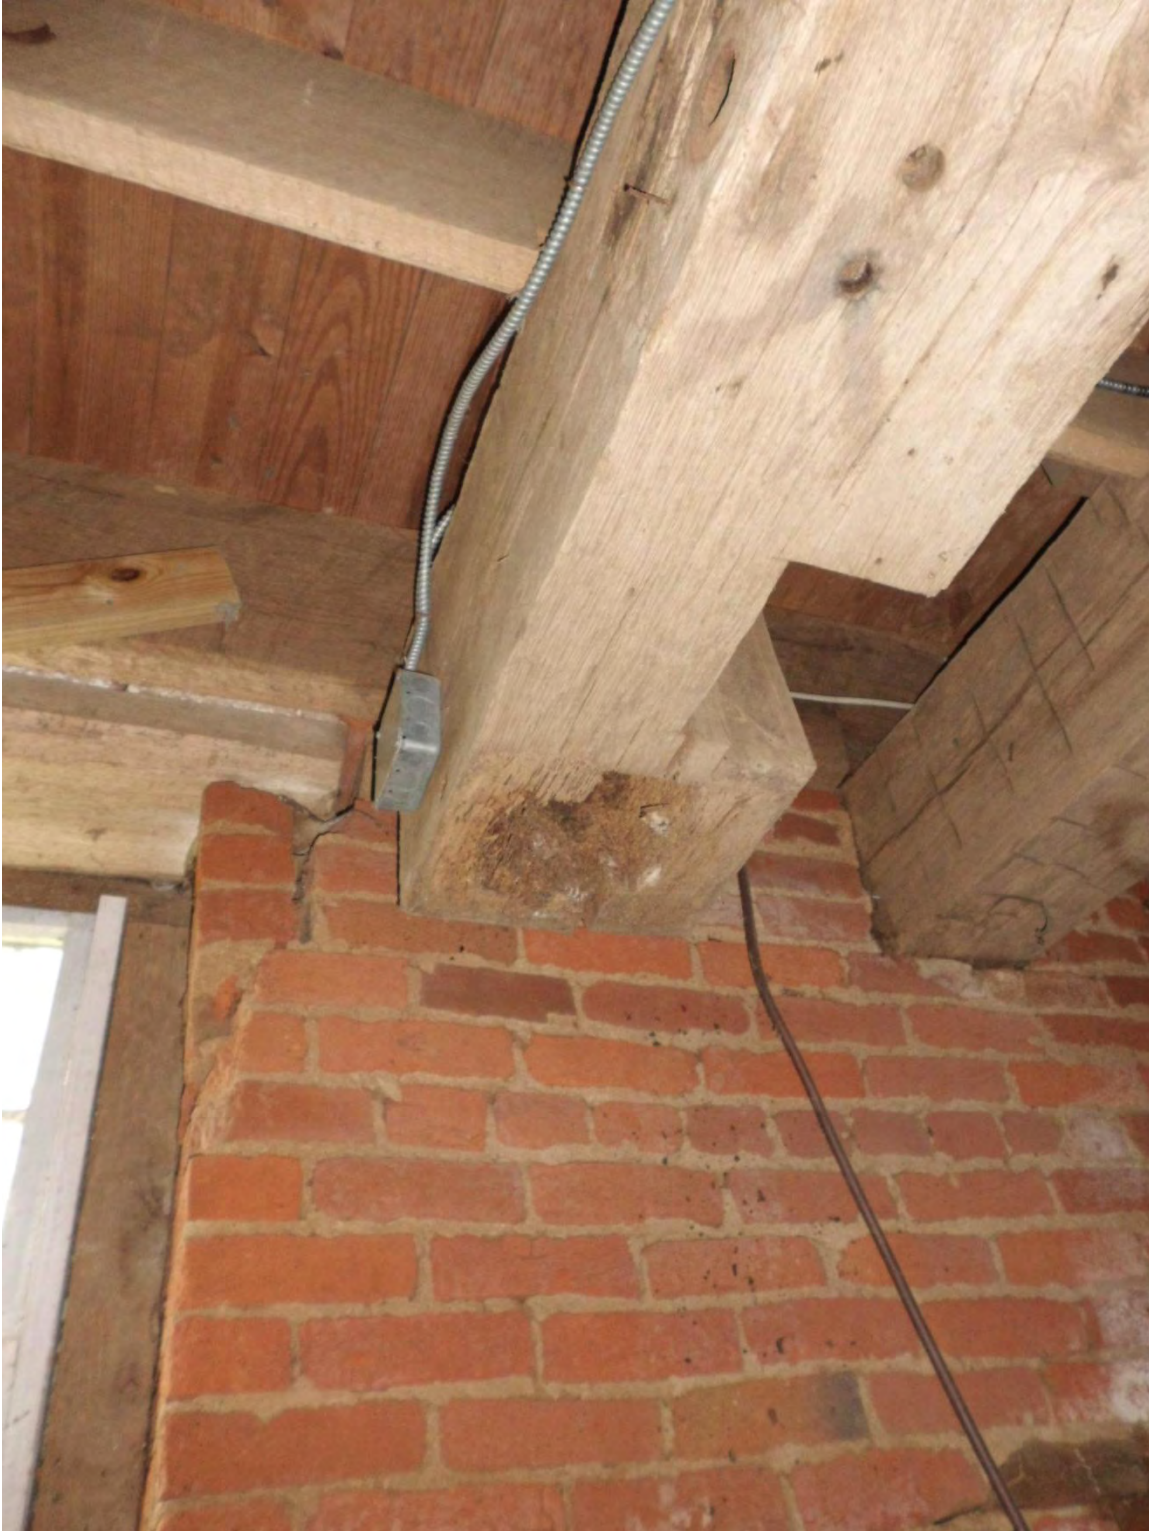
**Figure 43:** Hurst frame beam with loss of supporting post and cracked masonry at opening to left

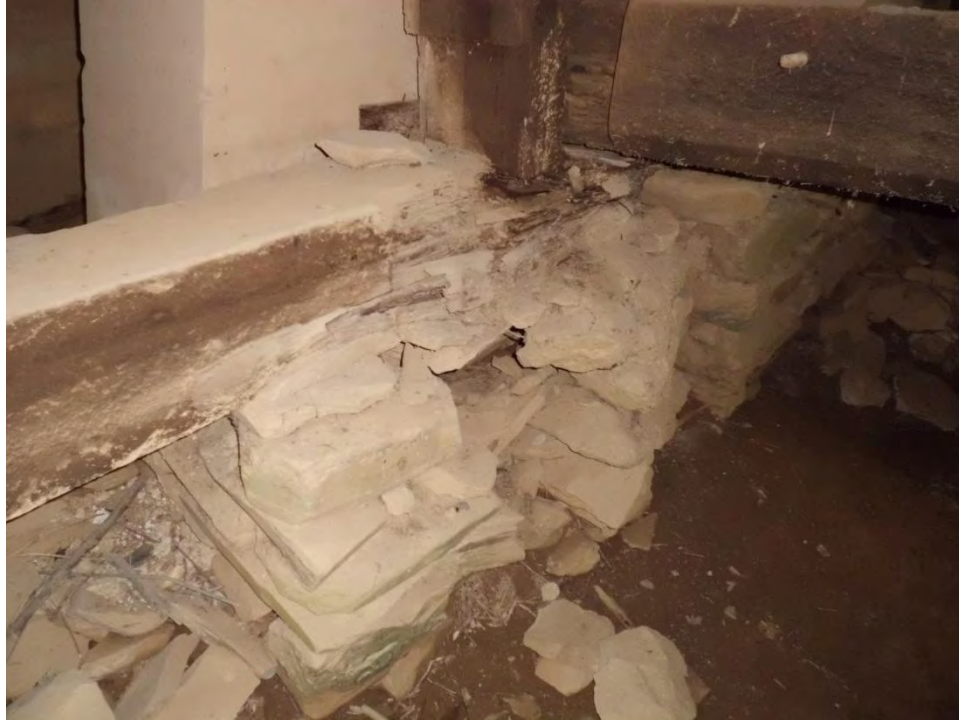
**Figure 44:** Hurst frame bearing deterioration and looseness in masonry below

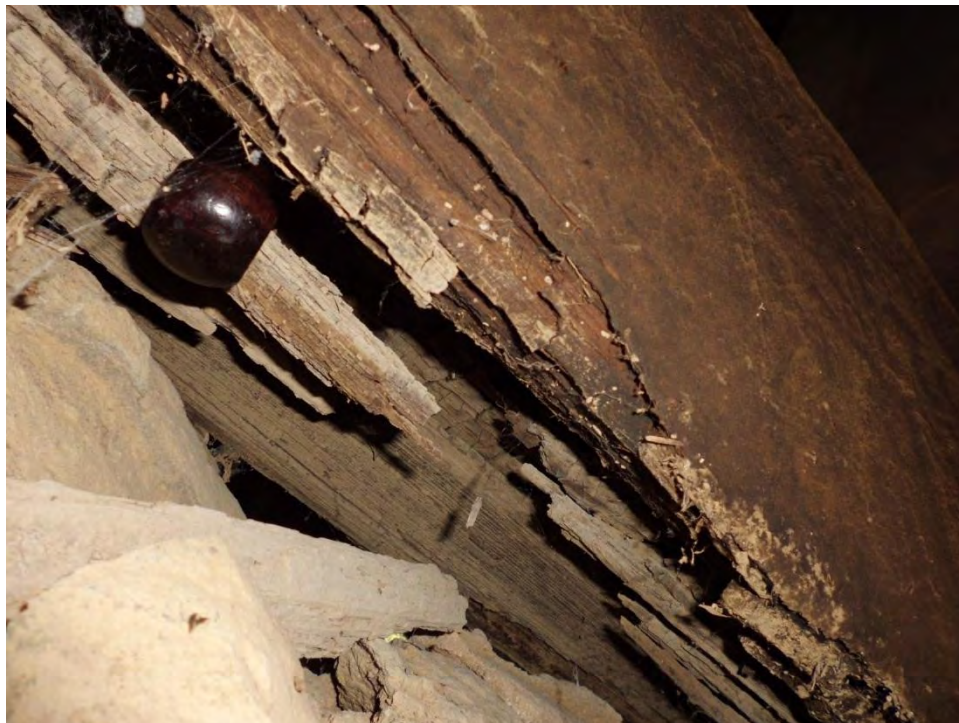
**Figure 45:** Hurst frame deterioration

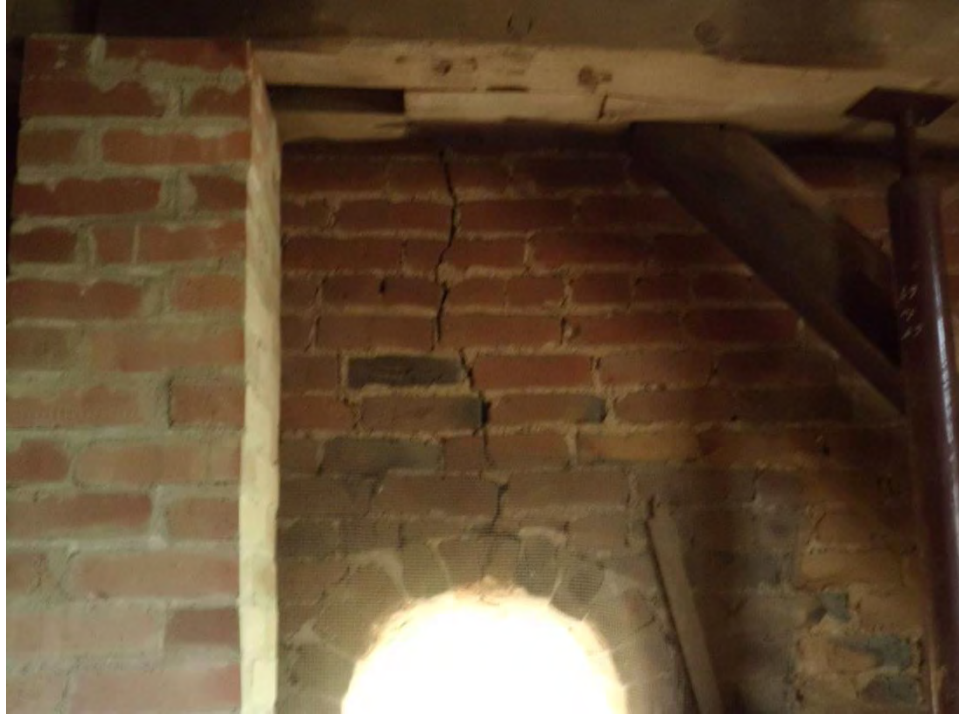
**Figure 46:** Vertical crack in masonry at west window of south elevation

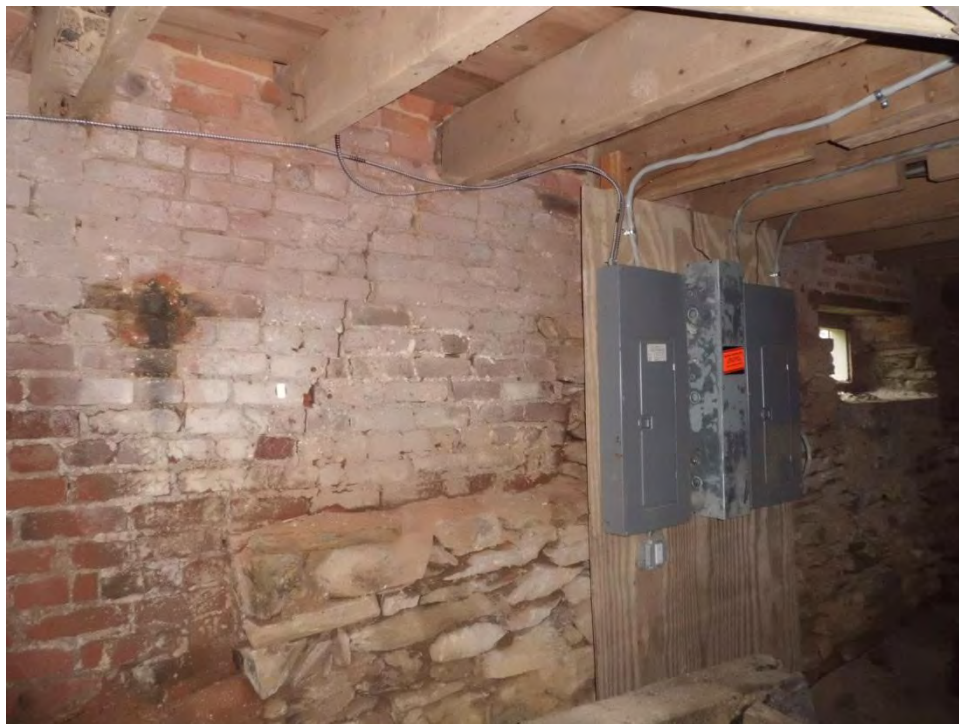
**Figure 47:** Vertical crack in brick masonry above stone foundation wall at northwest corner

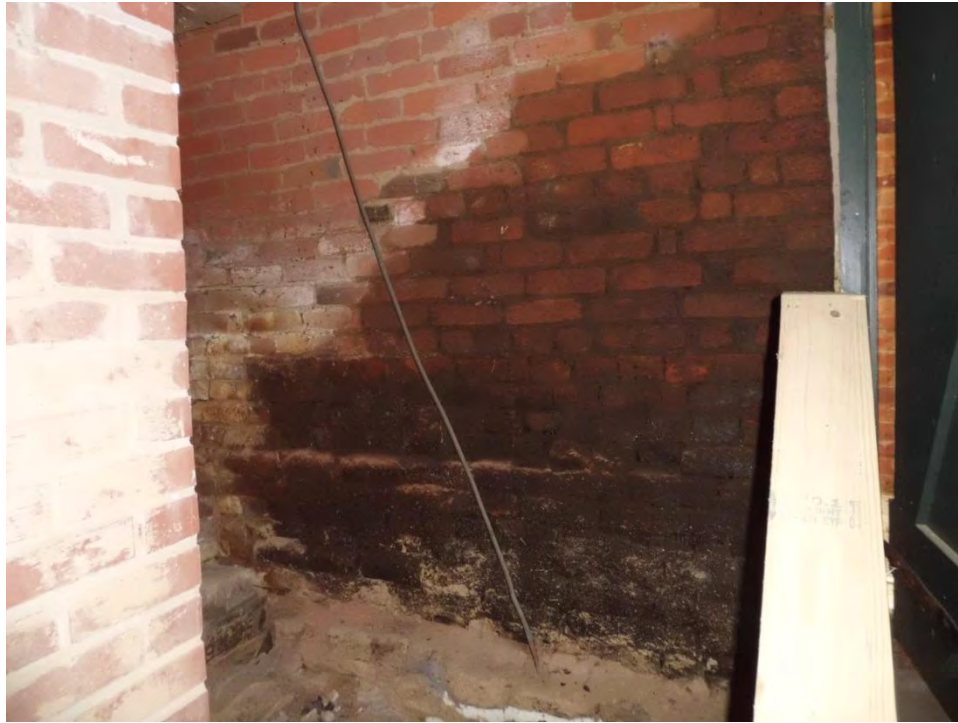
**Figure 48:** Saturation of brick masonry above west foundation wall

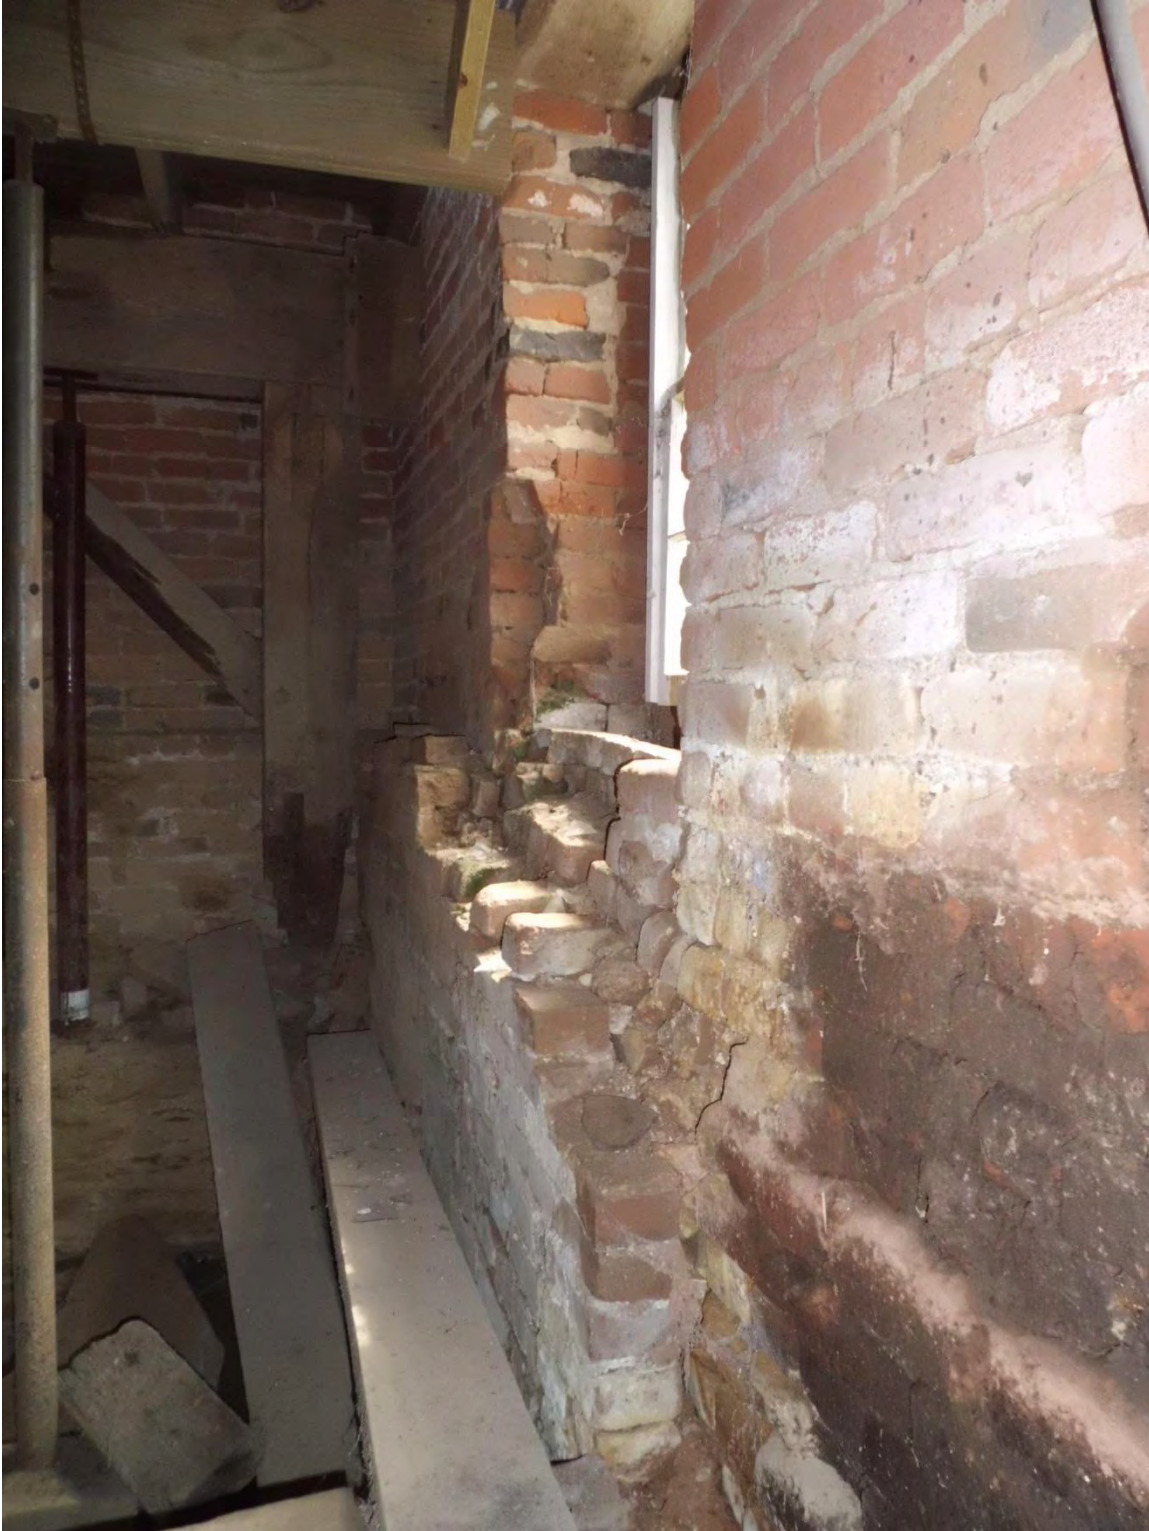
**Figure 49:** Deterioration of brick masonry at southern window of west foundation wall

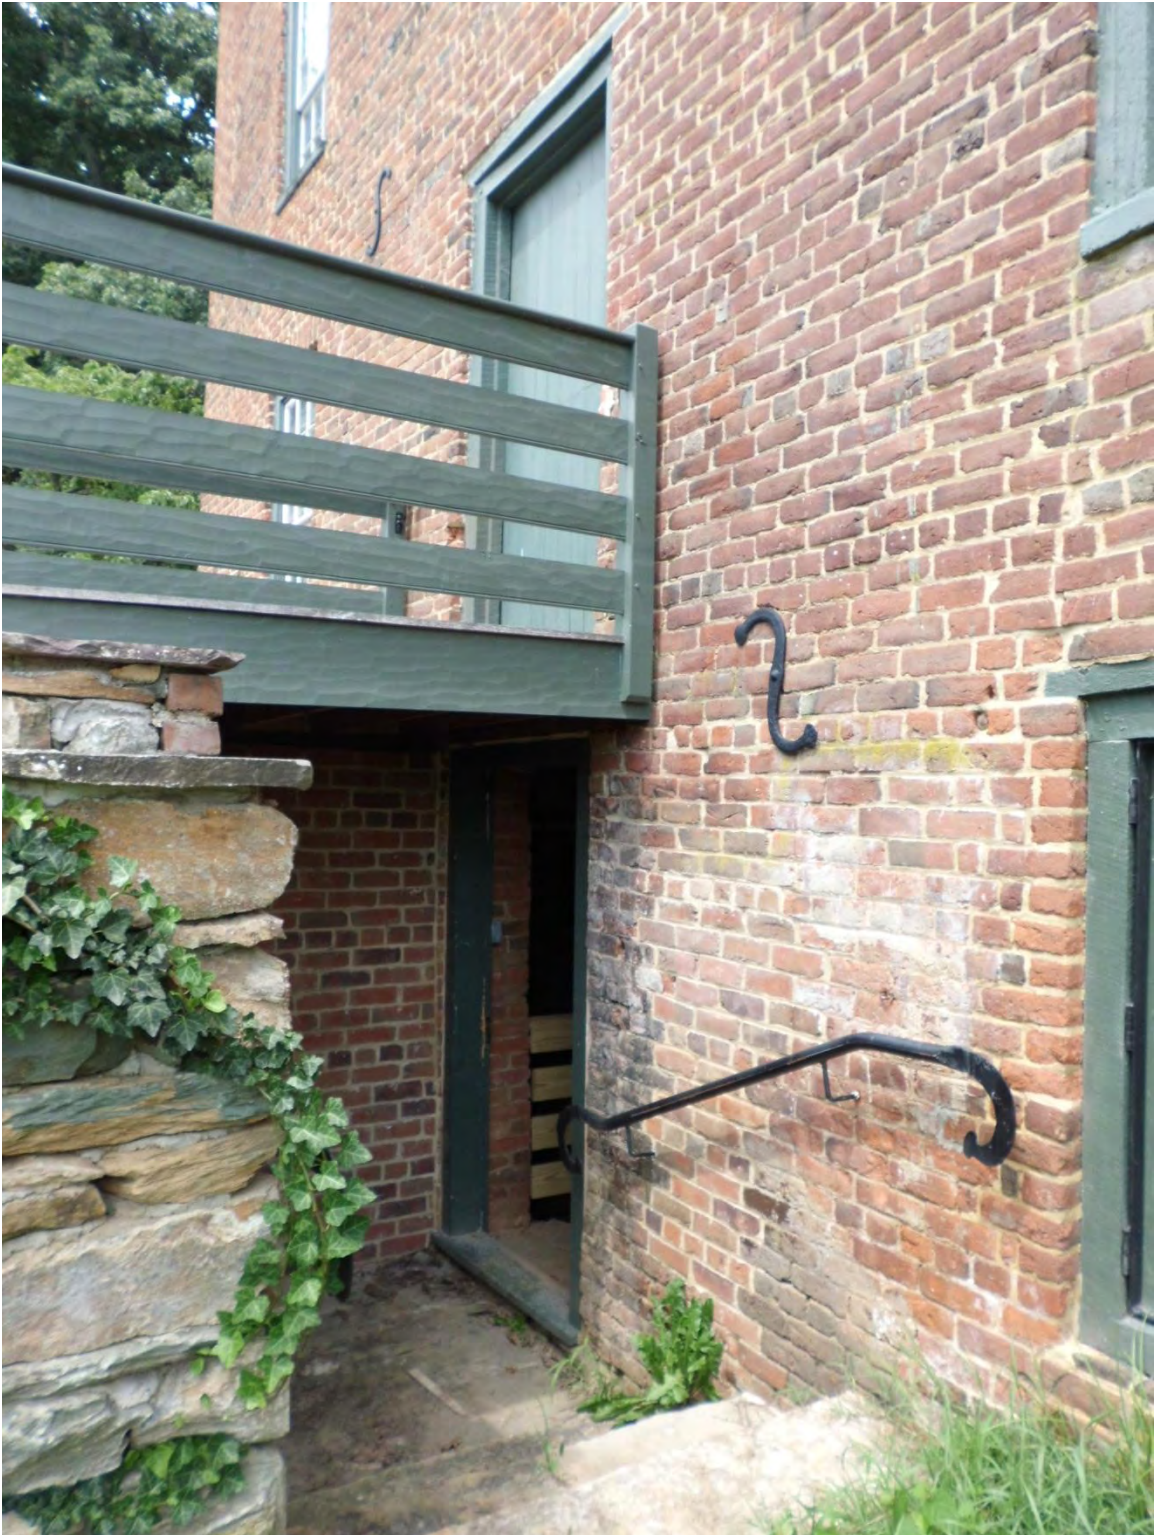
**Figure 50:** Installation of new first floor and basement entry along west wall

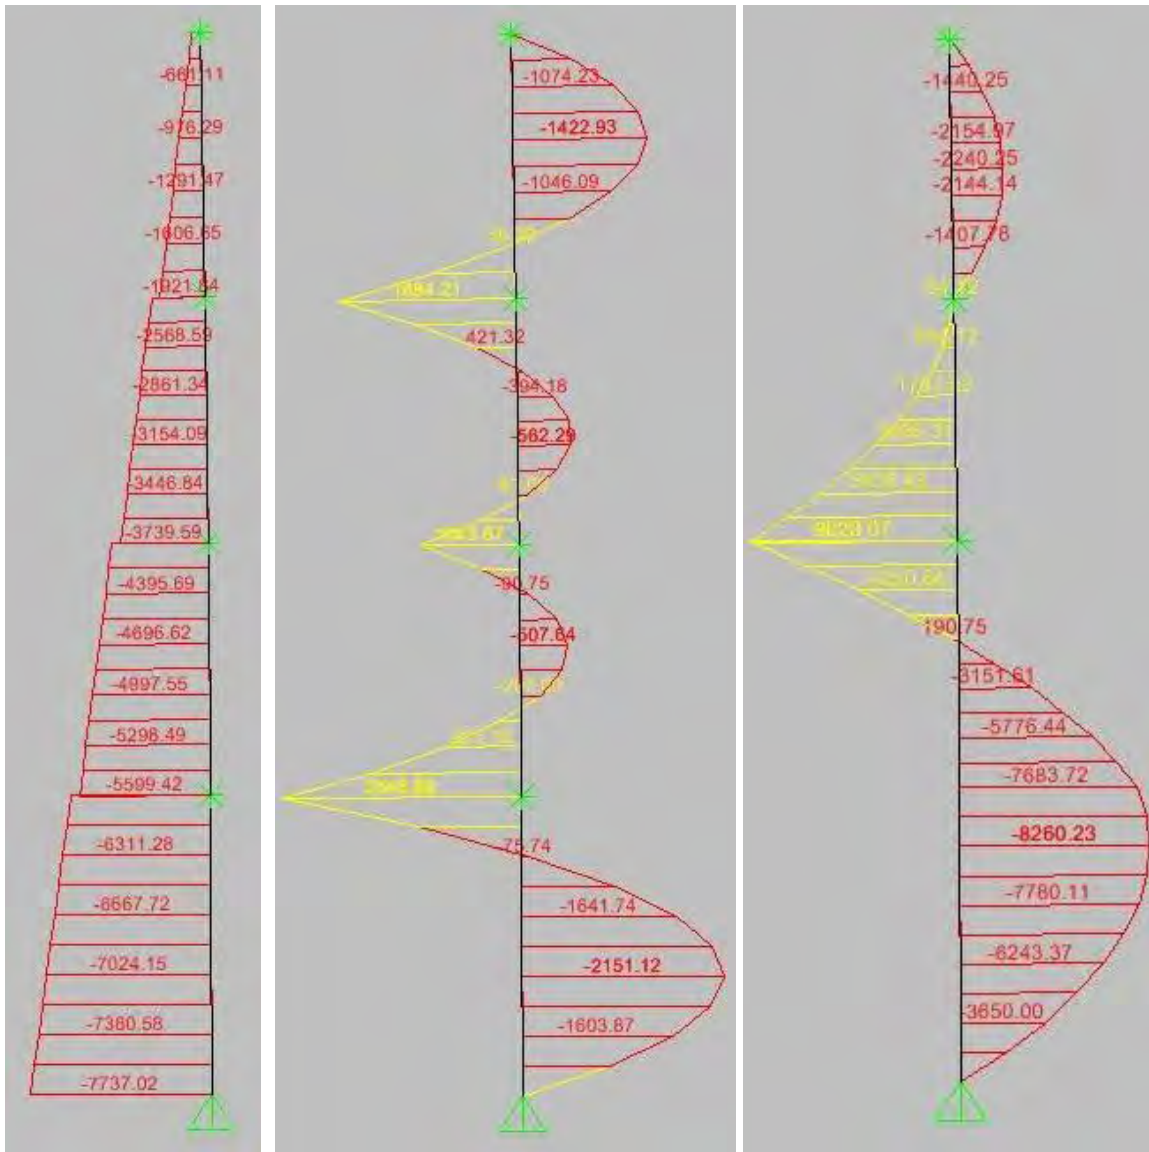
**Figure 57:** Applied axial load to south load-bearing masonry wall (pounds per linear foot) at left. Induced bending moment (pounds-inch) in south exterior wall due to lateral wind load and out-of-plane displacement when braced at each floor level by floor framing (center). At right, shown is the induced bending moment (pounds-inch) in south wall due to lateral wind load and out-of-plane displacement when braced at all floors except first floor (current condition).
