THE WATERFORD MILL  
*Waterford, Virginia*

HISTORIC STRUCTURE REPORT

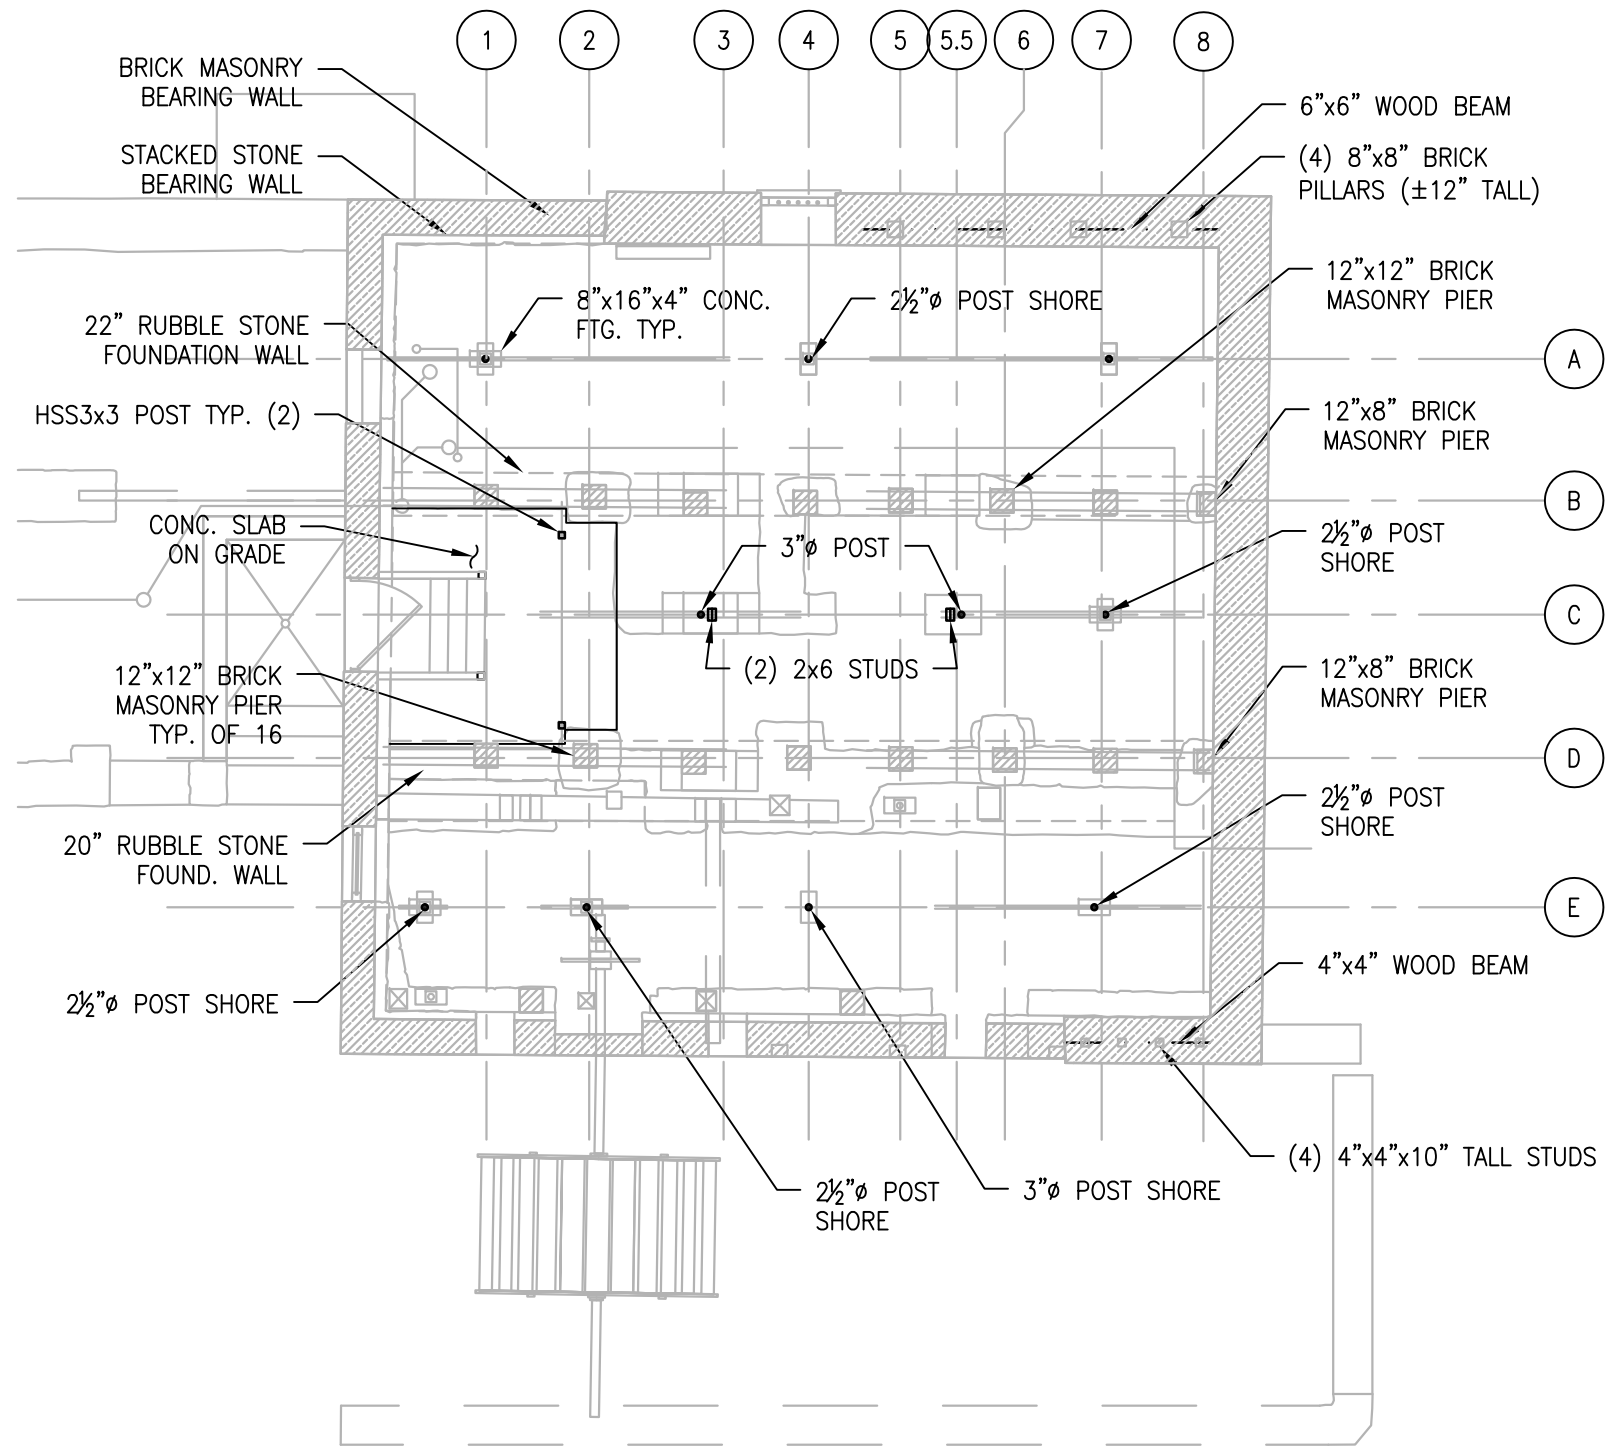
FOUNDATION SCHEDULE					
COLUMN	W <sub>r</sub>	W <sub>b</sub>	D	H	MATL.
B-2	29"	--	25"	11"	STONE
B-3	28"	51½"	21"	64"	CONC.
B-4	24"	--	20"	11"	STONE
B-5.5	27"	33"	21"	18"	CONC.
B-6	26"	--	24"	10"	STONE
B-8	25"	--	18"	9"	STONE
C-3	27"	51"	21"	65"	CONC.
C-5.5	28½"	39½"	21"	29"	CONC.
D-2	25"	--	30"	7"	STONE
D-3	26"	51"	21"	62"	CONC.
D-4	28"	--	32"	4"	STONE
D-5	12"	12"	--	--	BRICK
D-6	22"	33"	33"	6"	STONE
D-8	18"	--	30"	9"	STONE

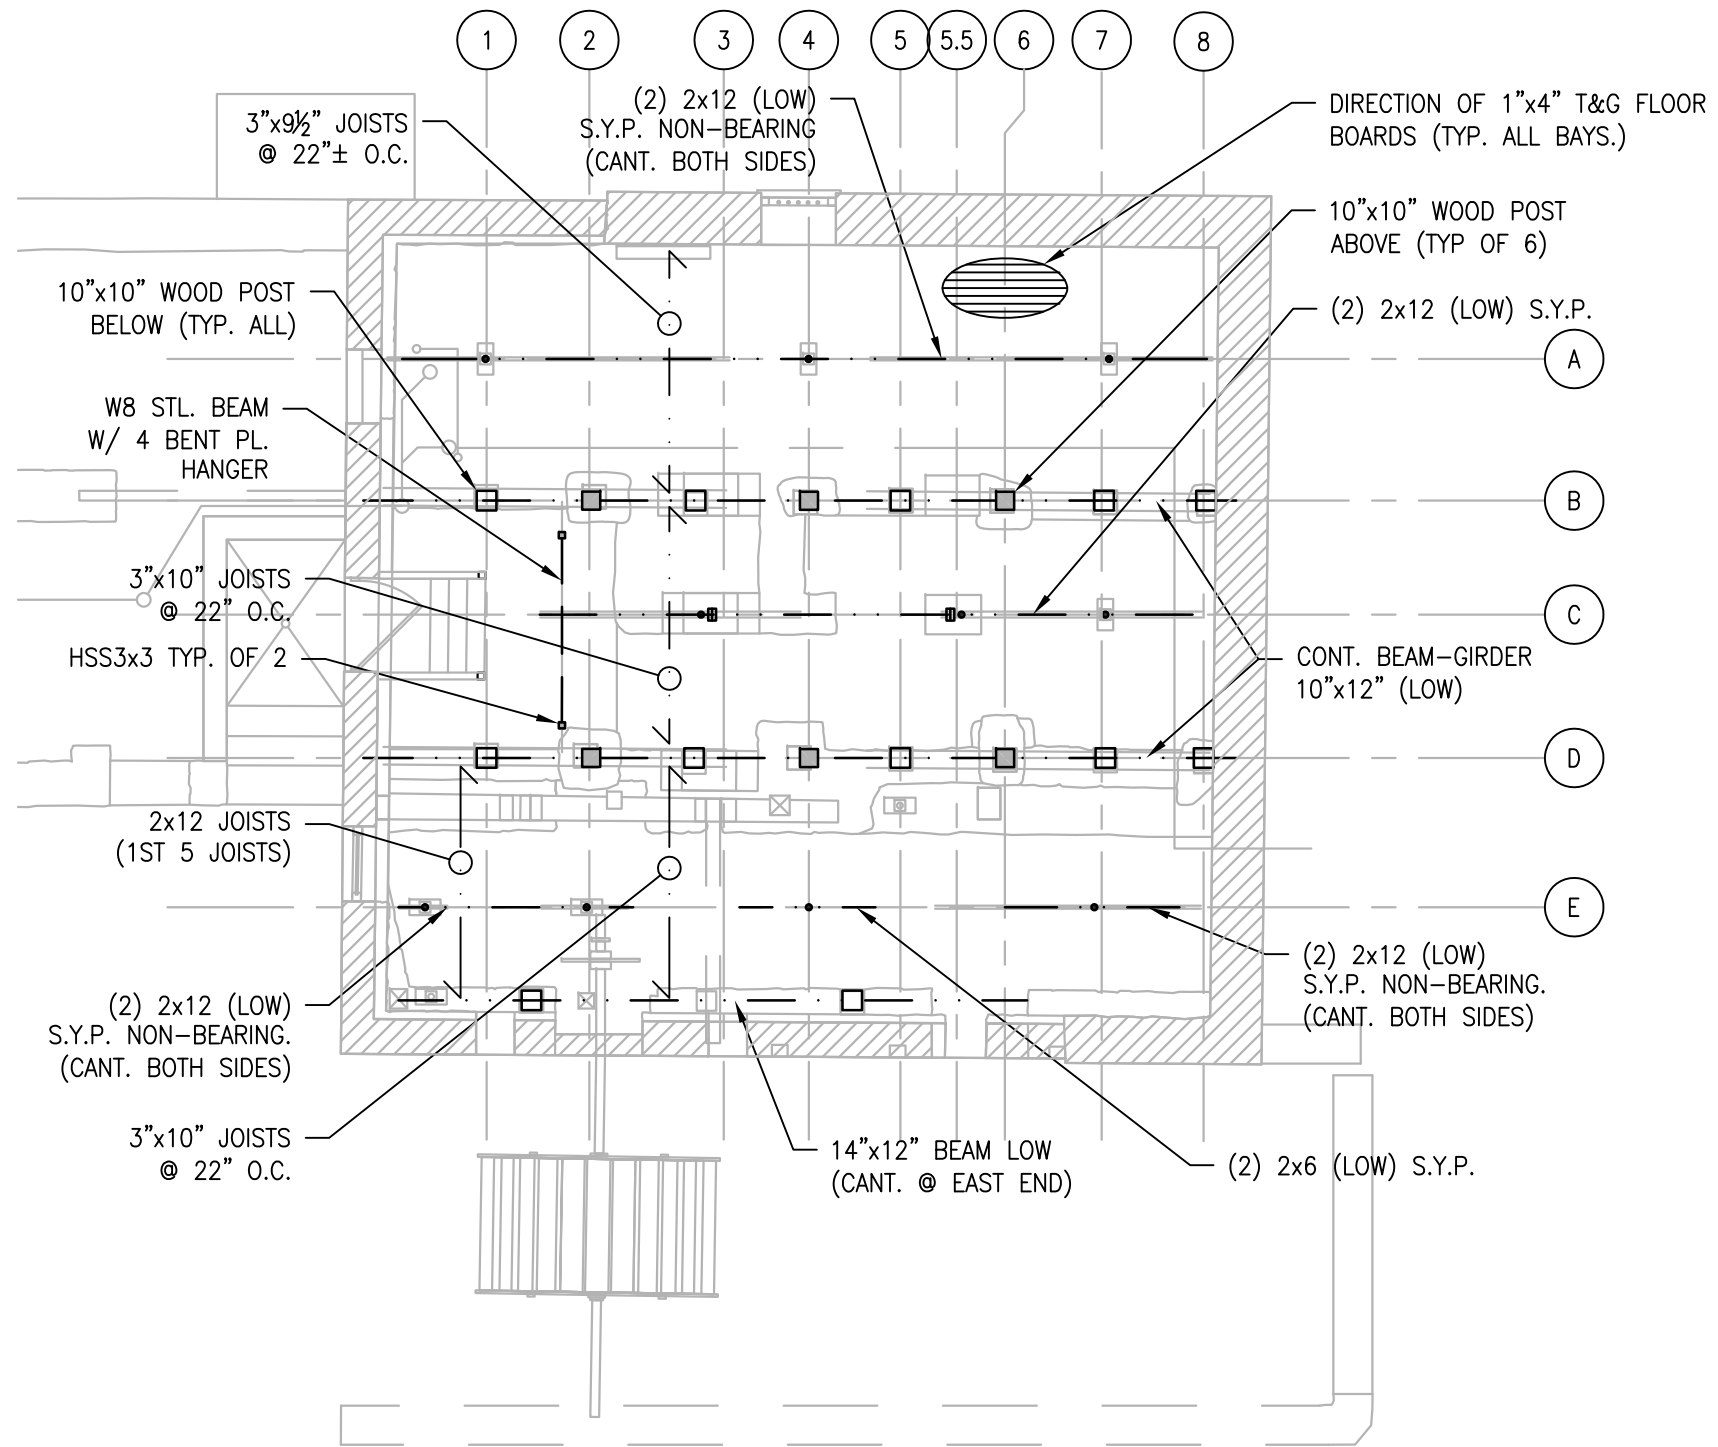
NOTE: EXISTING FIRST FLOOR FRAMING HAS AN ESTIMATED ALLOWABLE LIVE LOAD OF 100 PSF ASSUMING JOIST, BEAMS, & FLOOR BOARDS ARE IN AN UNDETERIORATED STATE. CAPACITY IS ESTIMATED ASSUMING AN UNLOADED FLOOR.

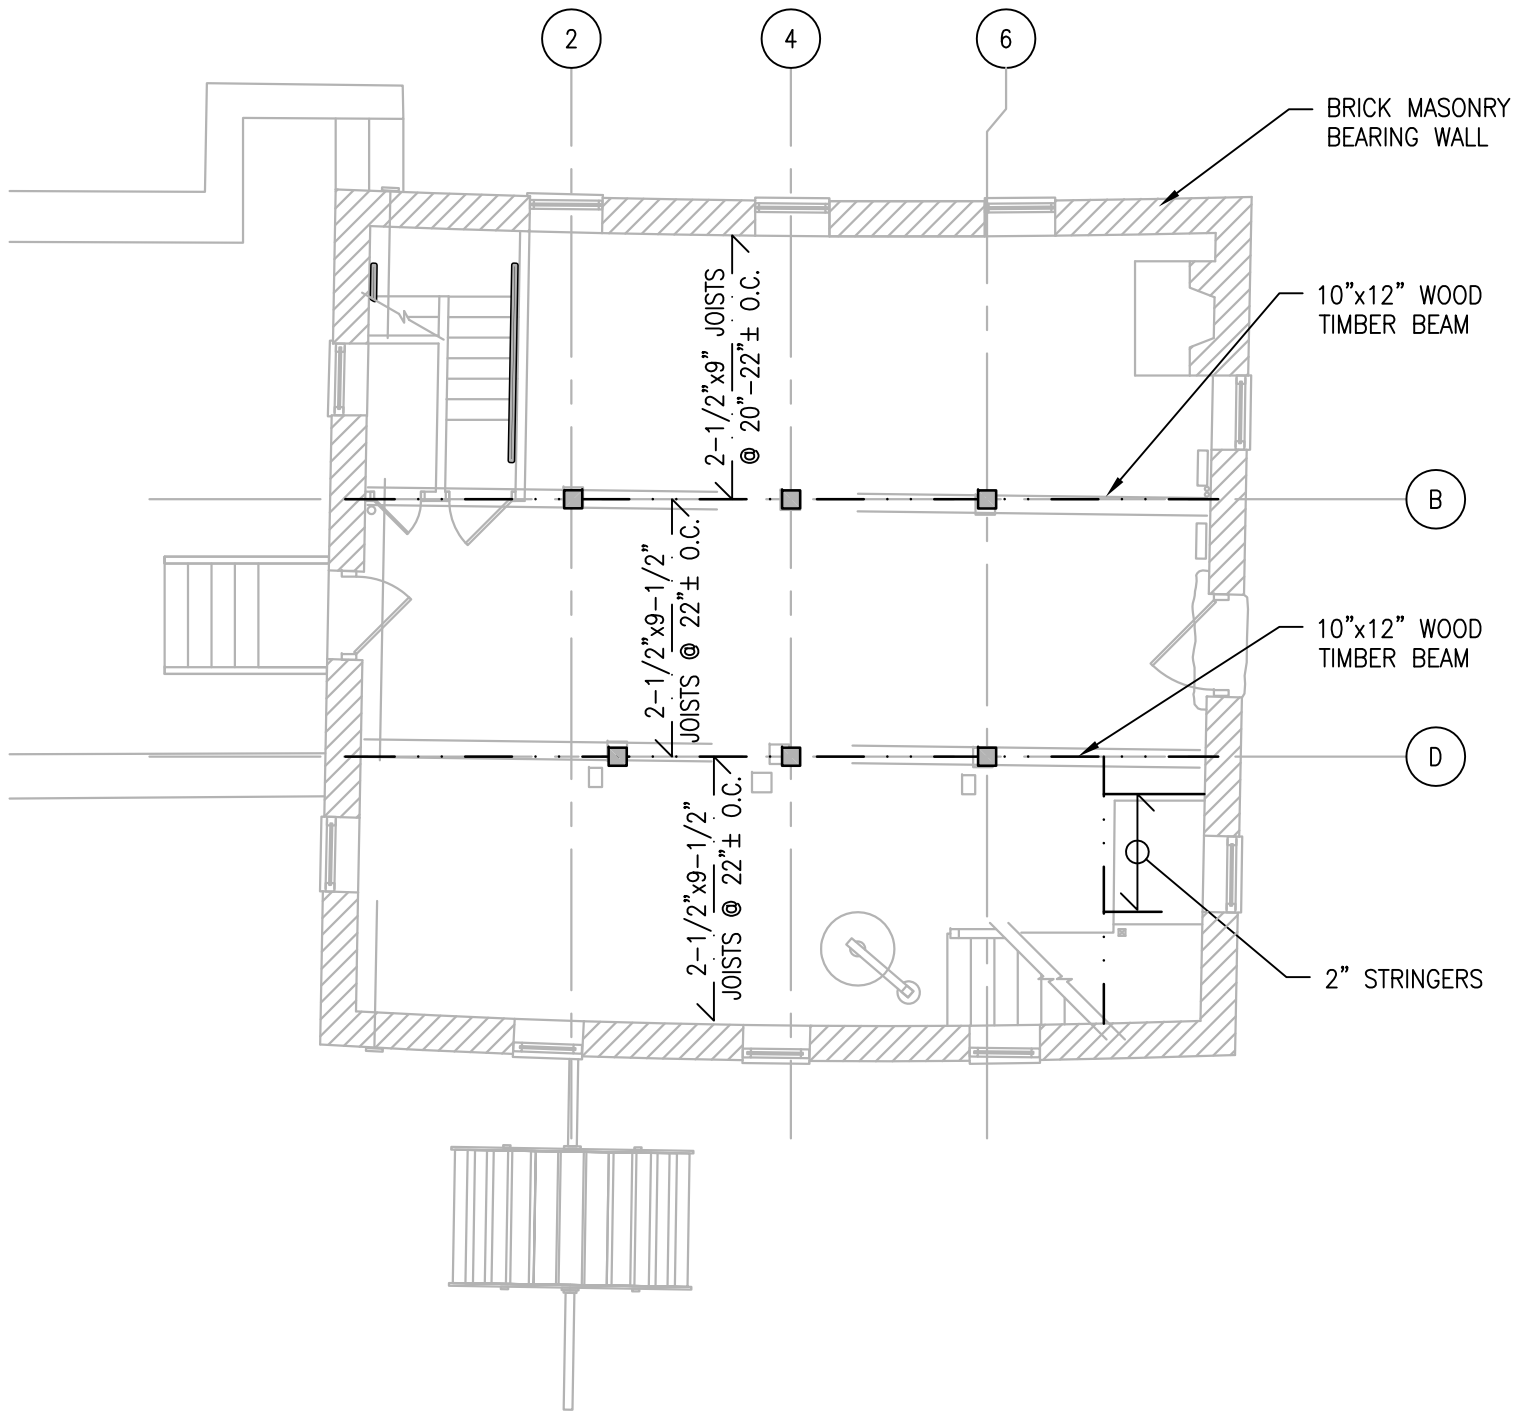
COLUMN SCHEDULE			
COLUMN	W	D	CORNER
B-2	9"	10"	1½" CHAMFER
B-4	10"	10"	1½" CHAMFER
B-6	10"	10"	1½" CHAMFER
D-2	10½"	10"	1¾" CHAMFER
D-4	9"	10"	1¾" CHAMFER
D-6	9½"	9½"	1½" CHAMFER
D-2 BRACE	7½"	10"	1½" CHAMFER
D-4 BRACE	10"	10"	1½" CHAMFER
D-6 BRACE	7½"	10"	1½" CHAMFER

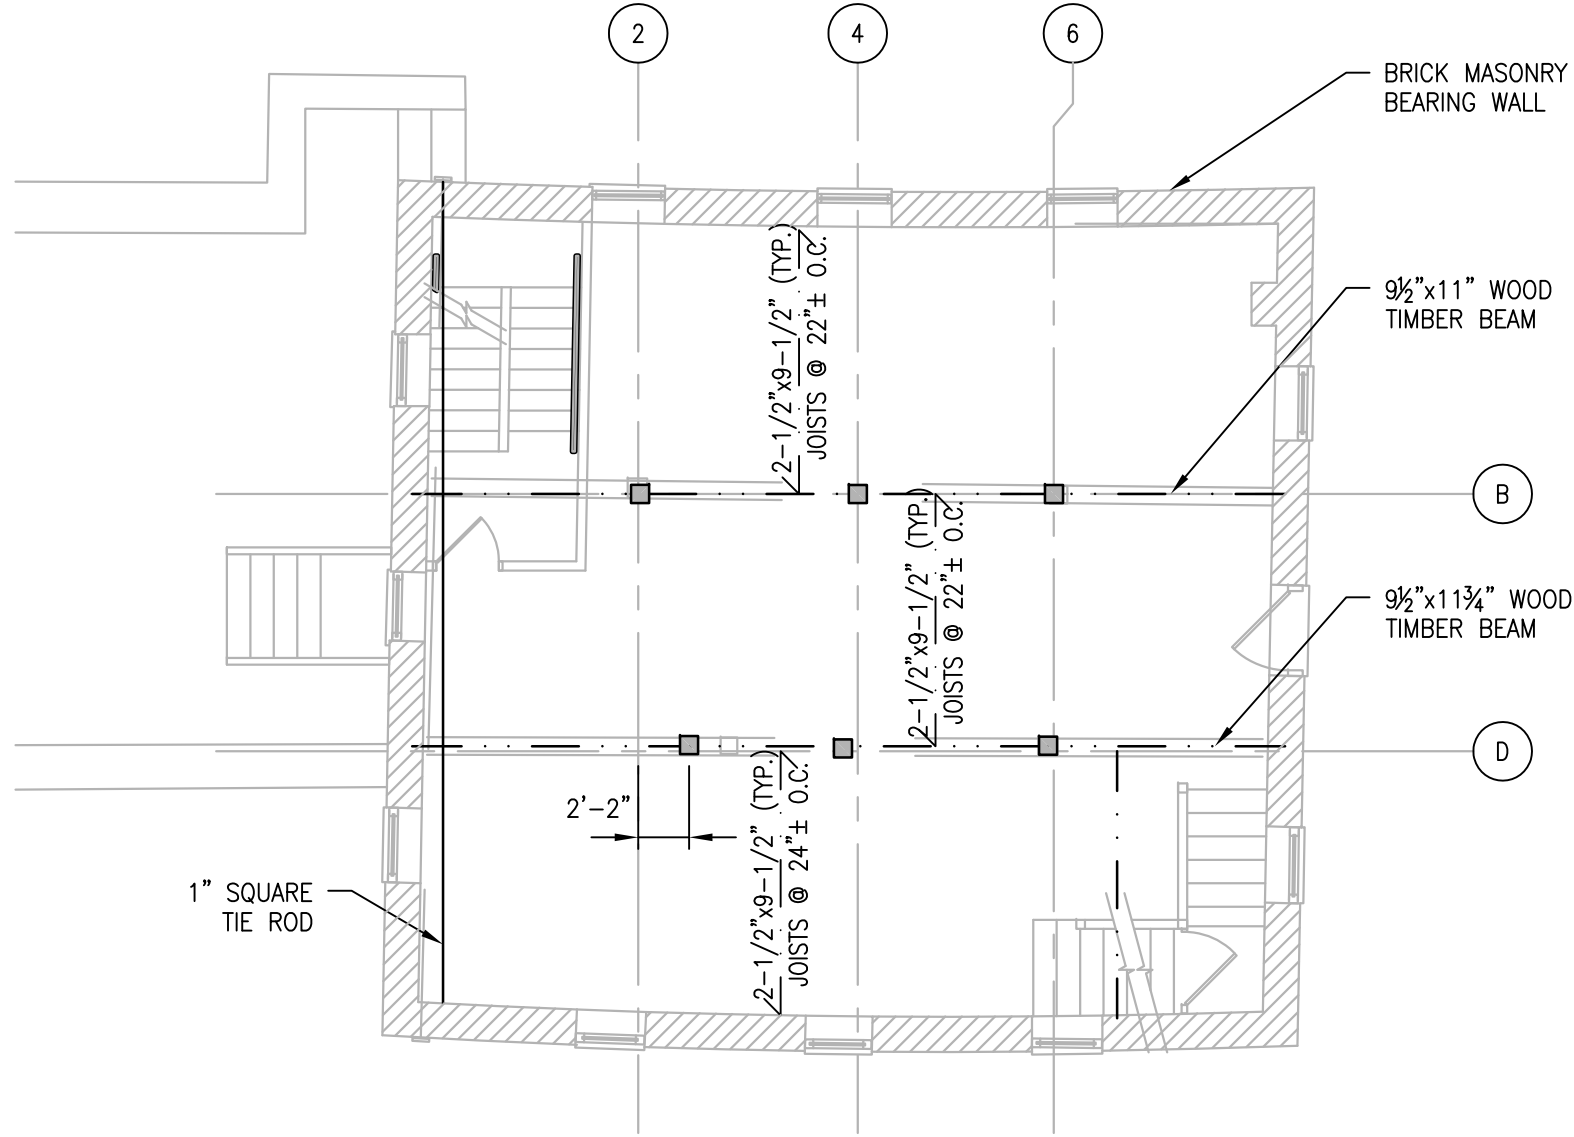
COLUMN SCHEDULE		
COLUMN	W	D
B-2	9 1/4"	9 1/2"
B-4	9"	9"
B-6	9 1/8"	9 1/2"
D-2	9 3/4"	9 3/4"
D-4	8 3/4"	8 7/8"
D-6	9 1/2"	9 1/2"

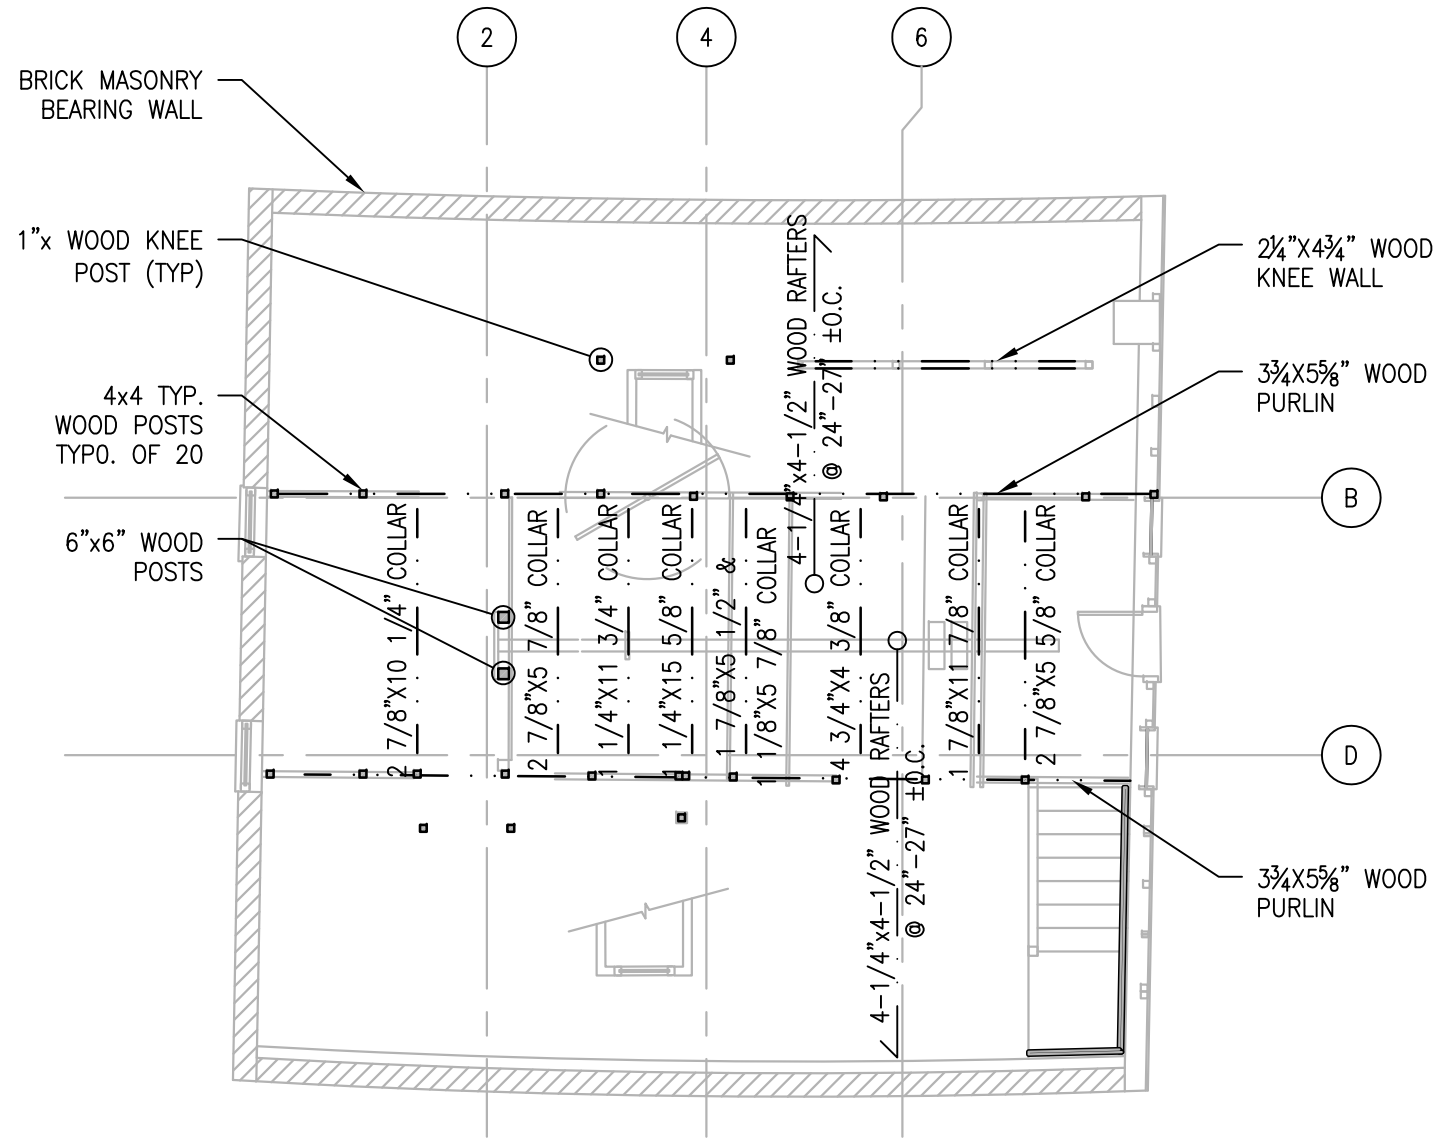
**NOTE:** EXISTING ROOF FRAMING HAS AN ESTIMATED ALLOWABLE LIVE LOAD CAPACITY OF 13 PSF ASSUMING RAFTERS & SUPPORTING MEMBERS ARE IN AN UNDETERIORATED STATE. CAPACITY IS ESTIMATED ASSUMING AN UNLOADED ROOF.
