The WARM SPRINGS
BATH HOUSE
An Historic Structures Report

29 July 2016

The Omni Homestead

*Terry Ammons of StudioAmmons and
Gibson Worsham of Glavé & Holmes Architecture*

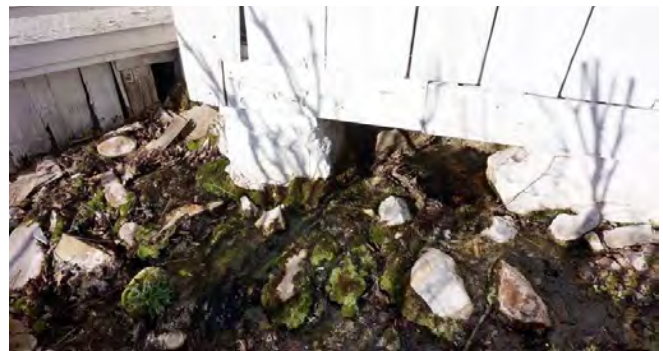
Fig 84. Seepage of water under the Southeast Dressing Room from leaks in the wall of the bath enclosure.

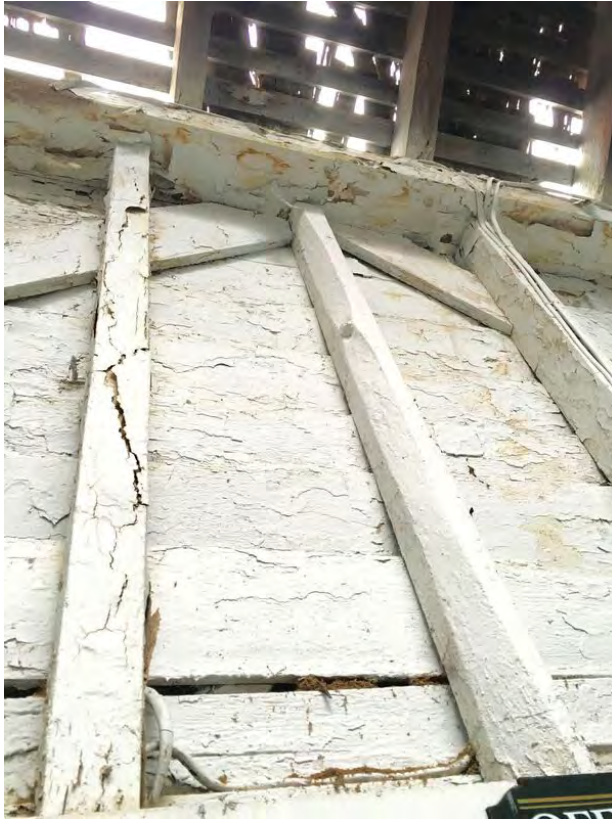
Fig 100. Moisture damage at south wall

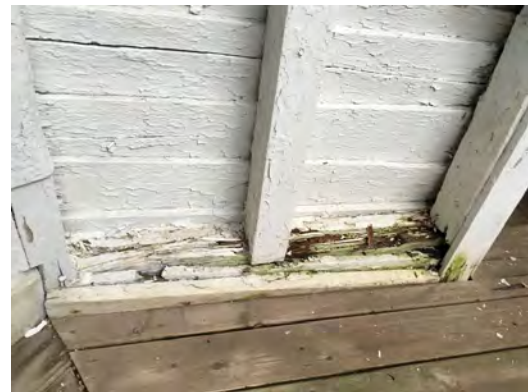
Fig 101. Moisture Damage at replaced sill on east wall

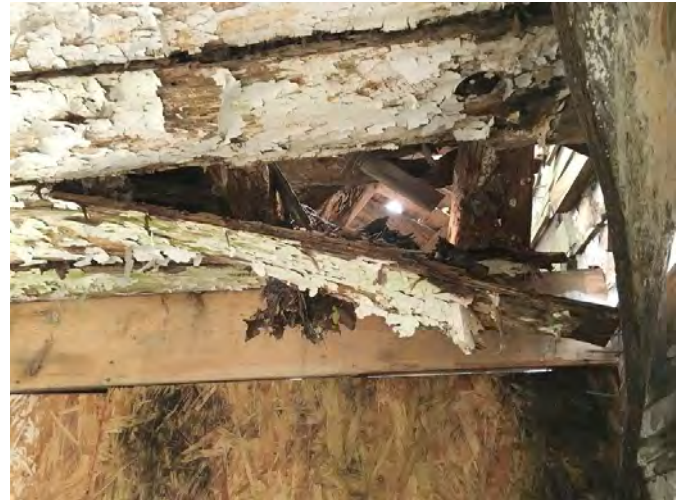
Fig 113. *Deterioration at the junction between the East Wing and the Southeast Addition.*

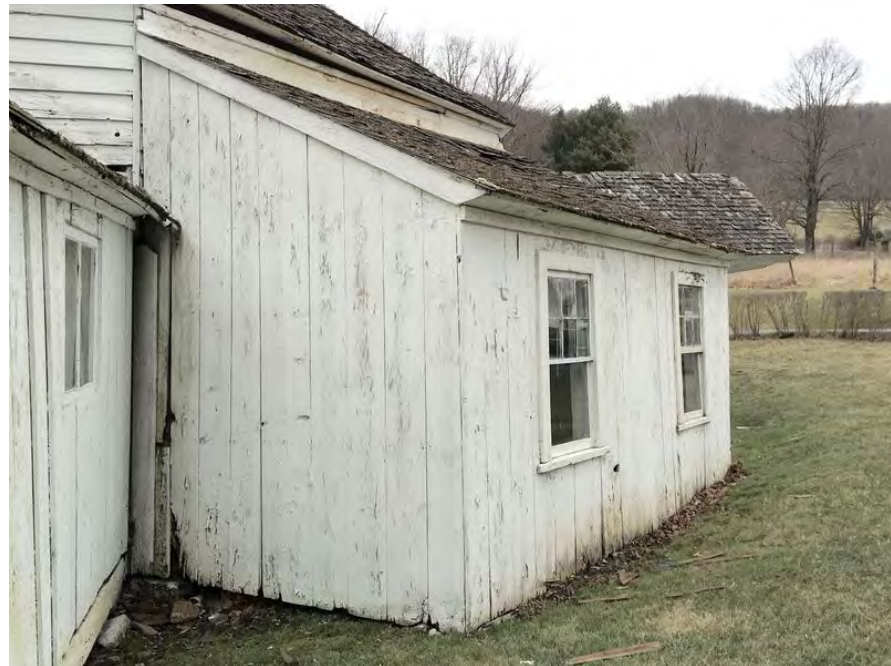
*Fig. 115. Northeast wing from the east.
Note how the slipped roof at
the top has dropped.*

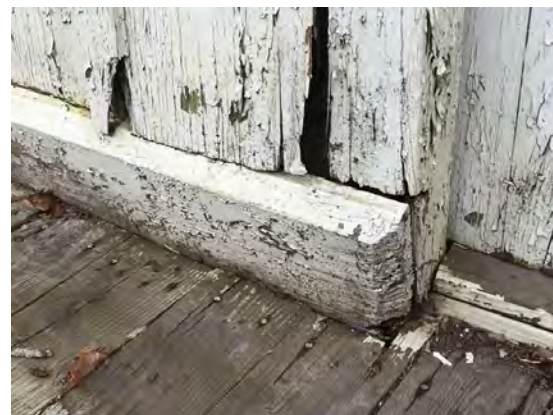
Fig. 122. Condition of the lower wall on the northwest.

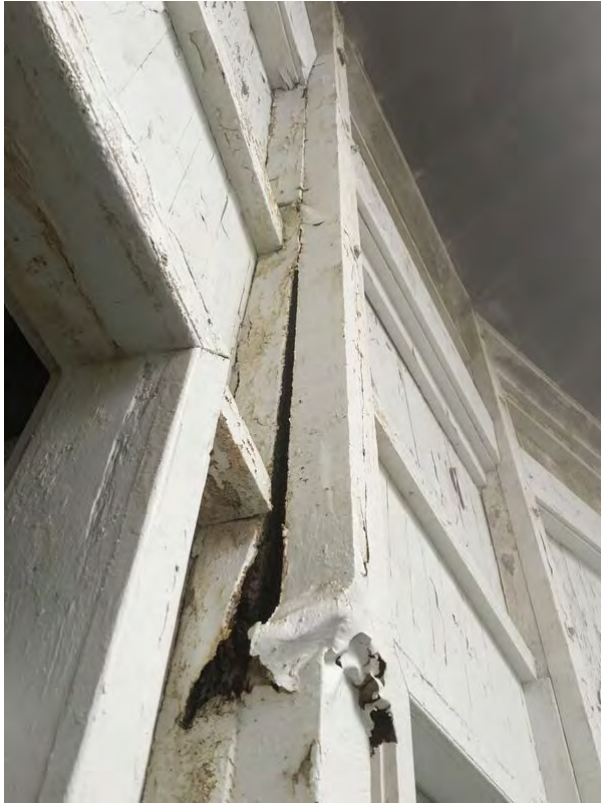
Fig 126. Inner ring structure buckling and showing moisture damage.

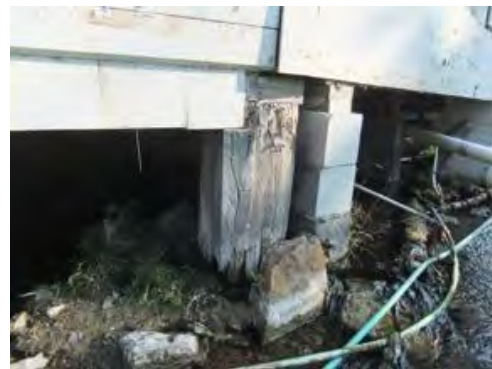
Figure 5: Timber Piles replaced with masonry piers

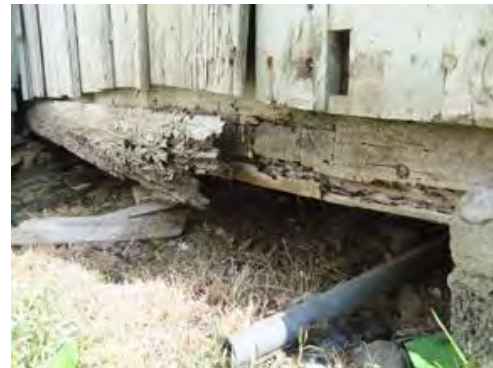
Figure 30: Sill Beam Deterioration
