# *The* PETERSBURG EXCHANGE BUILDING

## *A Historic Structure Report*

*24 November 2021*

**PREPARED BY:**  
*Studio Ammons Inc. &  
Landmark Preservation Associates*

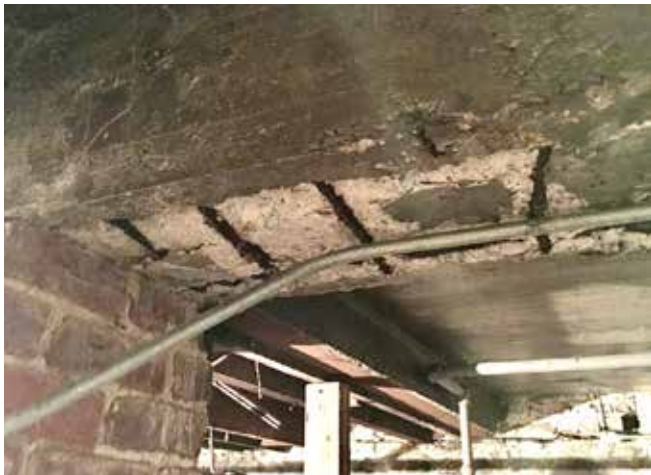
*Basement moisture has caused spalling of structural concrete exposing and causing the deterioration of reinforcing steel.*

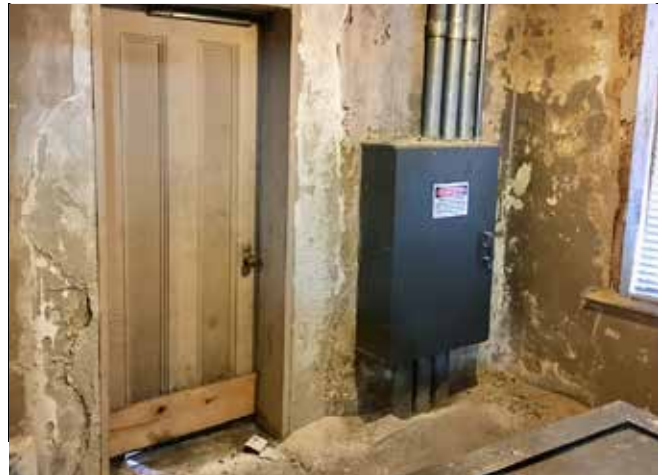
*Ground water at the building's northeast corner has kept the walls wet and caused the deterioration of original plaster and masonry.*

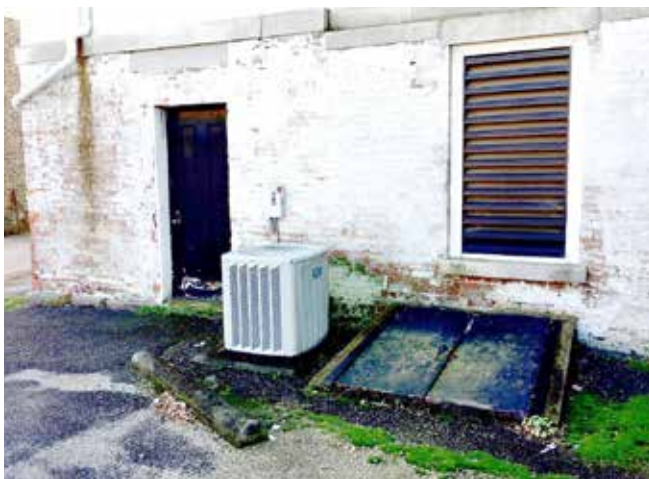
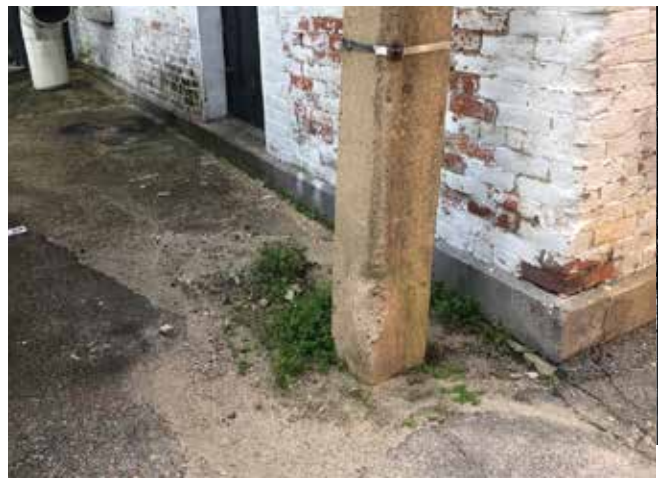
The bulkhead entrance on the northwest side of the building, which existed during the HABS survey of the building in the 1960's was removed when the new Siege Museum entrance was created at the rear of the building. Some water infiltration in the basement at this location is seen regularly and is partly the result of roof water from the elevator addition not being directed away from the building properly.

*Views showing original basement bulkhead entrance locations. (left) east side rear - the current bulkhead appears to have had its side walls partially poured with concrete at some point with the addition of steel doors. This location is a major source of water infiltration into the basement. (right) west side rear - the original basement entry was covered over when the building was renovated to be the Siege Museum and although it is not visible on the exterior, on the interior, surface and/or ground water continues to enter at this location.*

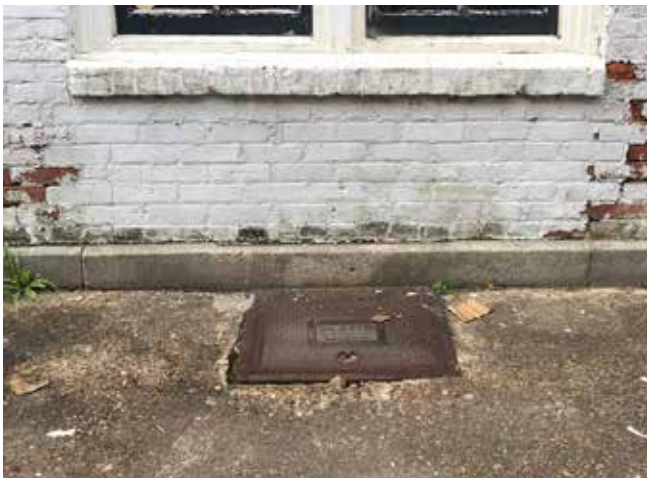
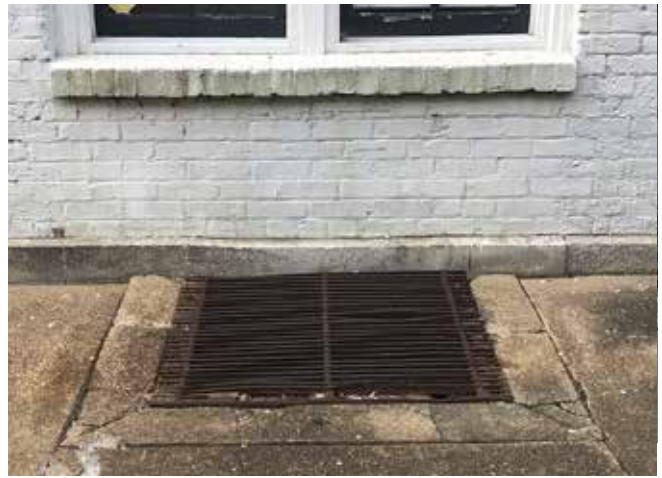
There are three locations along the east and west sides of the building where there were once openings from the sidewalk or alley into the basement both for access and delivery of coal. All three of these side openings into the basement are partially bricked or closed up but these interior closures are deteriorated or were originally just "quick fixes" to keep water/air out of the basement. At these side alley locations the water is entering the basement at these openings from a combination of increased surface water running down the alley as well as water dripping from open seams in the gutter system at the roof line. The splashing of dripping roof water keeps this portion of the exterior wall damp and joins forces with the excess surface water flow in the alley to keep these foundation walls and adjacent basement areas wet or damp at all times. Water flow from the east side alley often comes into the basement at such a rate that it flows across the basement floor and pools in low spots as far away as the center bay of the building.

*Coal chute (left), and surface grate (right) along the east alley side. A similar grated opening into the basement exists on the west alley side but has been filled in and paved over. With water flowing over the now low profile curb condition in the east alley, these openings are allowing a considerable amount of water into the basement which is migrating all the way to the center of the building*

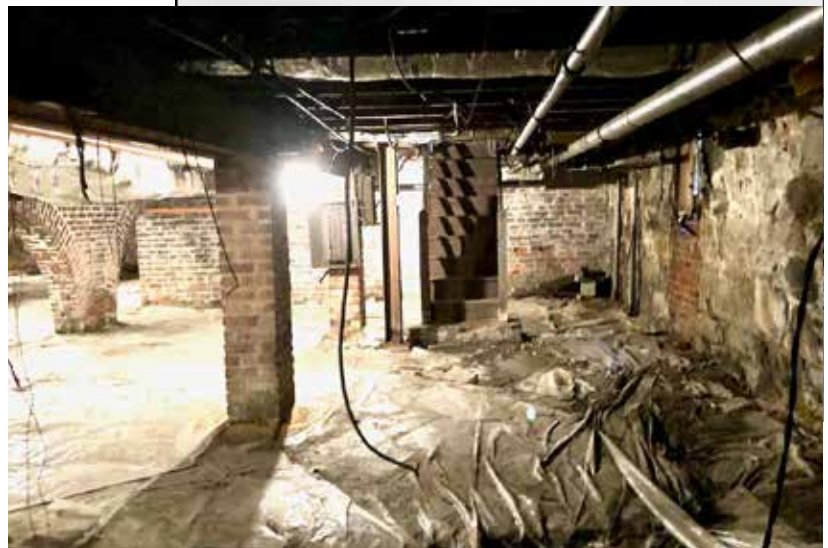
*Interior Basement views of the bricked up, grated opening on the east alley where a considerable amount of water is coming into the basement.*

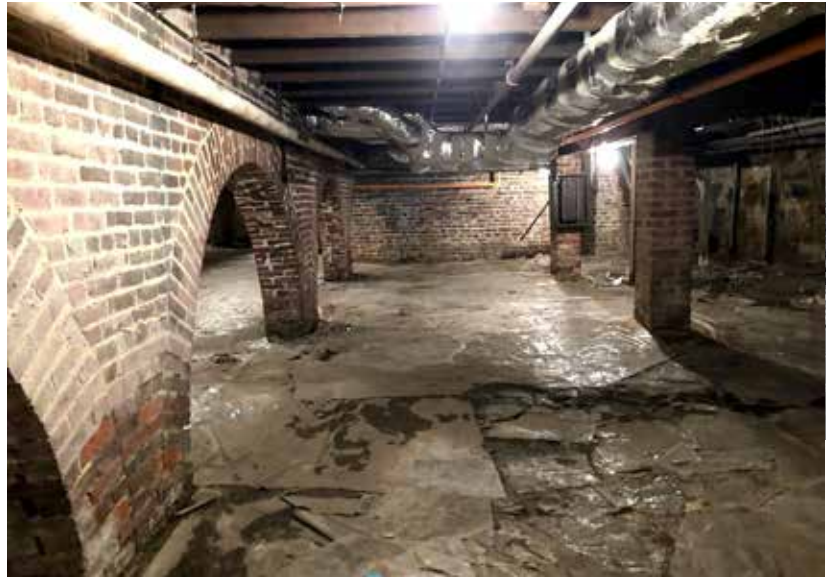
*(left) view of the west alley opening infill showing that the window sash may have been installed to allow light into the basement near the stair location.  
(right) Basement view looking down center bay showing how water from the east alley grated opening has migrated (dark areas on floor) all the way to the center of the building*

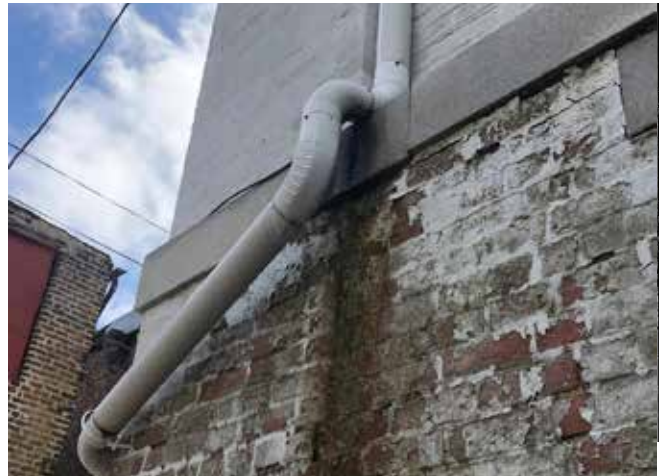
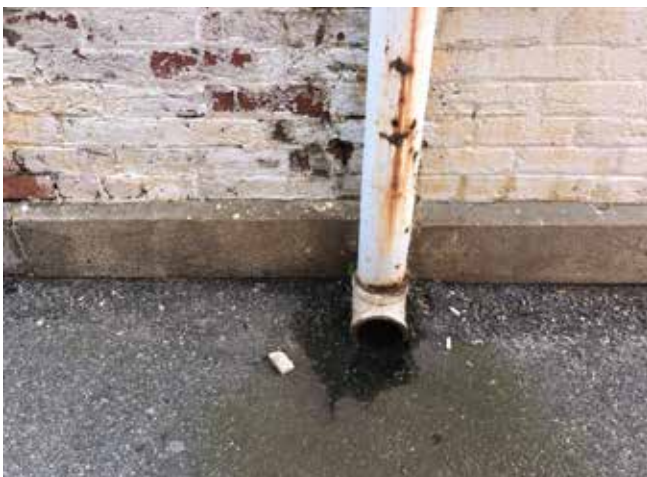
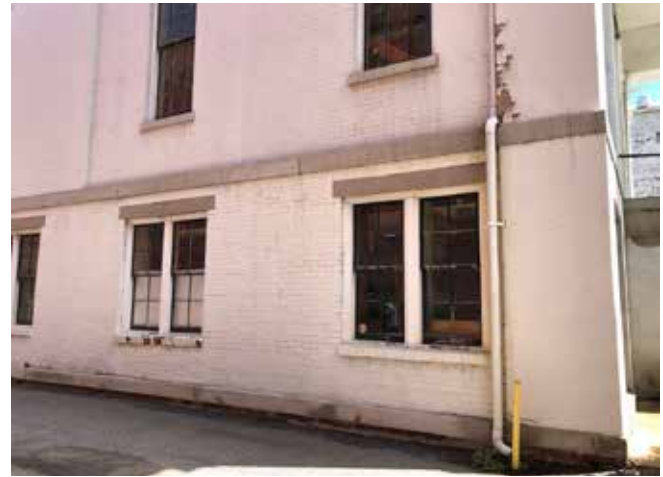
At the rear elevator addition, installed when the building was converted to the Siege Museum, no guttering system was installed on either the upper roofs or the entry canopy roof. All of the water is just falling at the rear of the building and splashing up onto the walls before going into the ground at the building's north basement walls.

*Views of existing gutters and poorly planned downspouts with leaking elbows and joints causing mortar and brick damage.*

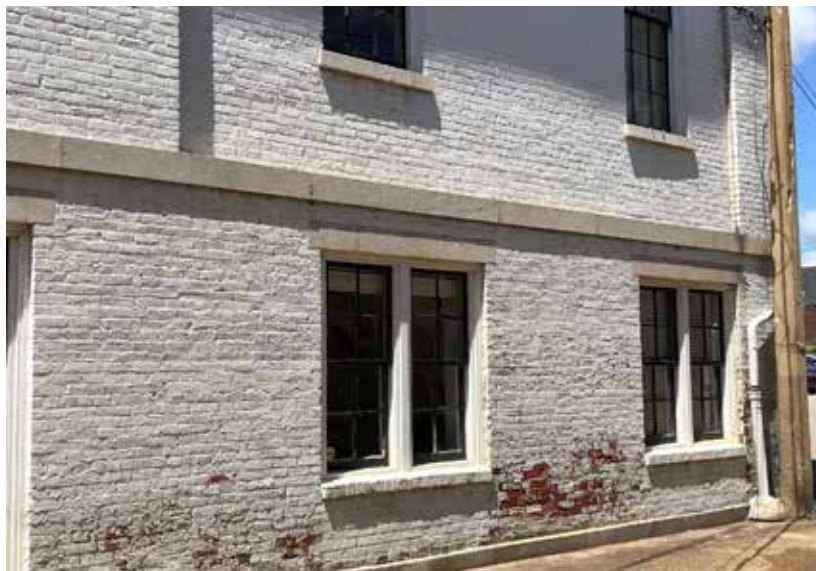
*Masonry damage from walls staying moist due to water dripping from leaks in the gutter system above and splashing on the concrete walk at grade.*

- 1) Using recommendations from the historic mortar analysis, repair and repointing of all water damaged masonry on the lower portion of the exterior walls should be done with careful consideration for the protection and retention of original brick. Areas of the wall that are currently painted should not be repainted after repointing. Final exterior paint choices should be made following the recommendations of an exterior paint analysis.
- 2) In coordination with roofing work, make in-kind replacements for all damaged or rotted wood members in the cornice and frieze and repaint based on the HSR/paint analysis recommendations.
- 3) Existing soffit vents are to be removed and the soffits repaired at these locations. (note that new roof top vents should be specified to replace the inadequate soffit vents).

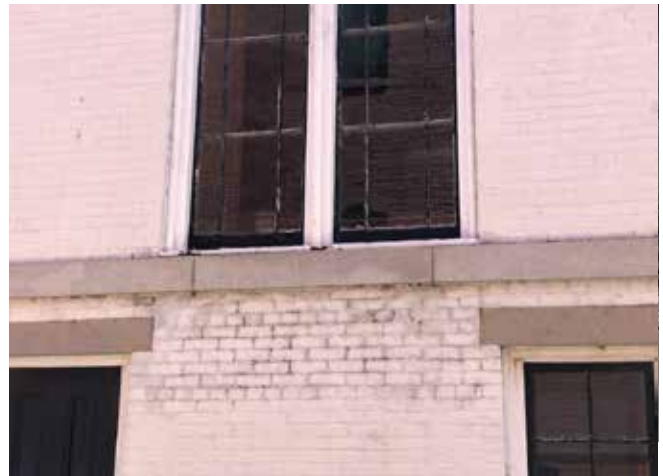
*Water damage at exterior walls from splashing and damaged/rotted window sills and jamb members allowing water to get inside of the masonry walls and keep areas wet.*

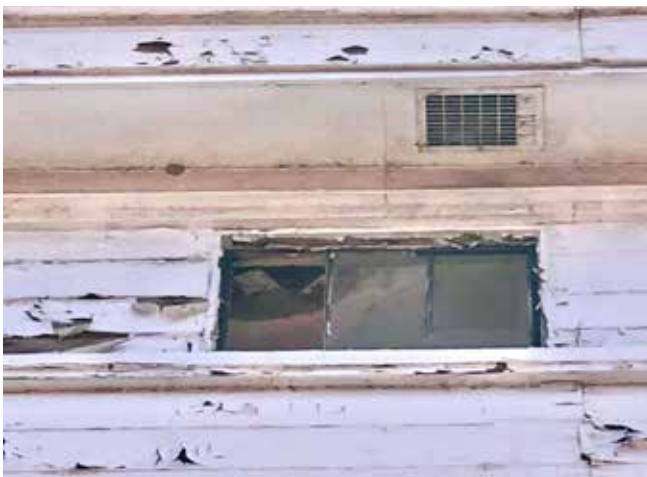
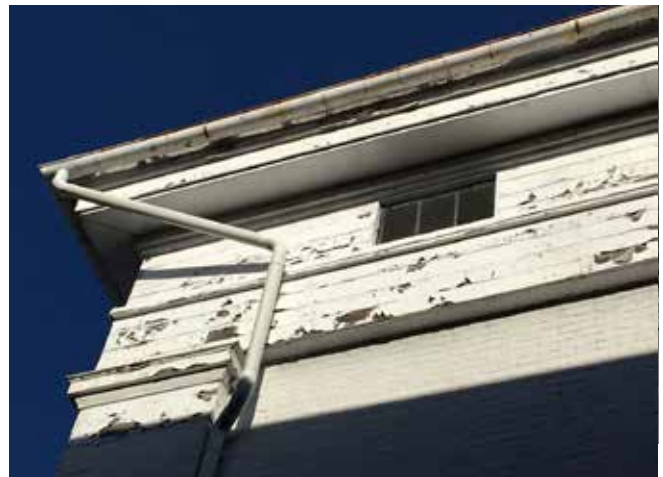
*Views of cornice and frieze areas showing deferred maintenance and need for repair along with broken window panes.*

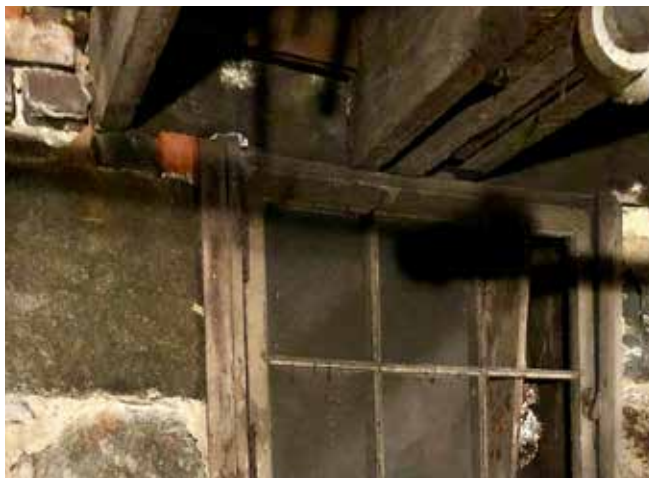
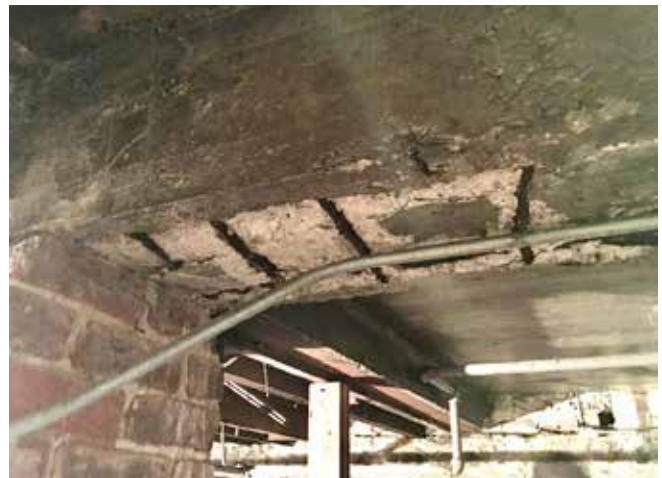
*Deteriorated joist bearings (left), spalling concrete and rusting supporting steel beam (right).*

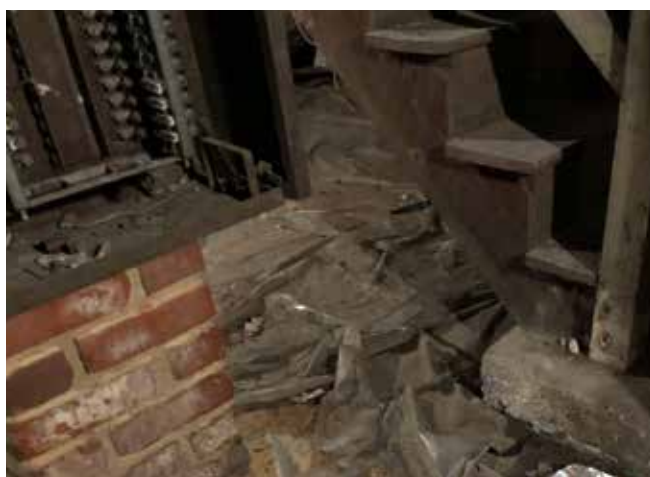
*Basement views showing stairs from Ground Floor and brick piers deteriorating at their base.*

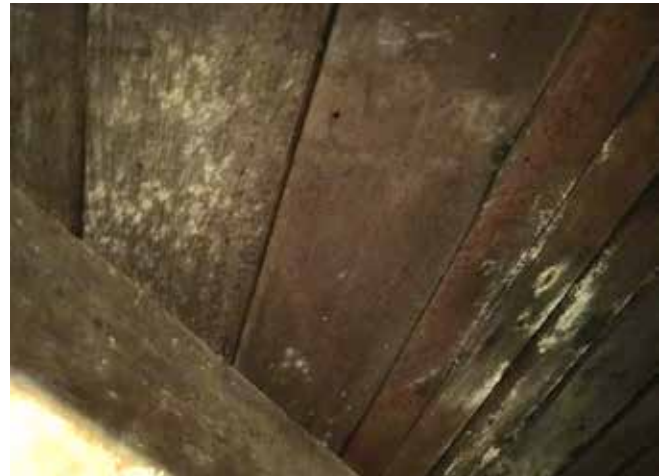
*View of the entrance to the boiler room in the northeast corner of the Basement (left), and view of mold on Ground Floor joists and subfloor (right).*

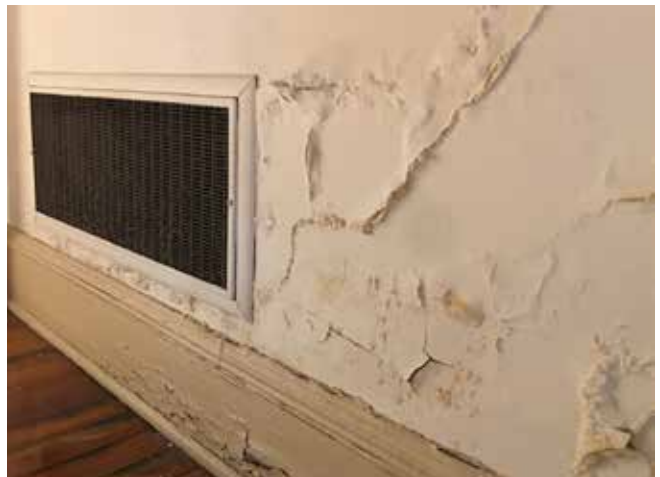
*Views of moisture damage in the areas around mechanical grills and concealed ductwork around the Second Floor gallery.*

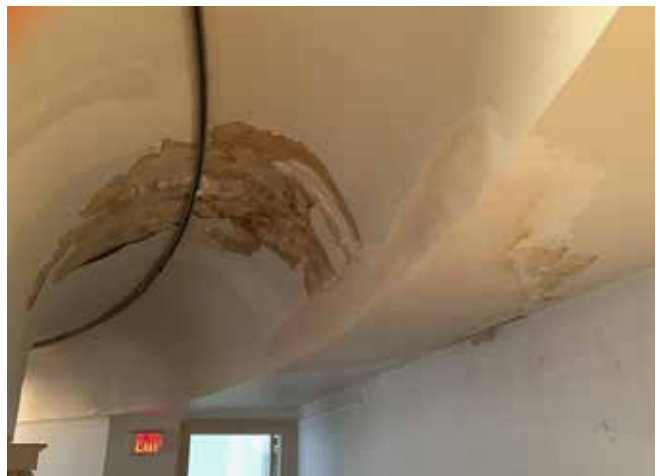
*Southeast gallery location where floor has dropped and structural framing repairs are necessary (left), and moisture damage to arched plaster gallery ceiling (right).*

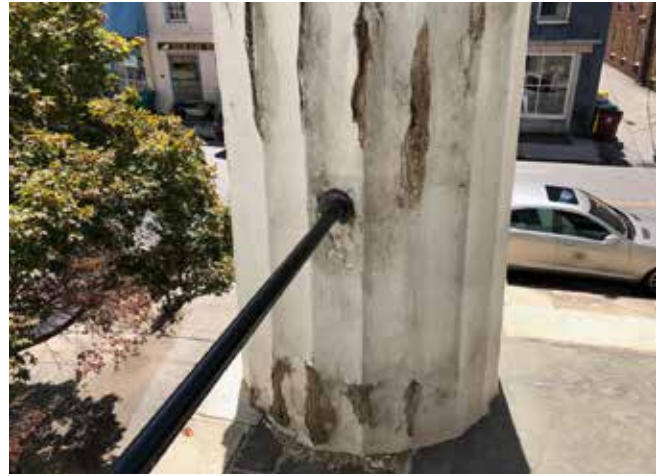
*Views of flagstone floor and stucco on brick Doric columns showing deteriorated finishes..*

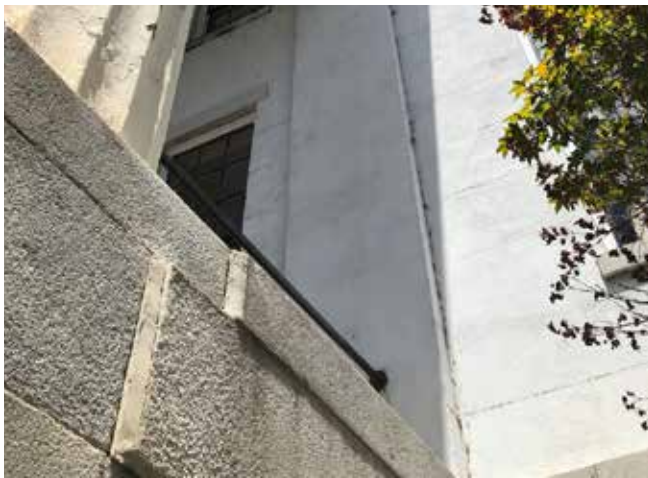
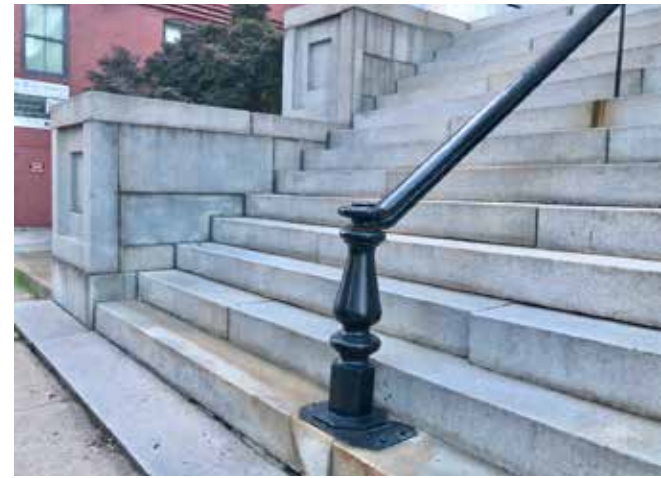
*Shifting granite facing stones (left), and cast iron newel and railing with granite patch at mounting (right).*

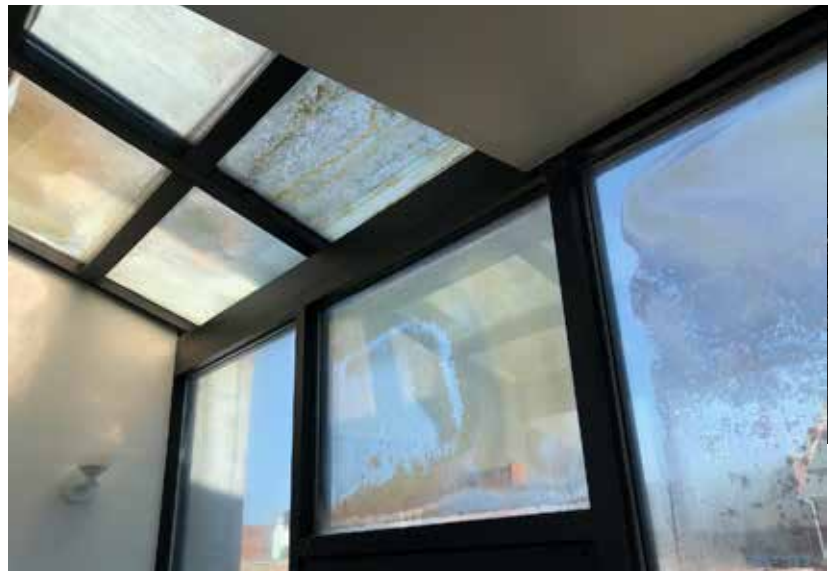
*Interior views of the Second Floor of the elevator tower connector showing the condition of the glass and lack of integrated HVAC systems.*
