The WARM SPRINGS
BATH HOUSE
An Historic Structures Report

29 July 2016

The Omni Homestead

*Terry Ammons of StudioAmmons and
Gibson Worsham of Glavé & Holmes Architecture*

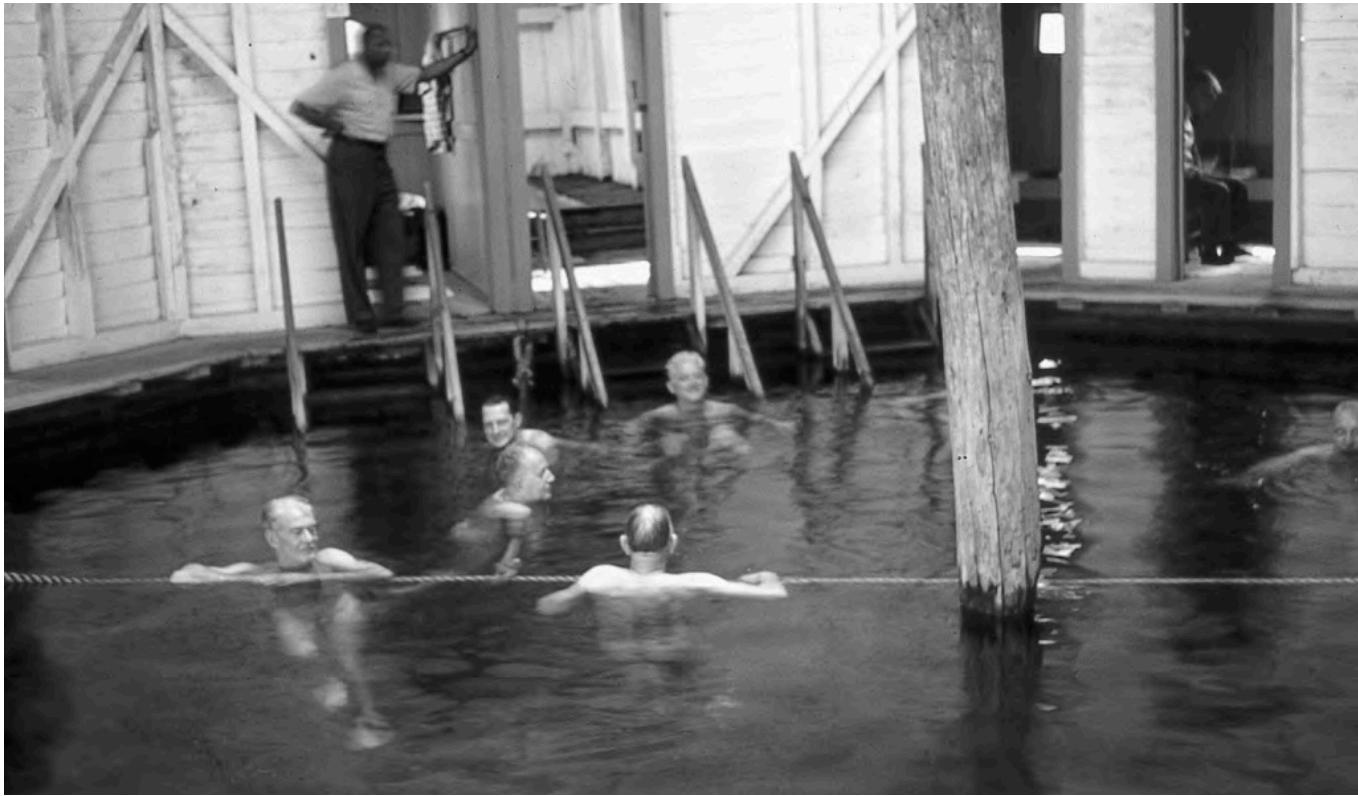
Fig. 50. The Gentlemen's Bath in 1955. Note that the replacement of the sill had not yet been done.

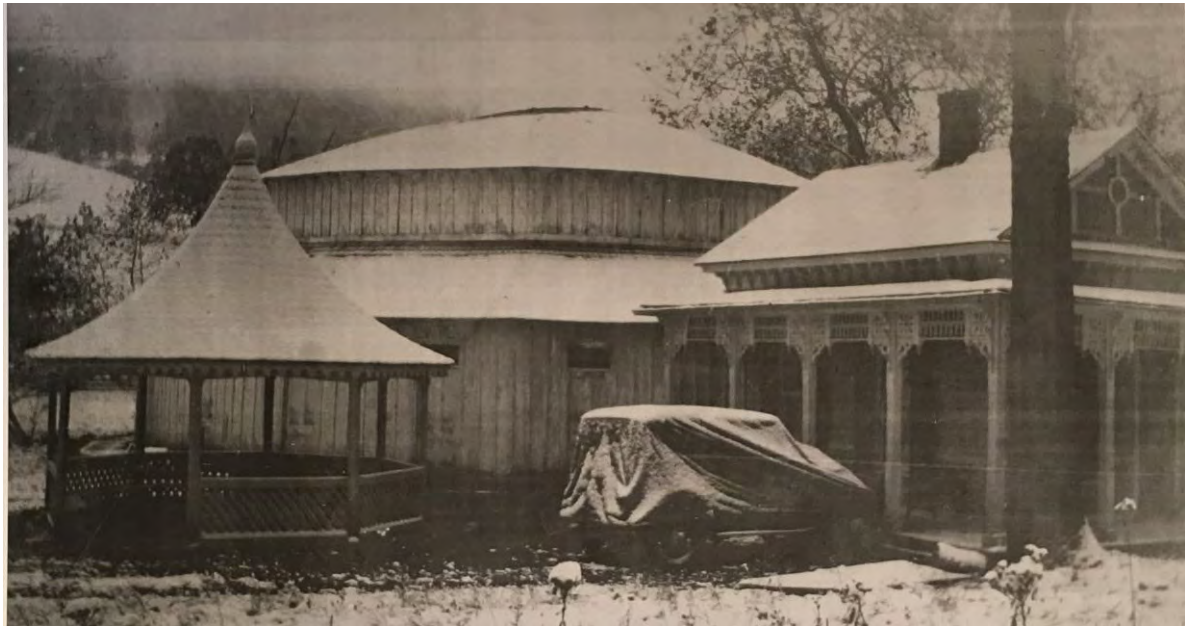
Fig. 71. The Ladies' Bath and Reception House in winter (1930s?). Collection of John T. Reddick. Note that the entry to the Drinking Spring is in the western bay. The parapet is missing

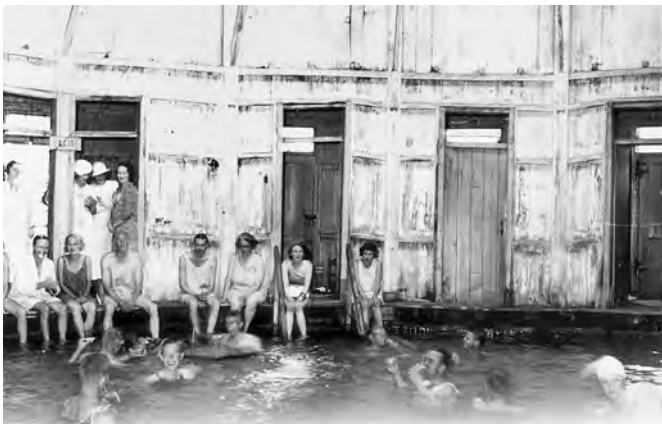
Fig. 72. Ingalls family annual party at the Warm Springs in the Ladies' Pool, 1920s, Looking northwest. Note the poor condition of the framing

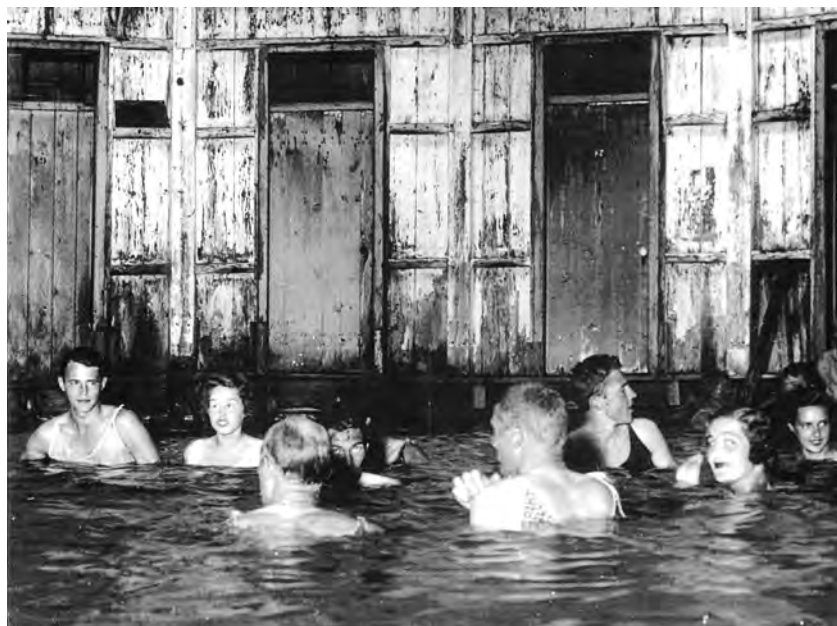
Fig 73. Ingalls family annual party at the Warm Springs in the Ladies' Pool, 1920s. Note the poor condition of the framing.

The changes made to the building can be seen by comparing the historic photographs from the late nineteenth and early twentieth centuries to the current building. The lower portions of the structure look fairly level in the early twentieth-century postcards (Figures 64 and 66), but by the time of the Ingalls family party in the 1920s (Figures 72 and 73), the structure appears rotten and buckling. At some point between the two sets of images a set of braces were installed to link the midpoint of the angle posts to the ring of the oculus, strengthening the roof. There was as yet no central post or umbrella structure at the top. After the 1920s, the inner frame was extensively repaired. The lower half of each post was replaced and the posts reinforced by new inner set of 3 1/2" deep by 6" wide posts that were bolted through the existing posts. The horizontal girts and vertical board cladding were also replaced around the entire building below the roof of the outer ring. The horizontal framing members and board cladding was retained above the overhead joists of the dressing rooms. A central post was added with an umbrella-like structure supporting the oculus.

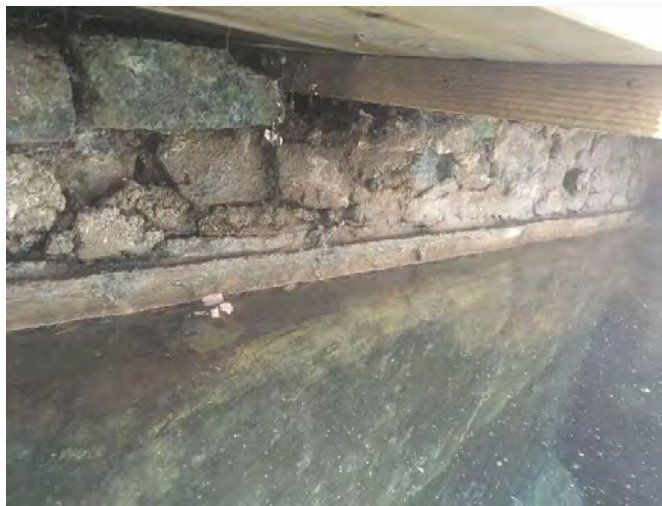
Fig. 82. The stone bath enclosure seen below the peripheral deck.

The Gentlemen's Bath is contained within a stone enclosure of a pool that is 36'-6" wide from side to side. It was likely built in the third quarter of the eighteenth century. The 2'-thick stone wall was set into sloping ground so as to maximize the depth of the pool. The top of the wall is nearly flush with the ground to the north and west and well above grade on the south. The rocky bottom of the bath slopes from 12"-18" inches from the northwest to the southeast. Water is drained by an opening in the eastern side of the south wall. The interior is parged with cement and the exterior, where exposed above the surface, is of coursed limestone rubble. The opening is strengthened by stone buttresses on each side. The two cement-parged stone steps that give access to the pool at the center of the north and south walls appear to be original features. They are located partially under the wood deck that extends around the perimeter and cantilevers over the water.

The stone wall is in roughly good condition, but is leaky in several places, notably on the east, southeast, and southwest sides. The escaping water flows away in muddy channels to join the main outflow, causing moisture problems for the structural underpinnings of the east and southeast wings. The stone wall on the southwest side is showing signs of dilapidation. Stones are falling out of the wall. On the interior, the sluice gate is in disrepair.

The exterior of the stone enclosure should be repaired and the exposed portions of the wall should be patched and repointed. The cement parging of the stone wall should be patched and repaired.

- The masonry pool enclosure should be repaired in areas where it has deteriorated and generally repointed. Repair the sluice gate and drain mechanism.

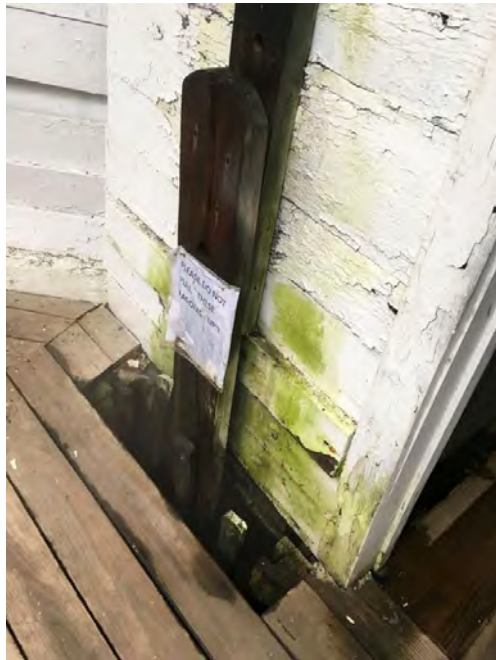
Fig 83.

The pool opening is filled by a wooden sluice gate, the sort of water control device used for millennia to manage flow within millraces and canals. The sluice gate consists of timber jambs built into the stone walls and a gate that slides vertically in grooves to permit draining of the pool. The gate is made of three vertical boards held together by metal straps on the exterior. The central board extends upwards as a paddle-shaped handle. This is pierced with a vertical line of holes by which the gate can be pegged at different heights to a similar board behind it. It appears to have been raised with the assistance of a pulley (no longer in place) hung from an iron ring that is still mounted in the underside of the top plate angle brace directly overhead. Three smaller paddles are let into the interior face of the gate. Raising them controls the amount of water that is let out through holes in the gate to control the water level and to create the spout bath located in the outfall area. The gates are similar in both the Gentlemen's and Ladies' Baths, except that the Ladies' Pool has only two secondary paddles, probably because the spout bath there is fed by a separate pipe.

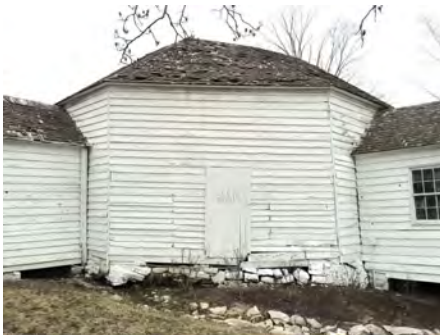
Fig 86. Southwest wall seen from southwest

The weatherboards on each face are separated by a beaded corner board that is angled to receive the cladding. The weatherboard overhangs the stone foundation on each side. On the southwest side, where no dressing room was added, the original beaded corner board extends down as much as twelve inches below the lower edge of the weatherboard, suggesting that the sheathing originally extended over the stone to line up with the siding on the west wing. The polygonal hipped roof is covered with plain wood shingles. The hipped roof culminates in a large central oculus. The c. twelve-foot diameter opening, in combination with the permeable siding, permits rapid, ongoing ventilation of the damp, vapor-laden air out of the building, protecting it from moisture-related damage.

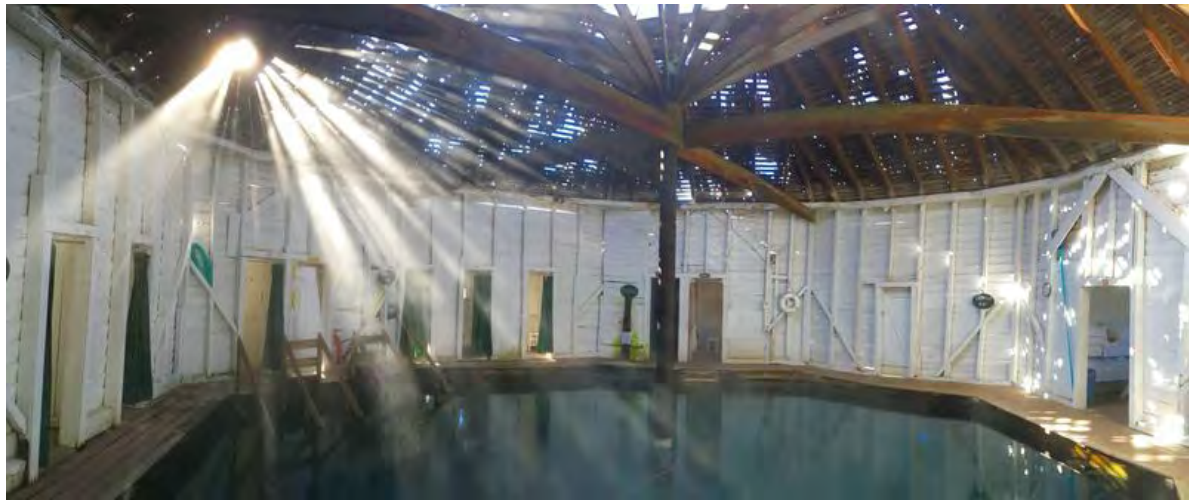
Fig. 89. Interior of the Gentlemen's Bath.

On the interior, the heavily whitewashed structure consists of eight vertically framed sections joined to form an octagonal volume. Eight 5 1/2" wide x 4 1/4" deep corner posts are mortised into a 6" tall by 8" deep top plate. Studs fill the eight intervening sections of the perimeter wall. The top plate is made structurally continuous by half-lapped, pegged joints and reinforced by eight short splice plates (4 1/2" tall by 7" deep) spanning between and mortised into the plates at each corner. Nothing remains of the original sill, which sat on the top of the stone enclosure with their exterior faces aligned. The sill, which was cut each time a new dressing room door was added, was fully replaced in the mid-twentieth century with discontinuous sections built up of three 2 x 10's.

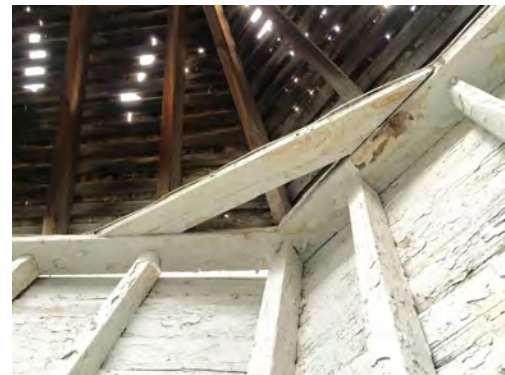
Fig. 90. Typical splice plate

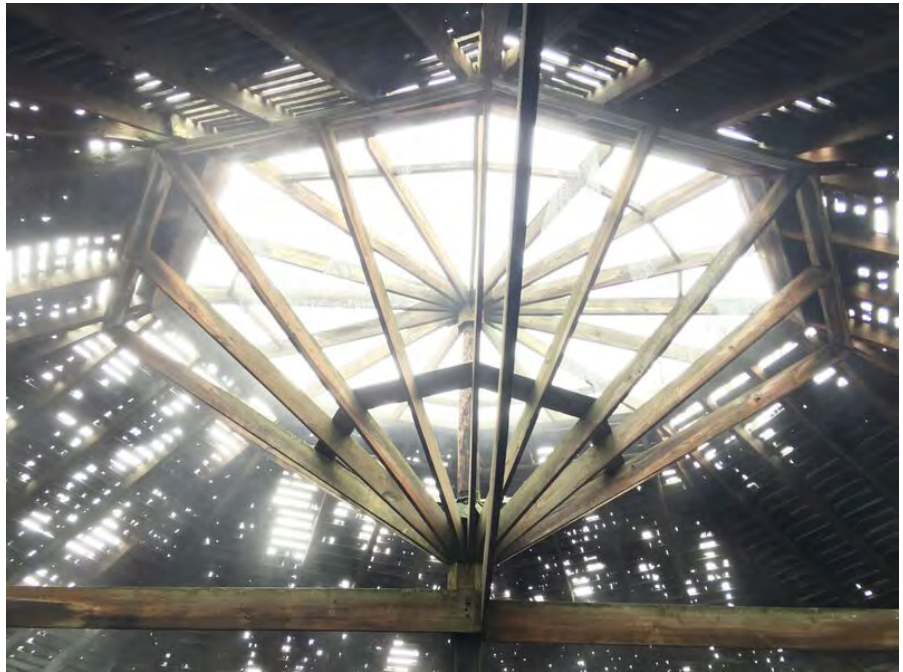
Fig. 99. Octagonal pool roof structure

The roof structure is original. The hip rafters extend to the corners of the frame of the octagonal oculus at the center of the roof. Parallel common rafters corresponding to the studs run between the hips. Each rafter is inscribed with a Roman numeral framing mark. Birdsmouths on the ends of each rafter are notched into the top of the top plate. The roofing shingles are carried on early, widely spaced battens that span between the rafters. It is not yet clear if the framing of the oculus itself is of an early date. The exterior of the oculus was originally provided with a low decorative parapet visible in early images.

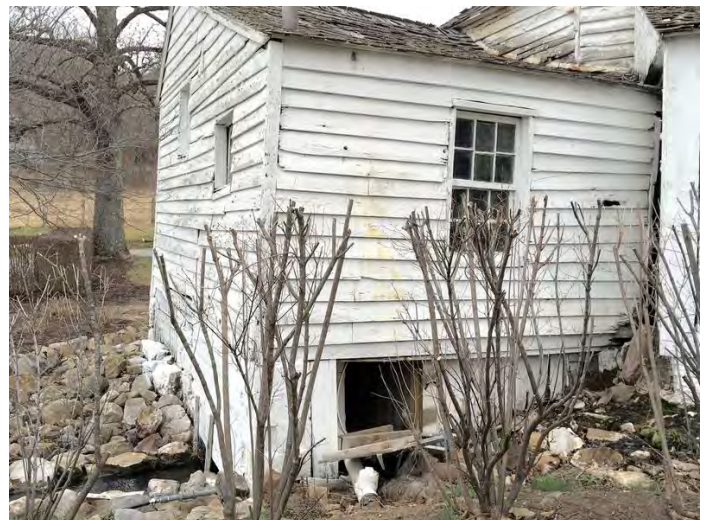
A weatherboarded leanto, probably originally supported on stone piers, was added along the east side in the late 1840s to house the spout bath that was improvised in the existing outflow area. It has been substantially repaired, with the roof structure entirely replaced with modern materials in recent years. There is an inaccessible area on the interior separating the central room from the spout bath. The wing is reached by means of a corridor in the eastern portion of the original south dressing room wing. The corridor is connected to the spout bath leanto by a door in its east wall and by an added door into the main room.

*Fig. 106. Spout bath leanto
from the southeast*

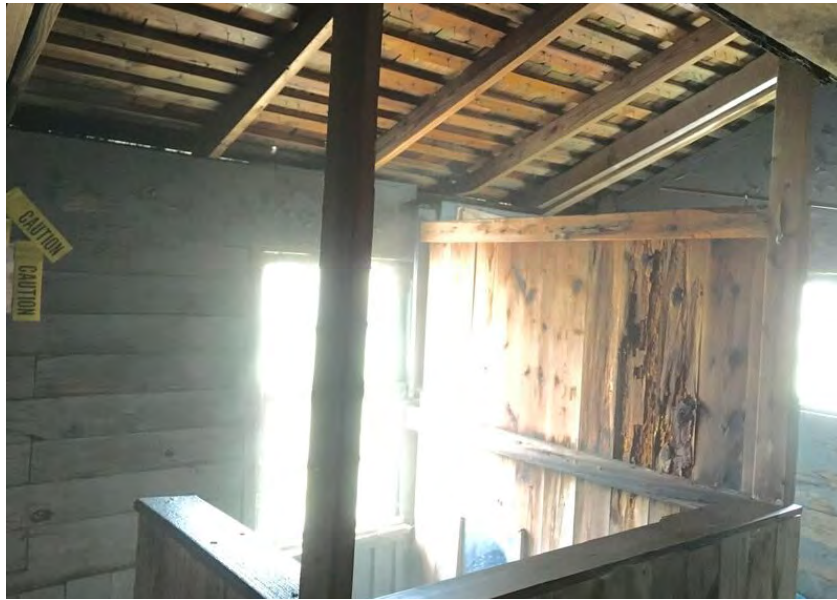
Fig 107. Spout bath leanto interior looking southeast

The leanto contains a wooden stair (rebuilt in recent years) to the lower area under the floor where the spout bath operates. The stair is surrounded by a modern, solid wooden railing with a wide top. The leanto is lit by a six-over-six sash window with a roughly built frame made of reused tongue-and-groove boards. The spout bath is located within a low-ceilinged space that is contained within stuccoed stone walls. The interior sheathing, which survives on the west wall, consists of wide, random-width, plain tongue-and-groove boards. The plain, narrow sheathing on the exterior walls appears to have been replaced in the mid-twentieth century. Beyond the stair is a toilet room in the south end of the leanto. The toilet area is screened by a modern vertical board partition. The southeast corner of the leanto is supported on a stacked concrete block pier added in the mid-twentieth century. The area between the piers is enclosed with vertical boards.

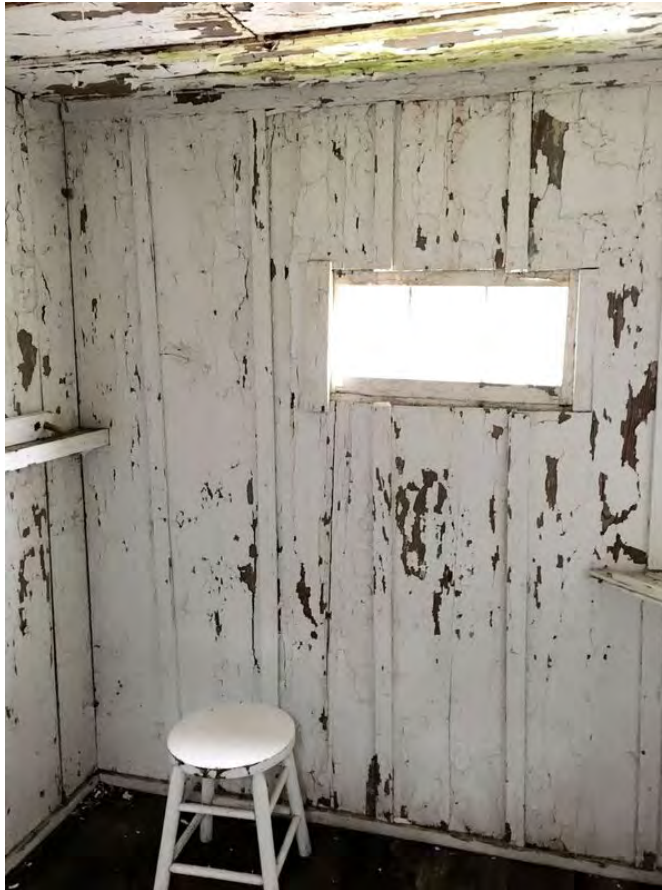
Fig. 114. Interior of southeast wing

with the roof of the spout bath leanto collects rainwater and is an ongoing source of maintenance trouble.

The three transom-style windows and their minimal frames are in reparable condition. The roofing, which is in poor condition, has permitted water into the interior. As a result, the ceiling on the interior is in poor condition. Interior wall sheathing is in fair condition.

- Remove water seeping under the southeast addition by sealing the stone pool enclosure.
- Repair the floor structure as needed using traditional materials and construction techniques copied from the adjacent wings.
- Repair and rebuild the rotten areas at the junction of the southeast addition and the east wing.
- Clean, repair and reglaze the three transom-style windows.
- Replace the damaged roof sheathing, roof shingles, and flashing.

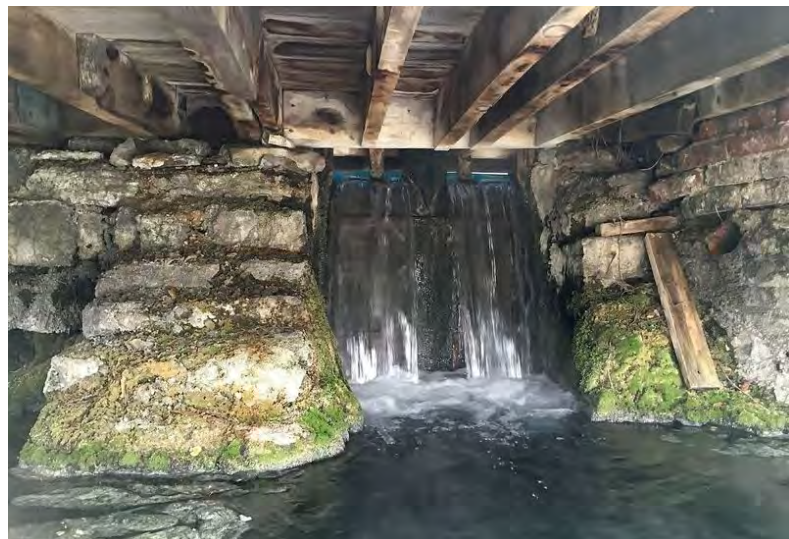
Fig 117. Outflow from the Ladies' Bath showing stone buttress to left and brick spout bath enclosure to the right.

The stone wall is in roughly good condition, but is leaky in several places, notably on the east, southeast, and southwest sides. Further inspection will require partial disassembly of portions of the building. On the interior, the sluice gate is in disrepair.

The exterior of the stone enclosure should be repaired and the exposed portions of the wall should be patched and repointed. The cement parging of the stone wall should be patched and repaired as needed to prevent leakage.

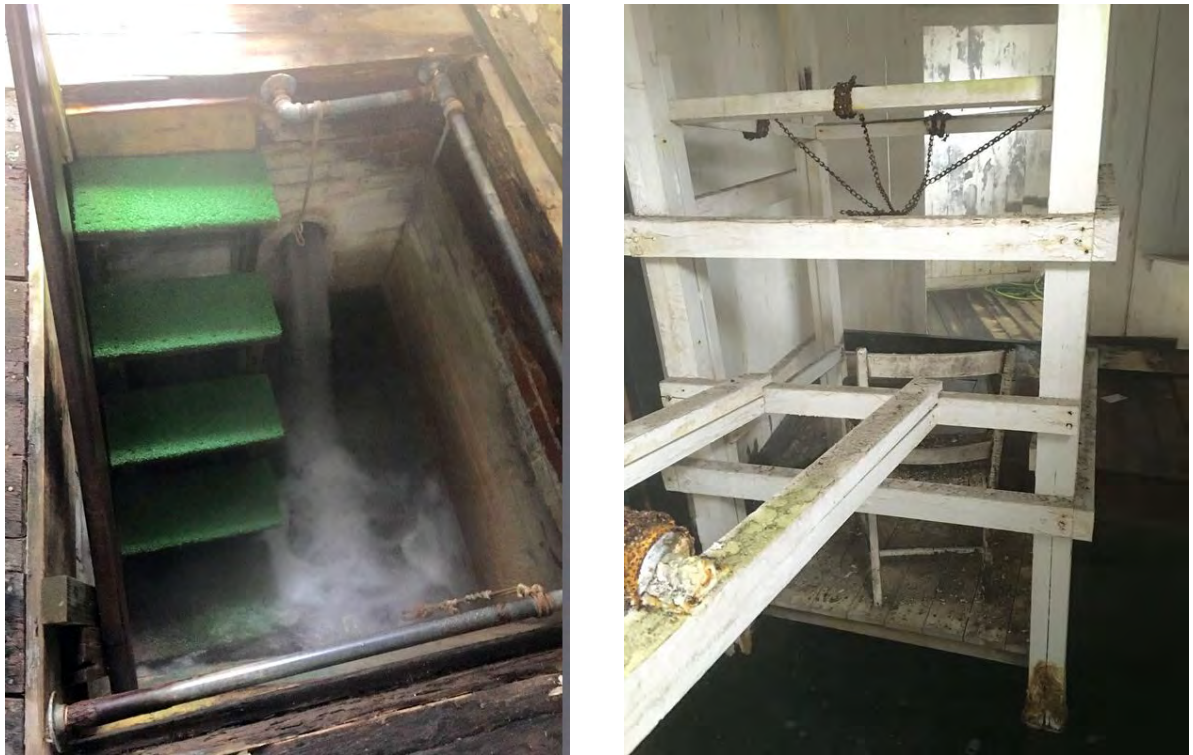
Fig 118. Brick tank for the spout bath on interior (left) and the rebuilt invalid lift (right)

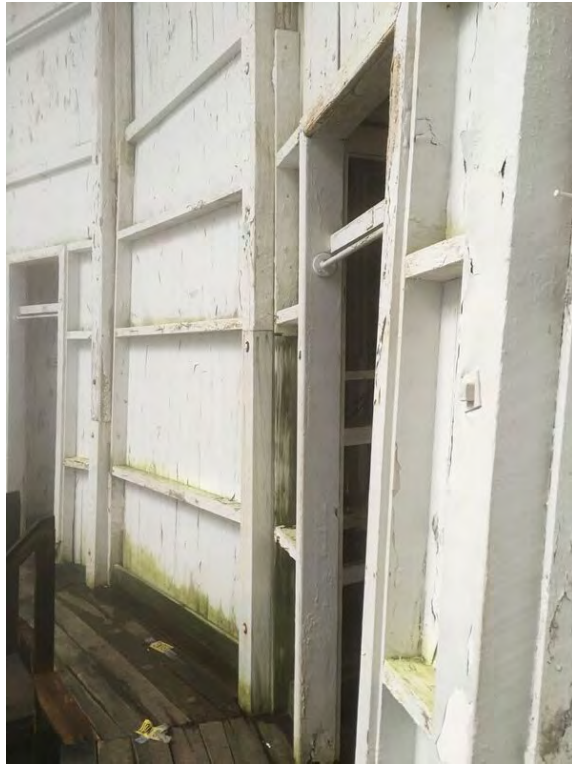
Fig. 124. Lower section of the interior wall (typical).

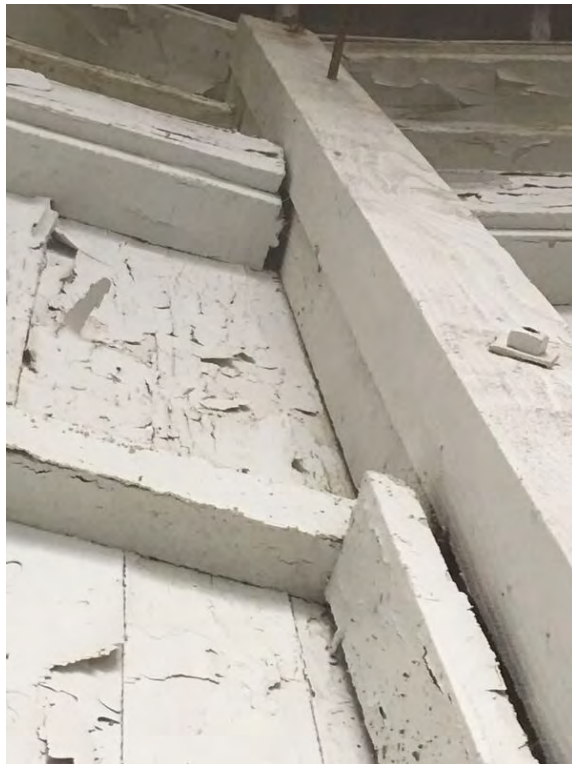
Fig. 125. View of typical inner ring wall showing mortise-and-tenon original upper structure and added face post and lower structure.

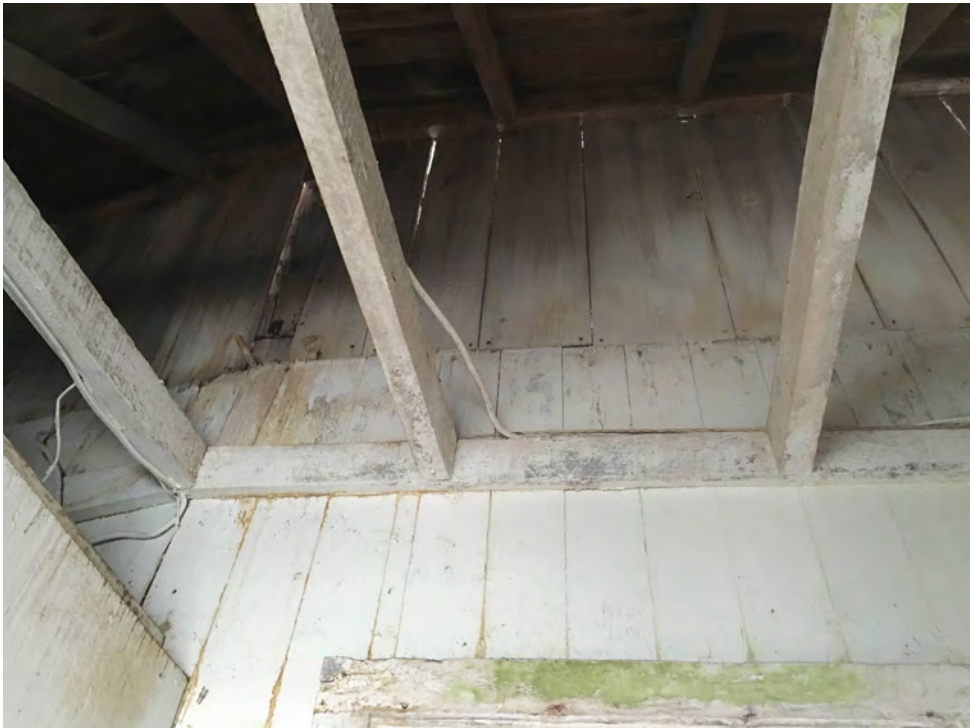
Fig 128. View from dressing room showing original upper sheathing and replaced lower sheathing on inner ring

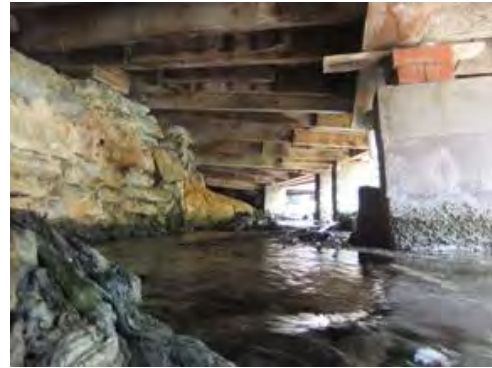
Figure 4: Foundations and Floor Framing

- The inner foundation wall appeared in stable condition, with areas of mortar loss or decomposition; this condition is to be expected, given the age of foundations and relatively inaccessible areas depicted in Figure 4.
- The perimeter piers appear to be a mixed assembly of masonry, including dry-stacked concrete masonry units (cmu), with additional brick or wood shims. Some piers appear to have settled unevenly and are currently out of plumb. The pier in Figure 4 is both out of plumb and has built up levels of shimming.
- Some of the perimeter piers show a structural history of timber piles, now rotted at their bearings, and subsequently replaced with cmu (Figure 5).

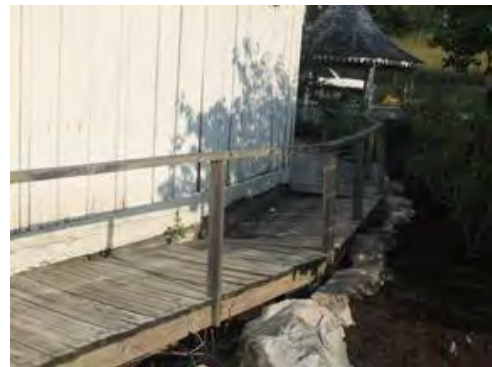
Figure 6: Deck Walk Deterioration

- Figure 6 depicts significant displacement along the interface between the walkway and the WBH, likely the result of failing connections and/or deteriorating wood members. The magnitude of movement indicates that little support remains in this section, and presents both a tripping hazard and the potential for a failure with further movement if subjected to pedestrian loads. The area was appropriately roped off at the time of our observations.
- Figure 7 shows that in addition to framing member support, there are areas of deck plank

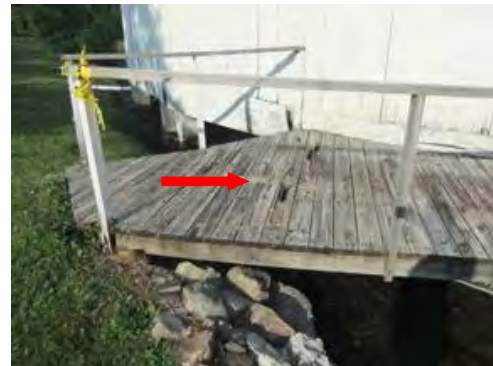
Figure 7: Deck Walk Deterioration

deterioration, again significant enough to potentially lead to a localized failure under foot traffic.

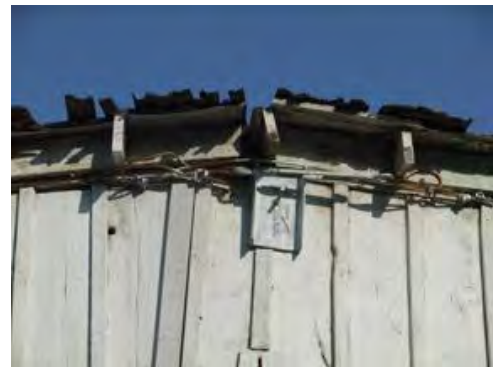
Figure 8: Retrofit cables and tie rods

- As depicted in Figure 8, retrofit structural cables have been installed at the upper sill level, wrapping around the full perimeter at this height. The cables appear to be tightened with a turnbuckle system.
- In addition, exterior channel end plates are present to receive the connection for three internal tie rods.
- Figure 8 also shows a highly uneven edge of wood roof shingles. In general, the roofing shingles appear to be in moderate to poor condition, with a number of penetrations apparent.

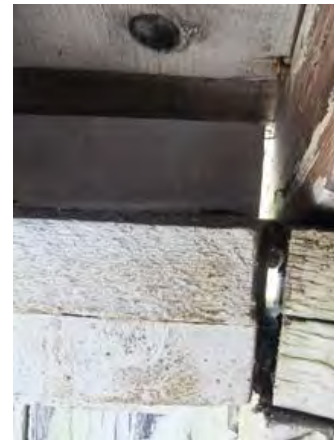
Figure 10: Separation at Double Top Plate at Main Perimeter Wall

- As depicted in Figure 10, the current connection between the top plates, which is the upper eave transition between rafters and main perimeter wall, has clear discontinuities that preclude it from resisting tension.

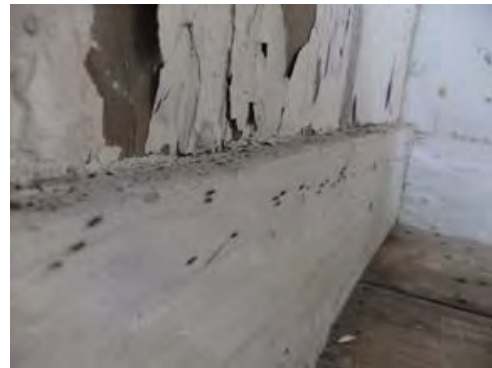
Figure 13: Active presence of insects in side vestibule.

- Figure 13 depicts ongoing insect activity that is likely concurrent with moisture collection and areas of wood rot.
- Figure 14 shows an area of wood sill deterioration directly above the spillway. The increased moisture presence has likely contributed to this condition. Vertical settlement of the wood post above this beam appears to be associated with localized crushing of the rotting wood.
- Figure 15 depicts a rotting post base as an example of localized wood deterioration observed at various areas within the structure.

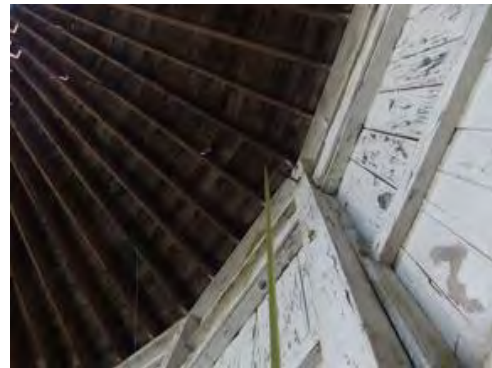
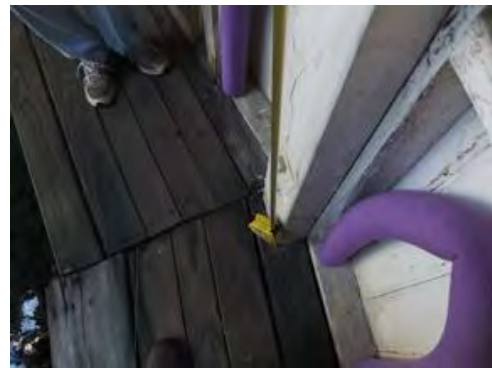
Figure 16a & 16b: Lateral displacement of posts

out of plumb. Magnitudes of lateral displacement, from platform level to the level of the internal tie rods, were estimated based upon the use of plumb bobs and tape measures, as depicted in Figure 16a & 16b and documented in drawing SSK-1 in Appendix A.

- One post, on the north end, was measured to be close to 12 inches out of plumb.
- Posts on the south side were closer to 0” to 2” out of plumb.
- The direction of the lean favored the north, to north-east, potentially corresponding to observed areas of pier displacement and prior rebuilding.

The lateral displacement of the posts, as observed, is consistent with two primary physical behaviors. The first, as described earlier, is lateral displacement due to weakness in outward thrust resistance. Resistance to the outward thrust of the radiating roof rafters would be efficiently achieved with a perimeter tension ring. The lack of an effective tension ring at the upper level eave had, apparently at one point, resulted in an outward push upon the lower roof and partition walls of the low perimeter rooms. This thrust again could be resisted most efficiently by a tension ring at the lower eave, or, by in-plane stiffness in the dividing partition walls of the perimeter rooms.

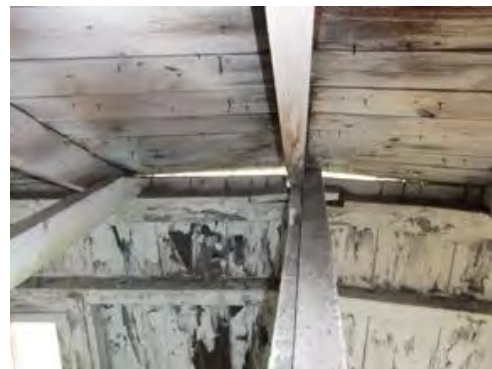
Figure 17: Separation of splice at outermost wall top plate.

- Figure 17 depicts a separation of the top plate at the outermost building perimeter. Unlike the top plate of the upper eave, here the top plate includes longitudinal splice plates to connect the top plates at each facet of the nearly circular plan. In Figure 17, the splice plate connectors have failed and the abutting top plates have pulled apart by approximately 1 inch.
- Figure 18 shows in-plane wracking of the perimeter room partitions, consistent with an outward, radial push at the top of the wall.

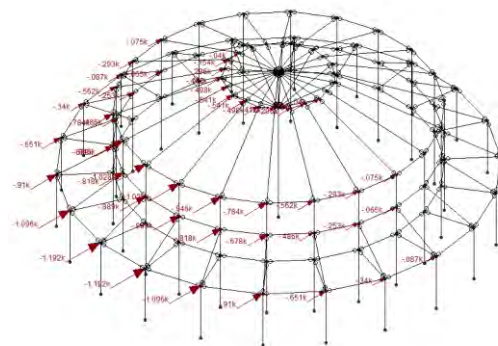
Figure 21: WBH – Wind Loads

Figure 19 depicts the basic geometry of the timber frame of the WBH. Figure 20 shows a basic distribution of gravity loads, which include the self-weight of the structure and its finishes, along with snow load. Figure 21 depicts a lateral wind load, based upon current code requirements.

The analysis of the basic timber frame when subjected to a load combination including lateral wind loads, showed the structure to be stable but with excessive lateral movements. Two subsequent analyses were then performed to assess the influence of the side boards. The side boards are typically 1" x 6" tongue and groove, oriented vertically and fastened to internal cross members spanning between the primary vertical posts. The joints are covered at the exterior exposure areas with wood battens.

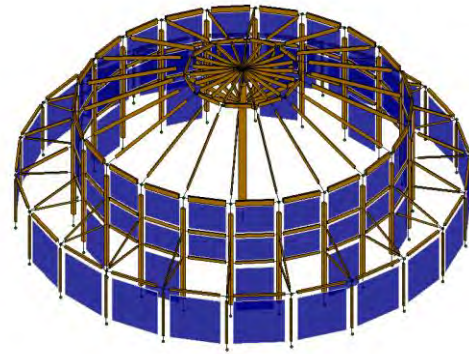
Figure 22: WBH – Wall Sheathing

Figure 22 represents the addition of wall boards, providing a diaphragm effect between the framing members. For the main interior wall, only every other bay was included, to represent the reduction of wall sheathing due to door openings. Only one such bay was removed for the outermost wall, to allow for the entrance door opening. Structural analysis found the net affect of wall sheathing to reduce lateral displacements by a factor of approximately 15, with magnitude results much more in-keeping with expected values.

A clear determination of the preliminary analysis is the significant influence of wall sheathing on the lateral resistance of the WBH structure. This will likely be an important consideration in developing future repair and/or strengthening schemes.

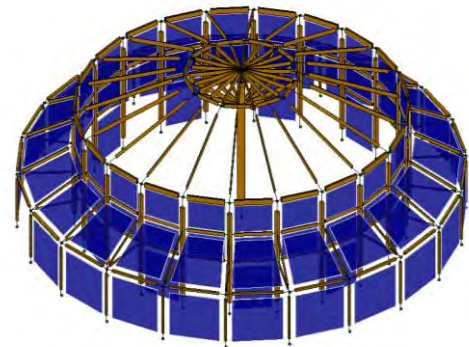
Figure 23: WBH – Wall and Side Roof Sheathing

In Figure 23, the analysis model was further changed to include sheathing at the low, perimeter roof. This resulted in a further reduction of lateral displacements, approximately 10% less than those of the model with wall sheathing only.

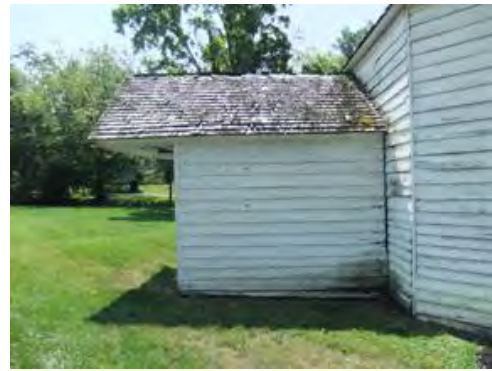
Figure 26: Entrance Vestibule - South

- Wood sill deterioration is a consistent condition around the building perimeter, exacerbated as the wood gets closer or in contact with the surrounding soil. Figure 26 depicts such deterioration along the south face of the entrance vestibule. This is particularly apparent at its east end where water travels along the interface between vestibule and main building wall, and is directed to this corner at grade below. Note increased water staining and biological growth in these areas.

- Both Figures 26 and 27 show the problem of the grade that surrounds the building sometimes sloping toward the building instead of away. This directs water toward the foundations and perimeter sills. The sill plate of Figure 27, taken at the northeast vestibule, is severely rotted as it is embedded in the surrounding soils.

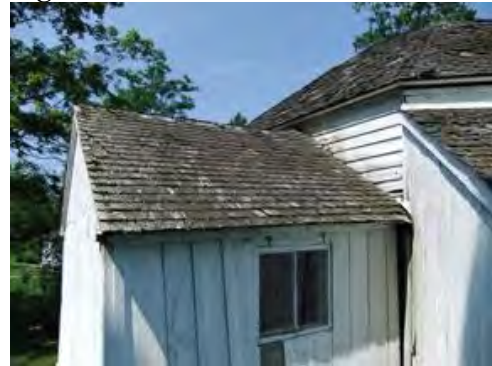
Figure 28: East Vestibule Rotation

- The east vestibule shows both sill deterioration and overall rotation relative to the main building (Figure 28). As the sills crush due to the sustained of building load while the material loses its integrity, connections above are strained and openings created, such as the gap apparent along the main building wall.

- Figures 28 and 29 show extensive areas of roof shingle deterioration, which is generally consistent for the entire main building and vestibule roofs.

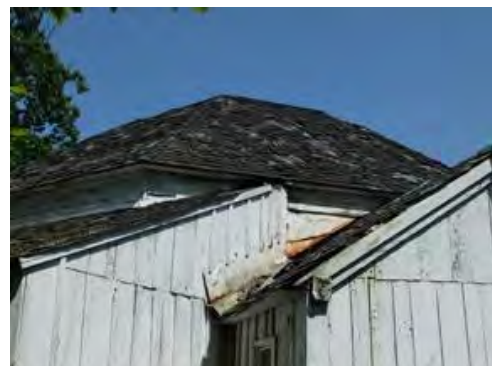
Figure 29: East Vestibule Flashing

- Figure 29 shows how this gap has been addressed over time along the roofline, with layers of metal flashing that have apparently failed repeatedly due to continued movement.

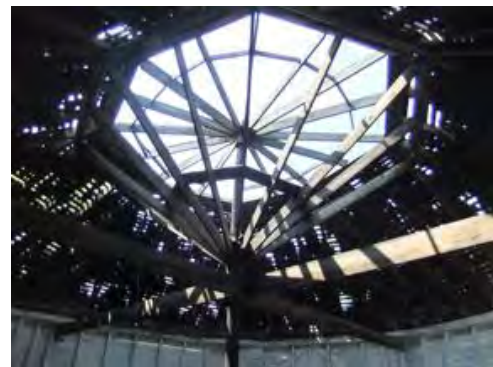
Figure 31: Framing & Penetrations

- Figure 31 shows widespread penetrations in the roofing, as many shingles have deteriorated and/or shifted out of place. Roofing penetrations leads to increased moisture along the rafters and down to the perimeter wall. The sustained presence of moisture at the wood interfaces can lead to material decomposition over time.

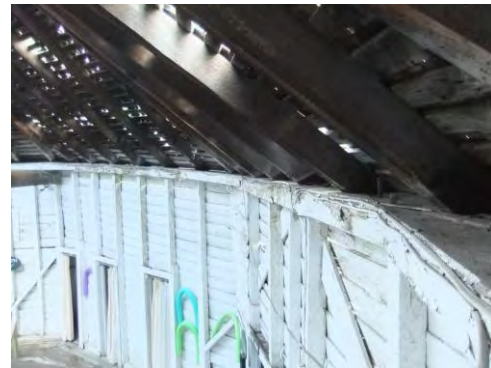
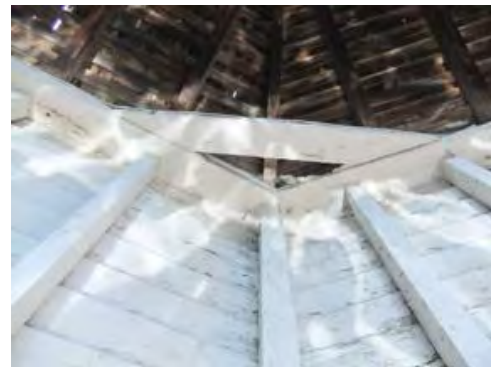
Figure 34: Top Plate Tension Ring

Thrust resistance from the roof framing is more effectively addressed in the historic structure of the MBH. As depicted in Figures 34 and 35, the 6" x 8" top plate serves as an effective tension ring through multiple means. First, the abutting top plate connections are half-lapped and pegged with wood dowels. Second, a cornering splice plate, measured at one location to be 4 1/2" x 7", connects the top plates with a dovetail lap that is also pegged with wood dowels.

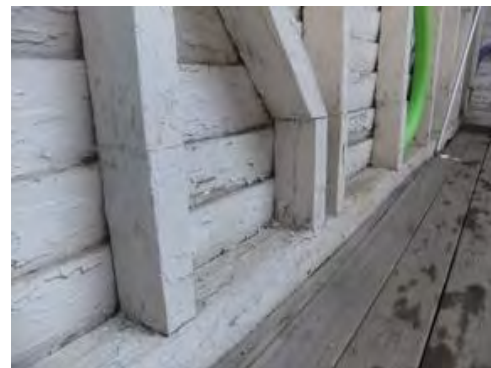
Figure 36: Stud & Brace Modifications

- Figure 36 an area along the north side of the structure where the bottoms of both wall studs and diagonal braces have been cut and reconnected with vertical stub members. The discontinuity of the bracing members significantly reduces the effectiveness of these components in providing lateral stability. The modification may have been implemented to repair rotting bases of the members as they connect to the sill. That this was only observed on the northern side may be correlated to the presence of exterior grade so close to the sill plate, allowing for a prior history of wood deterioration.
- Figures 37 and 38 show sill deterioration ongoing, again likely the result of sustained moisture.
- Figure 39 shows an area of wall brace deterioration.

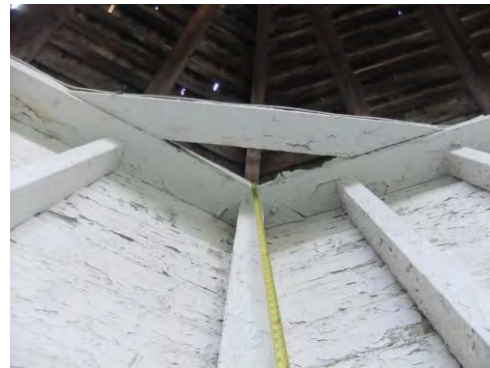
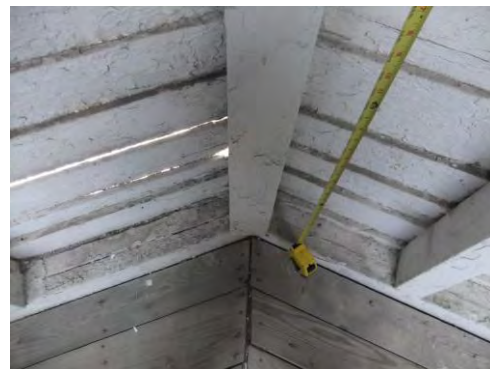
Figure 40a & 40b: Corner Post Plumbness

- Like the WBH, some out-of-plumbness was documented within the MBH structure. Figures 40a and 40b demonstrate the lean of one post. As indicated in SSK-4 of Appendix A, the overall magnitudes of lean are smaller than those documented in the WBH. However, similarly, there appears to be a generally tendency to lean towards the north.

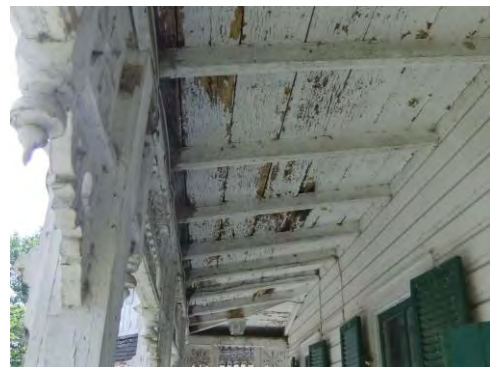
Figure 43: North Porch Roof Framing

Figure 43 depicts the framing of the north porch.

- Although the primary rafters appeared to be in good structural condition, the paint on the underside of the roof boards has deteriorated and localized areas of deterioration were observed.
