# *The* PETERSBURG EXCHANGE BUILDING

## *A Historic Structure Report*

*24 November 2021*

**PREPARED BY:**  
*Studio Ammons Inc. &  
Landmark Preservation Associates*

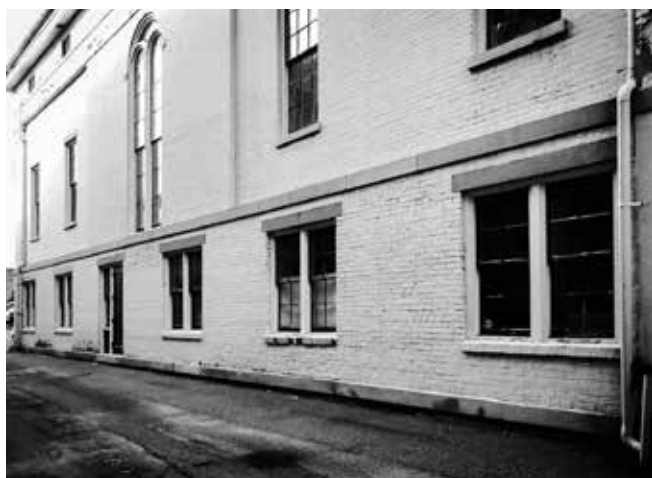
*Current view down the west alley side showing the typical white painted brick with brick infills under each window.*

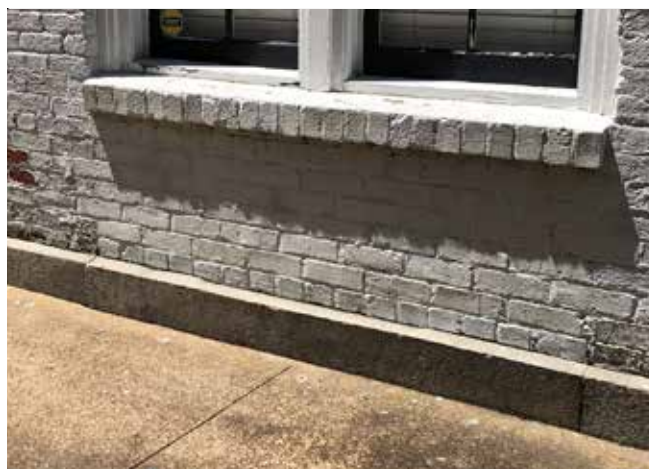
*Detail of brick infill under double window (typical on both alley sides).*

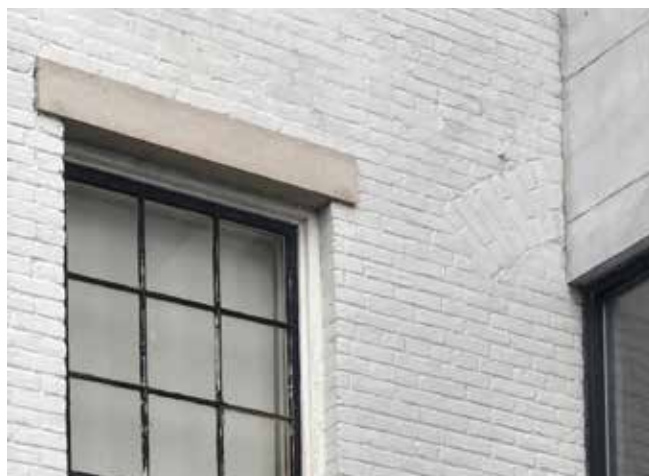
*View of the small portion of brick segmental arch from original rear opening on the First Floor. Most of the arch is now hidden behind the elevator addition (right).*

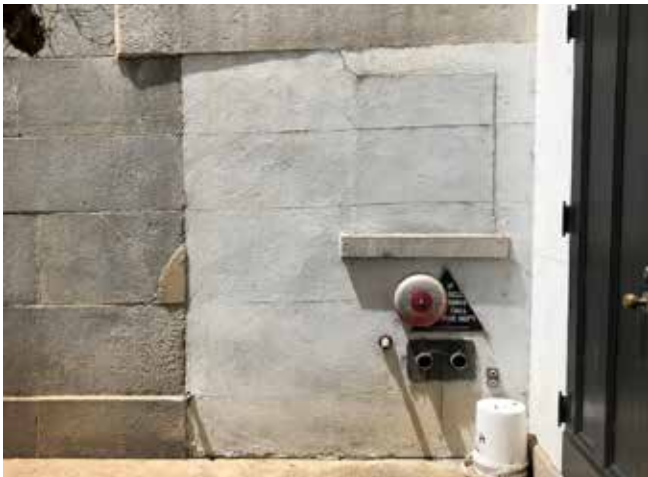
*Filled in entrance under east side of the portico with current entrance to the right*

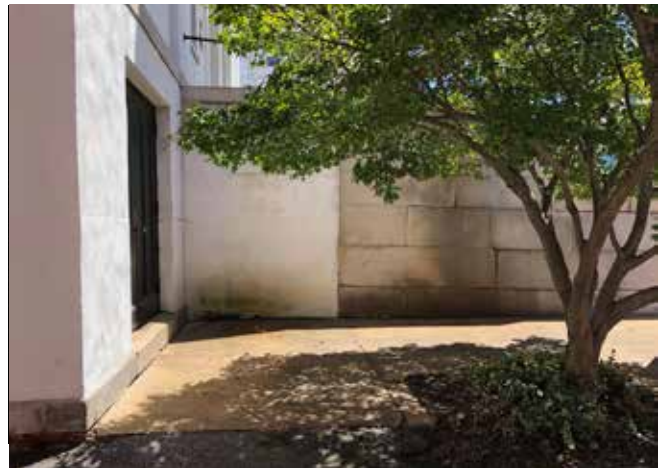
*Filled in entrance on west side of portico with double door entry to the left (not currently used)*

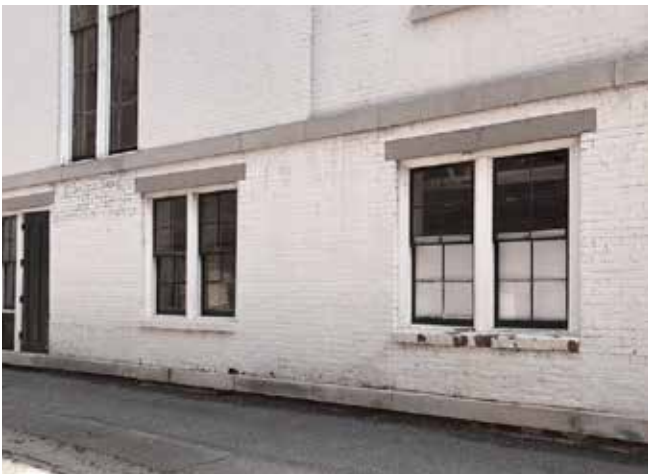
The ground story has double four-over-four wood sash windows which are not original to the building and may date to the 1920s, though the openings that contain the windows are original to the building. The windows have brick sills (which distinguishes them from the original windows, which have granite sills) and brick infill between the sills and the granite belt course at the base of the story. The belt course blocks under the infill have shallow outward-sloping thresholds indicating the former existence of entries, probably with sidelights (the evolution of these openings is discussed in greater detail in the architectural analysis section). Some of the openings have single-leaf two-panel wood doors flanked by single four-over-four wood sash windows with paneled aprons. The doors and possibly the flanking windows appear to date to the 1970s.

*View of 4-over-4 window infills with brick sills at alley openings. Typical of both alley sides.*

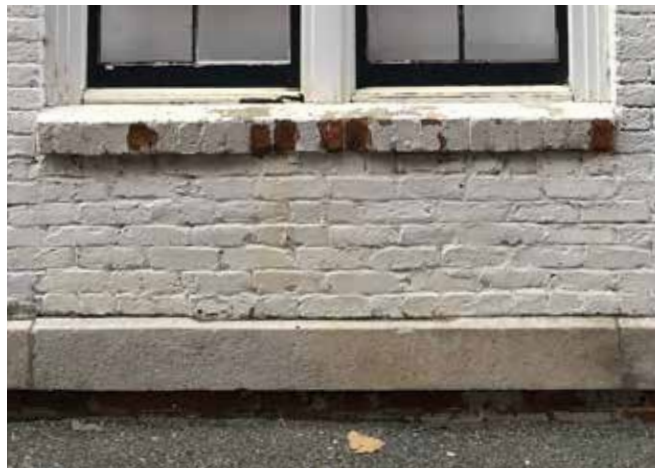
*Shallow sloping threshold in the center indicates a center door at one time.*

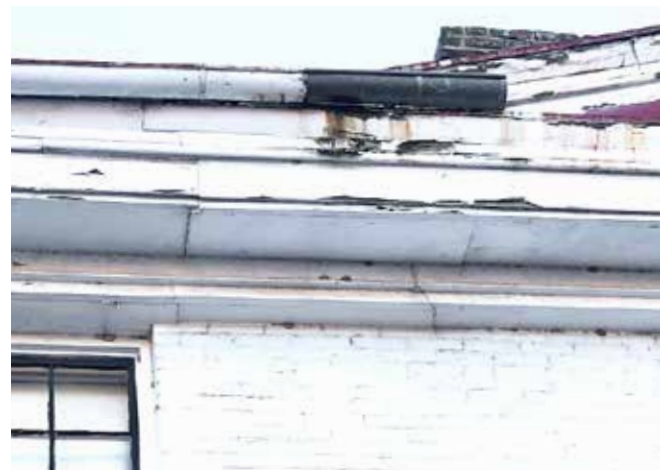
*Stepped seams in the cornice and fascia where original rear portico pediment extension was removed and patched.*

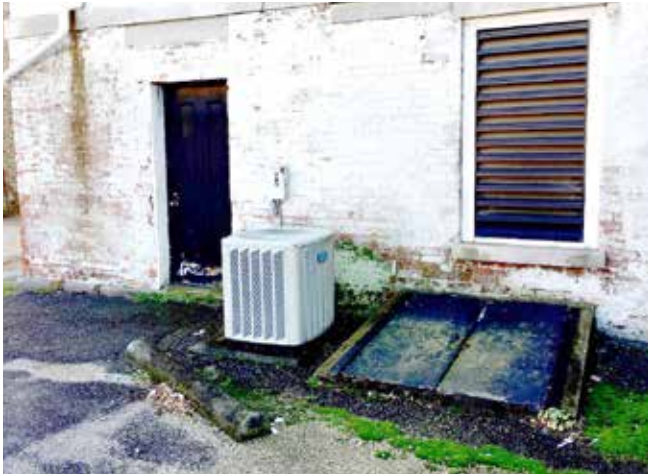
end of the architrave and frieze registers of the side elevation entablature. To the left of the elevator tower hyphen, aligned with a window that has been made into a vent, is a basement bulkhead with low-pitched sheet-metal doors that have been permanently closed by welded cross members. One of the bulkhead door leaves has a handle with heart-form attachments similar to eighteenth and early nineteenth century hardware. The handle is probably reproduction hardware. A matching bulkhead formerly existed to the right but was eliminated by the entry area of the elevator tower.

*View of the northeast bulkhead entrance to the basement and window turned into a vent above.*

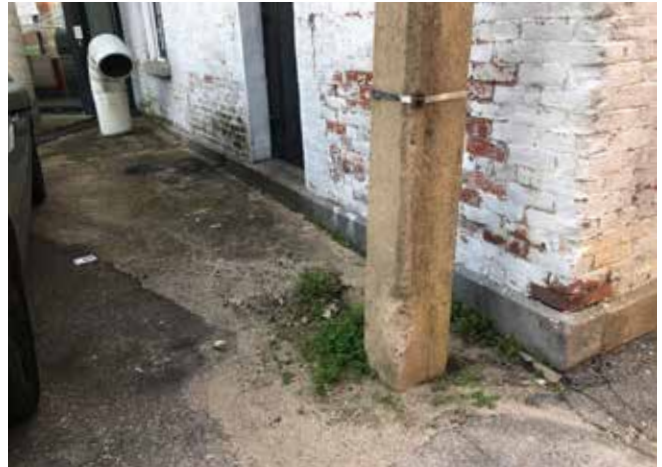
*Location of original northwest bulkhead now covered up by paving at 1970's entrance to the elevator tower. Bulkhead still exists in the basement*

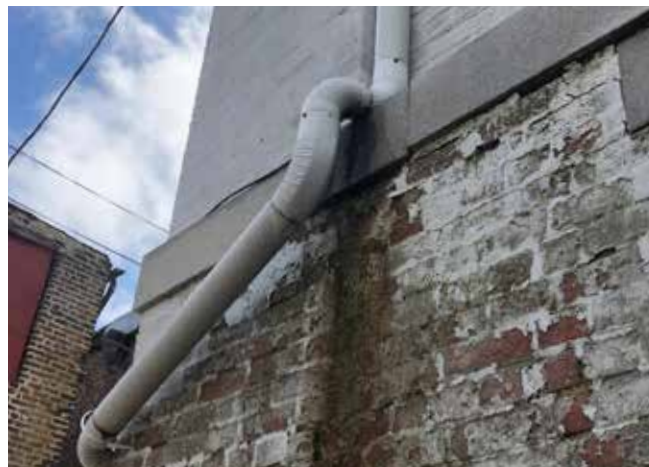
*Downspouts snaking around the building features.*

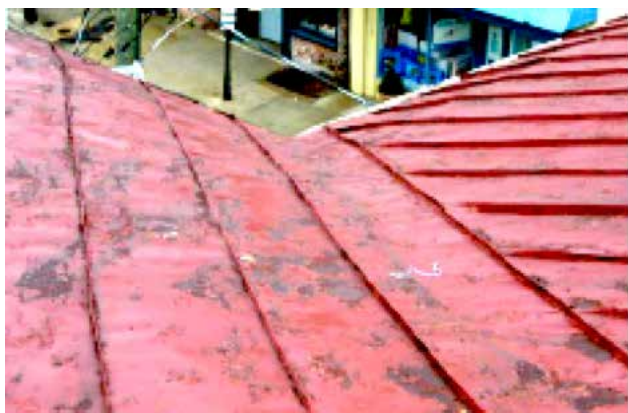
*Detail of existing roofing showing long panels and oil-canning along with severe rusting*

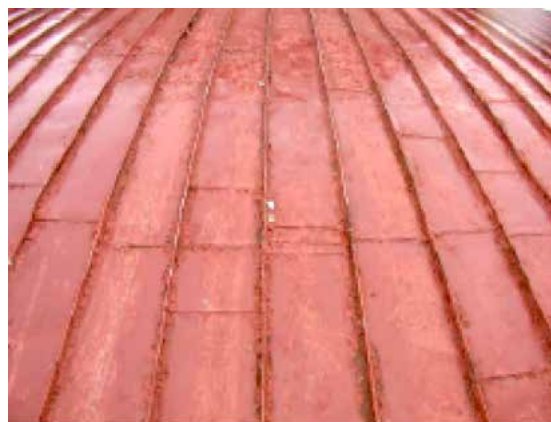
*Detail of existing dome roofing showing segmented terne metal panels still intact.*

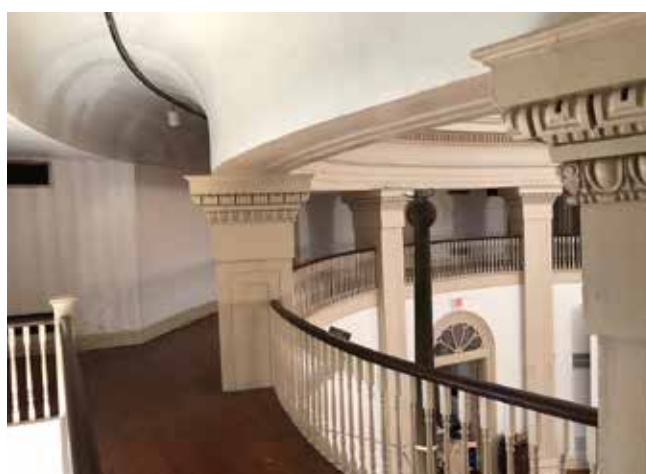
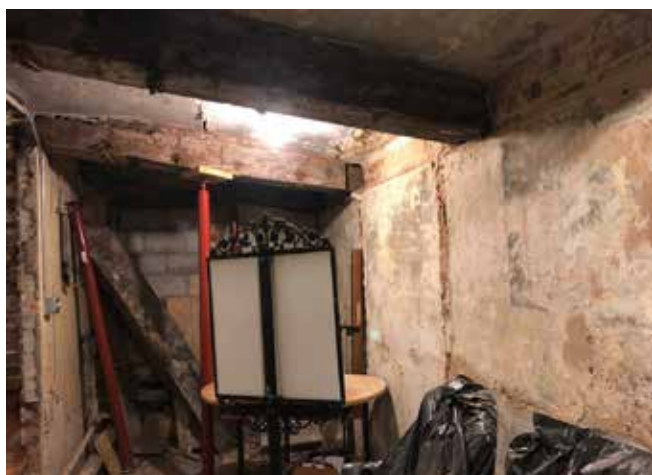
*Interior spaces that have not been used or maintained.*

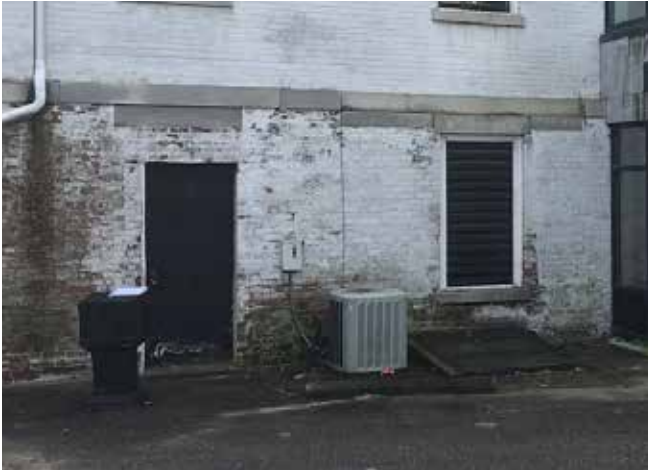
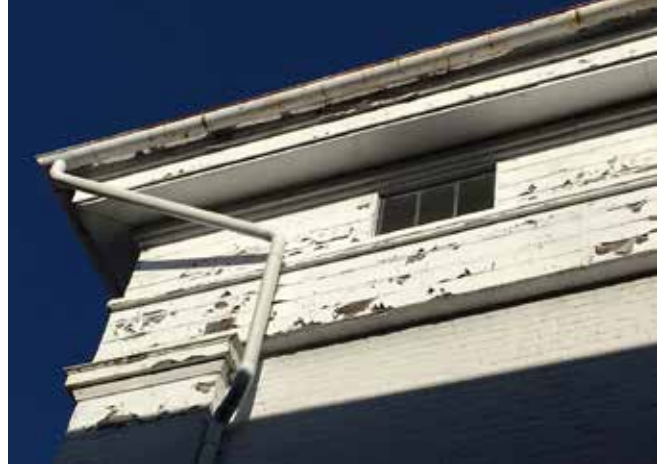
*Water issues and deferred maintenance are causing deterioration of historic fabric.*

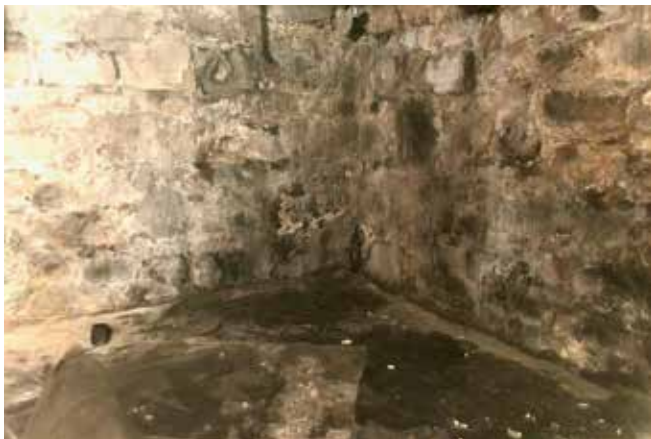
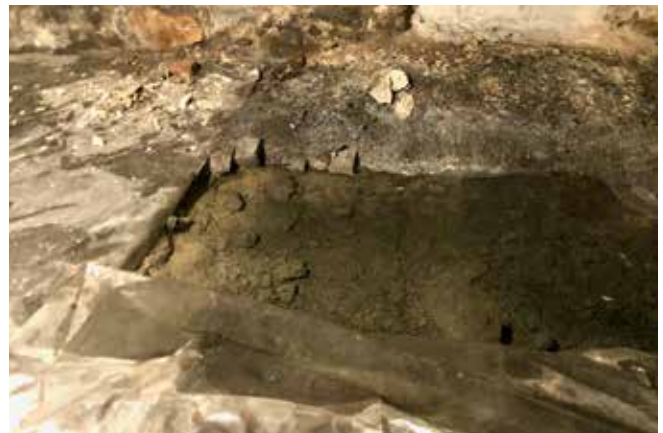
The most critical problem facing the building is from the variety of ways water is infiltrating the building envelope causing damage to both exterior and interior finishes and the deterioration of historic building fabric. The most severe damage is being done by a combination of surface and sub-surface water draining from the site around the building. These problems were most likely created by the paving of the rear portion of the Exchange Building lot and the layered building-up of the alley paving around the building during its 1970's renovation. Before this, portions of the side alleys had been paved with concrete, most likely during the city's occupation. Before this time, their surface would have consisted of a combination of unpaved areas and cobbles or Belgian block set in sand and would have provided a pervious surface to absorbing much of the water before it became a large volume of concentrated runoff heading toward the building. In addition, today, the severity and frequency of storms due to climate change has increased the volume of water trying to get into the ground behind the building exacerbating these drainage problems and causing the building's basement to remain wet at all times.

*Views of the active water infiltration in the basement from ground water along the rear wall/parking lot. Standing water collects in low spots and fills up the Mechanical Room (two images below) when the sump pump is not working. The plastic on the ground in the basement helps with vapor but is installed over a build up of dirt that has accumulated on top of the original brick floor.*

- 1) A new site drainage system should be installed to capture surface runoff and pipe it to the City's storm water system. This may consist of a French drain but other long term alternatives should be explored in planning for the reconfiguration of the parking area as a whole. It should be understood that simply trying to grade a slope away from the building may not be sufficient to manage the ground water effecting the building in such a tight urban condition with mostly paved surfaces.

- 3) All downspouts, on both the east and the west alleys, should be piped to the city's storm water system at Bank Street.
- 4) Sump pumps in the basement should be used as an emergency measure knowing that it may not be possible to eliminate all underground water migration. Once a sufficient site drainage system is in place then interior moisture can be monitored and measured to determine if additional measures should be taken within the building's footprint to manage water and moisture.

- 5) If external measures cannot eliminate damaging water and moisture infiltration into the basement, an interior drain system should be considered. Its design and installation should carefully consider the impact it will have on any historic fabric including basement flooring or archaeology. [long term]

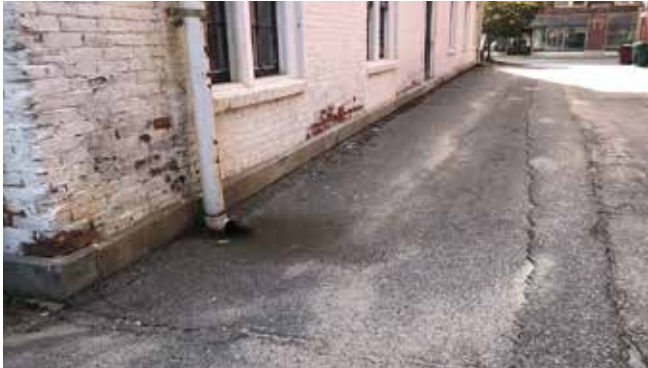
Over the years, the alleys have been paved many times, and the grade around the building has been raised causing water to flow towards the building and find its way into the basement, saturating the basement walls that remain constantly wet. At some point in the past, the city installed a surface site drain in the alley to the northeast of the building but although seemingly well positioned, the configuration of this drain is either not able to accommodate the flow pattern or quantity of water it currently receives and is therefore unable to mitigate the amount or speed of surface runoff from the paved parking area and the alleys.

*West alley views from back to front showing brick damage from water splashing on the pavement at the building wall as well as how paving, over time, has raised the alley surface up higher than the downspout outlet.*

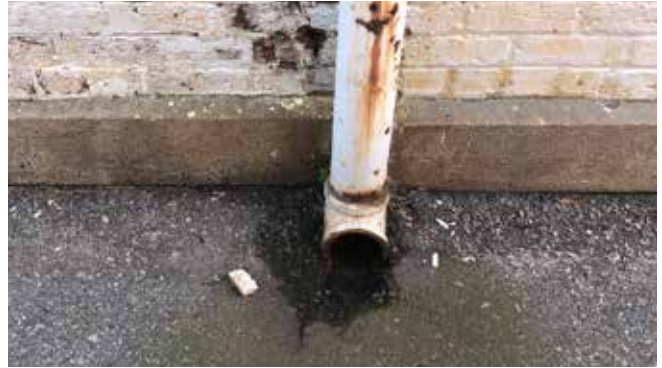
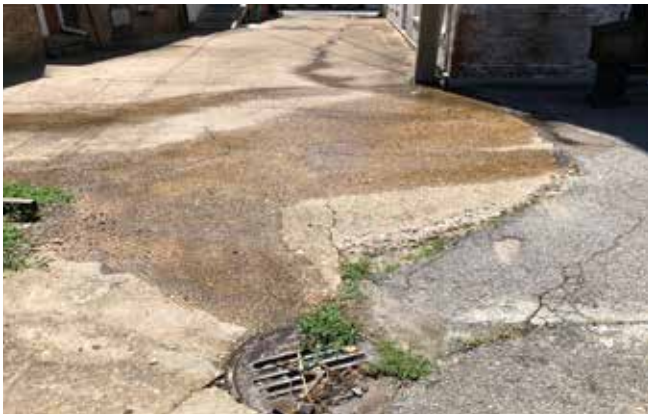
*(left) Site drain behind the building in the east alley is insufficient to manage the amount of water draining from all of the paved areas around and behind the building. (right)*

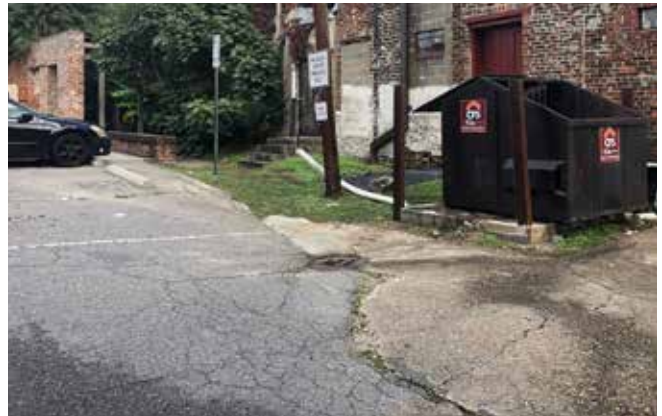
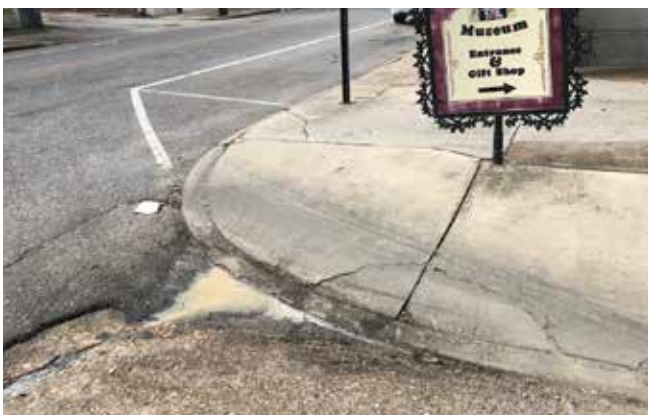
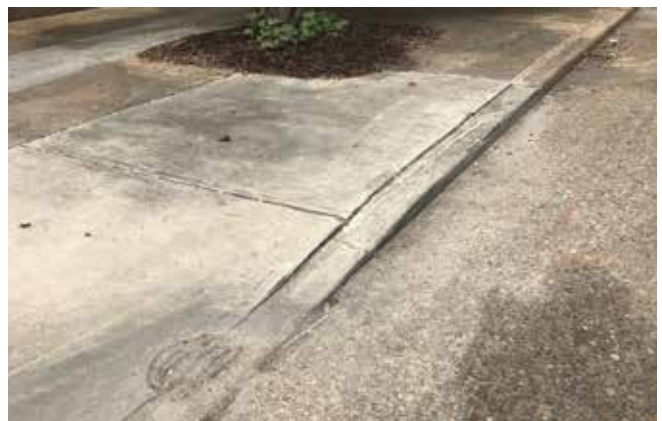
*Views of the lowered curb at the southeast corner of the site (left) and showing the build up of paving along the east side alley curb allowing large amounts of water to flow over the curb towards the building. (right)*

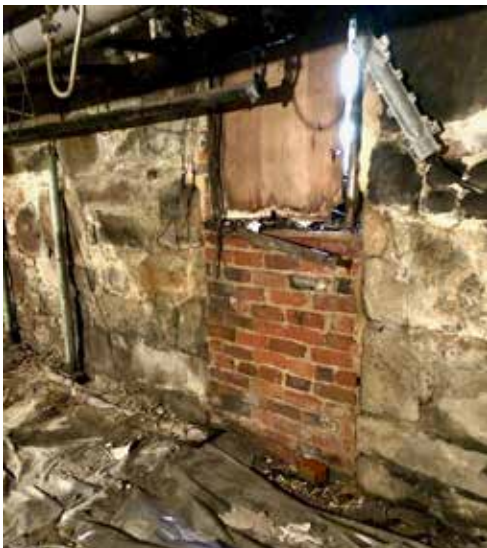
There are three locations along the east and west sides of the building where there were once openings from the sidewalk or alley into the basement both for access and delivery of coal. All three of these side openings into the basement are partially bricked or closed up but these interior closures are deteriorated or were originally just "quick fixes" to keep water/air out of the basement. At these side alley locations the water is entering the basement at these openings from a combination of increased surface water running down the alley as well as water dripping from open seams in the gutter system at the roof line. The splashing of dripping roof water keeps this portion of the exterior wall damp and joins forces with the excess surface water flow in the alley to keep these foundation walls and adjacent basement areas wet or damp at all times. Water flow from the east side alley often comes into the basement at such a rate that it flows across the basement floor and pools in low spots as far away as the center bay of the building.

*Interior Basement views of the bricked up, grated opening on the east alley where a considerable amount of water is coming into the basement.*

- 1) The two grated openings should be made water-tight at the sidewalk/alley level and the interior opening conditions should be stabilized to prevent water infiltration. Further investigation of the existing conditions may help determine an appropriate way to close the openings with properly sealed covers coordinated with restored curbing, stone, and brick work.

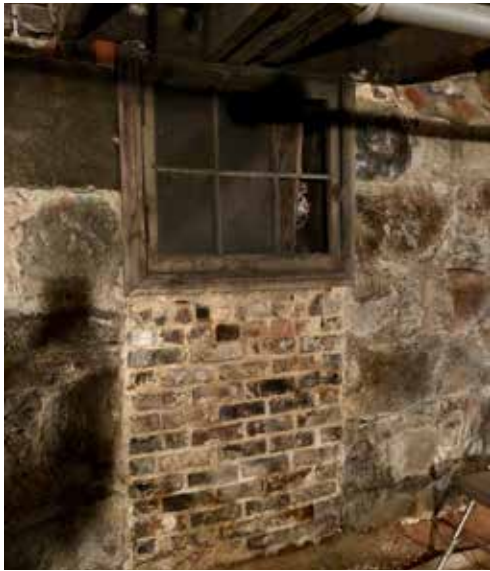
*(left) view of the west alley opening infill showing that the window sash may have been installed to allow light into the basement near the stair location.  
(right) Basement view looking down center bay showing how water from the east alley grated opening has migrated (dark areas on floor) all the way to the center of the building*

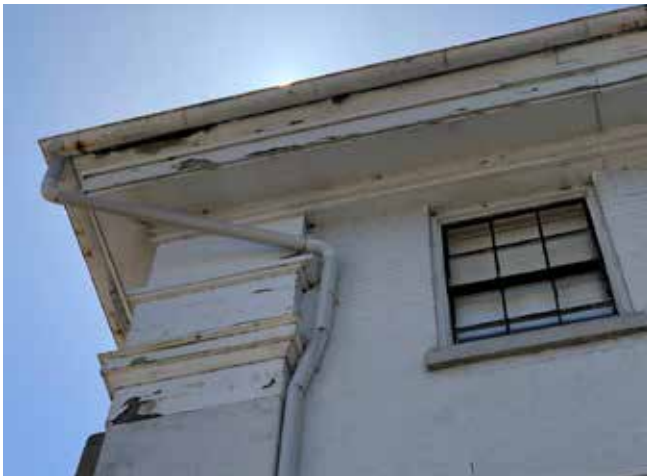
The guttering system around the building has not been maintained for years. At many locations, the continual dripping from open seams or joints is splashing at grade, keeping the foundation walls damp or wet for long periods of time. Due to the building's location, being surrounded on its east and west sides by alleys and other buildings, three sides of the building (one being the north side) do not get full sunlight for extended periods of the day and therefore, once wet, these walls have a tendency to stay damp for causing interior and exterior paint and plaster problems as well as more damaging spawling of the brick surfaces due to freeze/thaw cycles.

*Views of existing gutters and poorly planned downspouts with leaking elbows and joints causing mortar and brick damage.*

- 1) All gutters and downspouts should be removed and replaced. Roofing demolition will reveal if the short slope along the edges of the building roof have covered up original built-in gutters. If so, then the original built-in gutters will be restored allowing for the downspouts to drop from the soffit with no elbows. If no evidence of original built-in gutters is found, then a new system of half-round gutters and resized downspouts will be installed taking care to minimize joints and elbows to connect with new cast iron boots at grade.

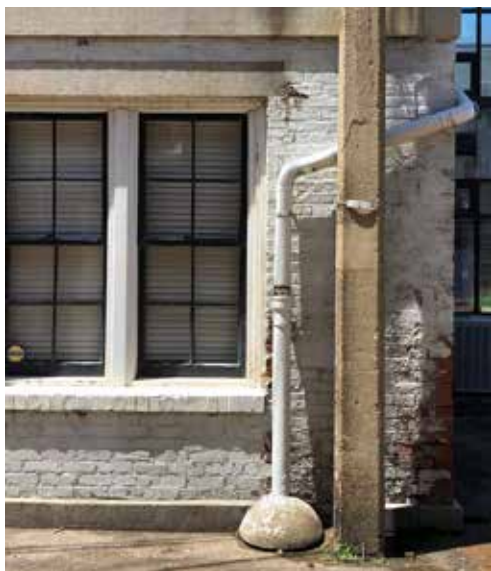
*Masonry damage from walls staying moist due to water dripping from leaks in the gutter system above and splashing on the concrete walk at grade.*

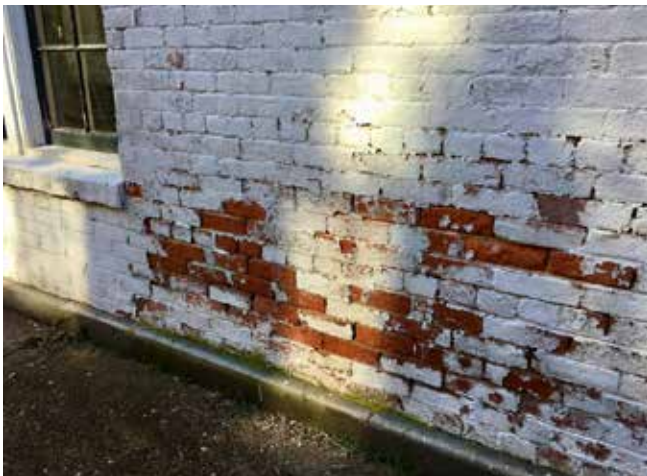
The building's exterior walls and finishes have suffered from a combination of water problems (as noted previously under Water Infiltration) and deferred maintenance related to wood trim, brick repointing and painting, and window repair. The current condition of the exterior walls reflects this lack of maintenance primarily within 4-6' of grade around the building, and at the cornice line around the building where rotted and deteriorated wood needs to be replaced along with a wholesale cleaning, re-securing and painting of the cornice, frieze and all associated trim. During its renovation in the 1970's the exterior brick appears to have been sandblasted prior to repainting.

*Water damage at exterior walls from splashing and damaged/rotted window sills and jamb members allowing water to get inside of the masonry walls and keep areas wet.*

- 1) Using recommendations from the historic mortar analysis, repair and repointing of all water damaged masonry on the lower portion of the exterior walls should be done with careful consideration for the protection and retention of original brick. Areas of the wall that are currently painted should not be repainted after repointing. Final exterior paint choices should be made following the recommendations of an exterior paint analysis.
- 2) In coordination with roofing work, make in-kind replacements for all damaged or rotted wood members in the cornice and frieze and repaint based on the HSR/paint analysis recommendations.
- 3) Existing soffit vents are to be removed and the soffits repaired at these locations. (note that new roof top vents should be specified to replace the inadequate soffit vents).

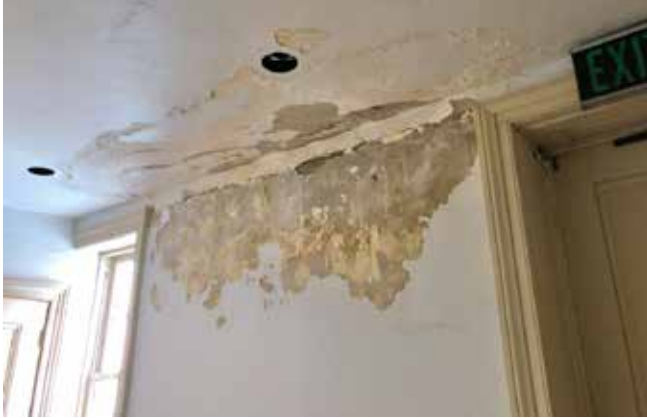
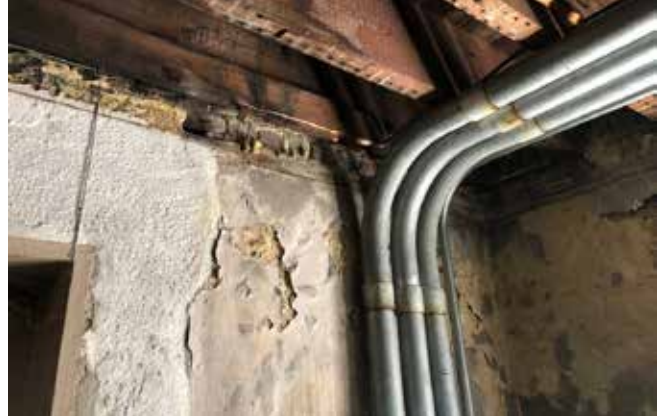
The interior finishes on the building's exterior walls suffer from water and moisture damage from two sources: 1) rising damp from the ground water issues referenced in the previous Water Infiltration section of this report, and 2) water infiltration at window locations where deferred maintenance has allowed the migration of moisture into the masonry walls effecting the interior plaster around these areas.

*Views of interior plaster damage due to water infiltration (Left) along the west alley below the two story rotunda window and (Right) at the rear Ground Floor wall in the northeast mechanical room.*

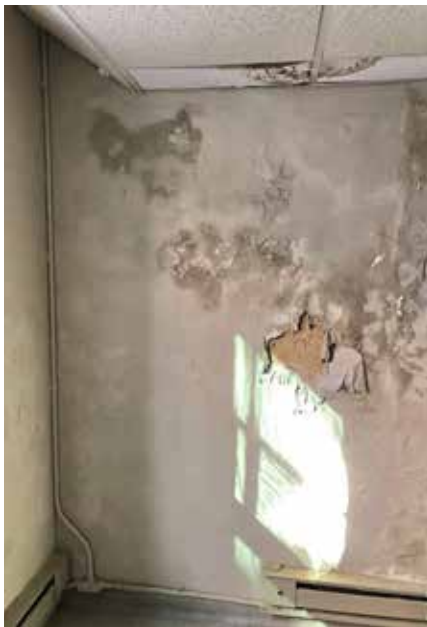
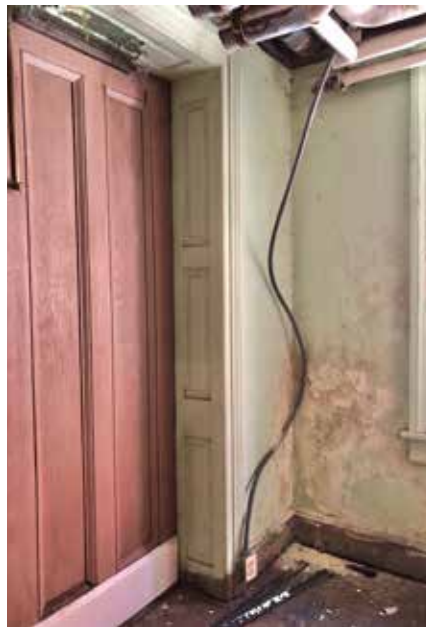
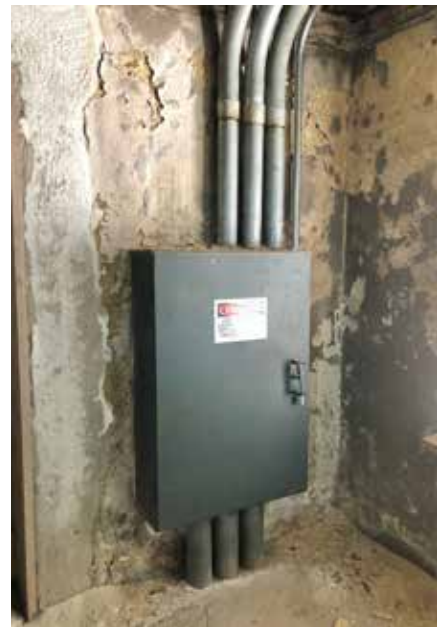
*Interior views of plaster damage from sustained wall dampness.*

- 1) Interior finish stabilization should be done only after all work to remediate moisture infiltration is completed. All damaged plaster and rotted wood trim should be fully documented before removal down to sound substrate. Remove no more plaster than is absolutely necessary for future installation of new finish plaster system. Stabilize the surface of any exposed base or brown coat with a consolidate that will prevent surface damage and allow for future finishes to be applied.
- 2) In areas around windows in finished/occupied locations, plaster should be repaired and the areas repainted.

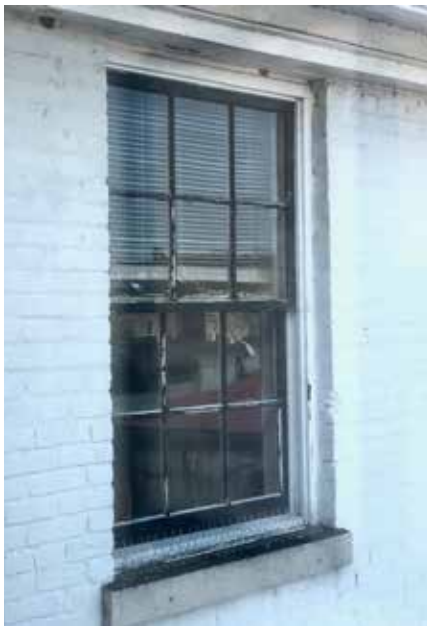
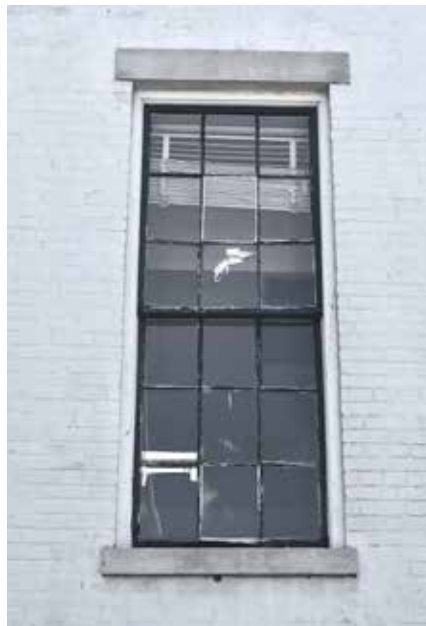
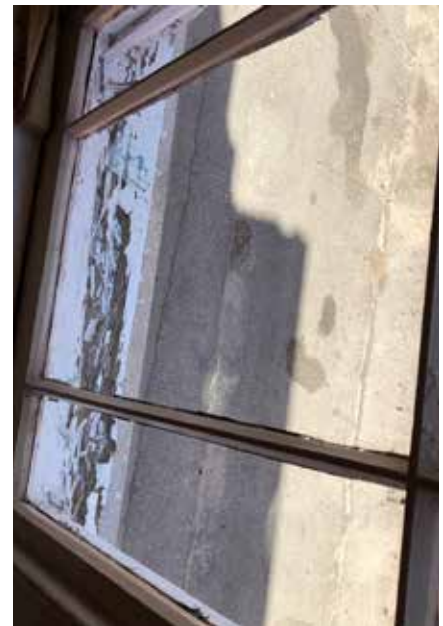
Windows throughout the building are in a general state of deterioration. Limited repairs have been made to the sashes over the last 20 years but little work has been done to restore damaged or rotted frames, sills, and stools. Several glass panes are loose or missing and muntin repair is needed throughout most of the original sashes. Newer sashes that were fabricated and installed, in the most recent round of repairs, were made from soft pine which is already showing signs of water damage from lack of maintenance and proper painting and glazing. The range of damage to window sashes has contributed to a variety of water infiltration problems causing damage to interior finishes around the windows - primarily interior plaster damage. Rather than make proper repairs, the sashes in the roof cupola were covered with plywood to protect them until they could be restored. Some of the plywood panels have been removed allowing light into the dome but now, with these panels off, the damage to the sashes and frames may cause damage to the interior dome finishes and must be addressed before any additional damage occurs.

*Typical exterior window views showing glazing that is falling out, broken panes and damaged sashes and sills.*

- 1) All window sashes are to be removed and repaired/restored in the shop including the replacement of any rotted or damaged materials and the resetting and glazing of existing glass panes. Any replacement glass must be reviewed next to original glass to determine the appropriate "wavy" value Blendheim glass to use for replacement. Modern flat glass should be identified for replacement with a more historically appropriate Blendheim glass. Damaged or rotted areas of sash frames should be repaired with a sandable and shapable wood epoxy and prime and painted per the recommendations of the historic paint analysis report.
- 2) All frames are to be assessed for rot and damage and members repaired in situ where possible with wood epoxy and consolidant prior to the reinstallation of restored sashes. Note that final paint color will be determined after future paint analysis is undertaken.

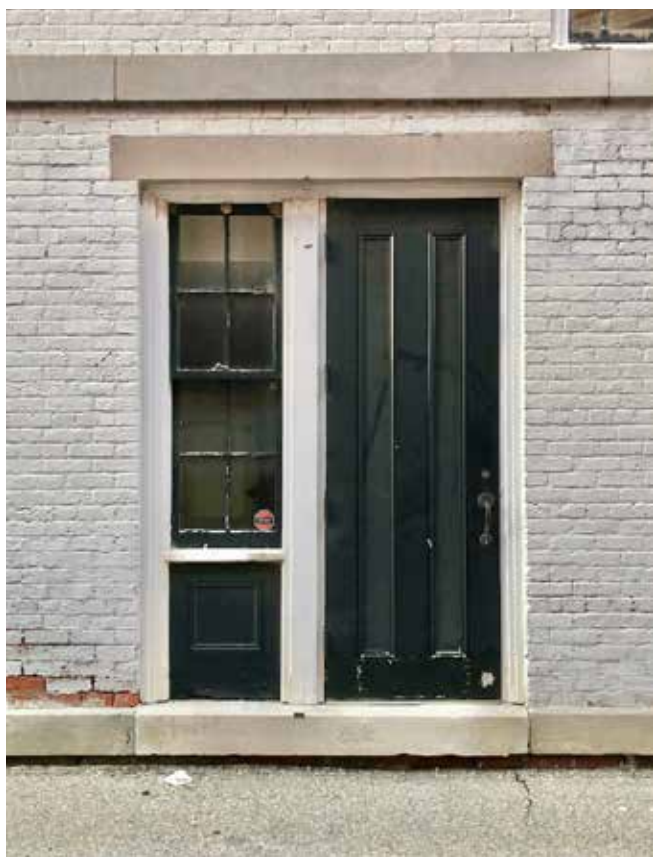
*View of an original alley opening with a door and sidelight infill. Note the granite sill shows evidence of an earlier centered door.*

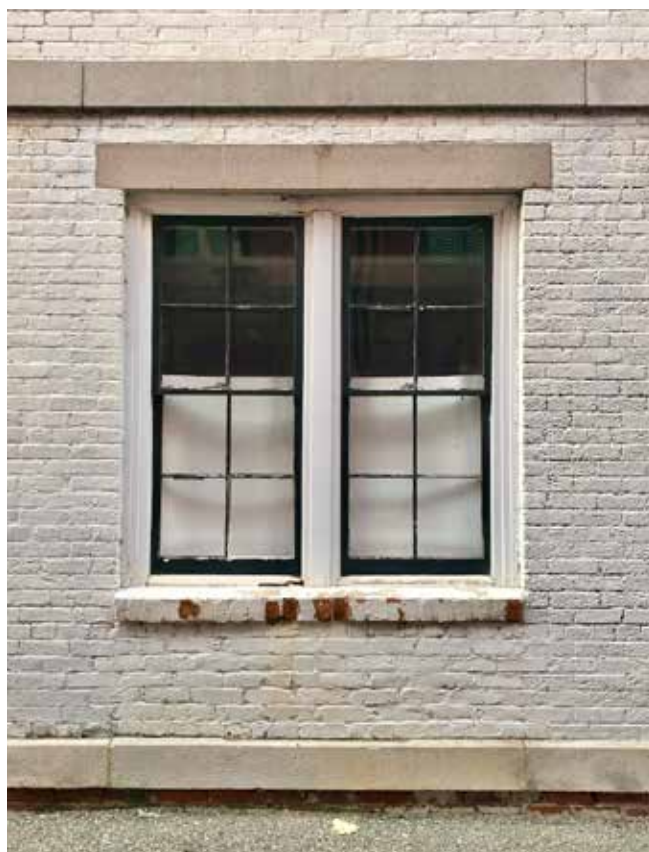
*Most of the original alley openings have been filled in with 20th c. windows with brick sills.*

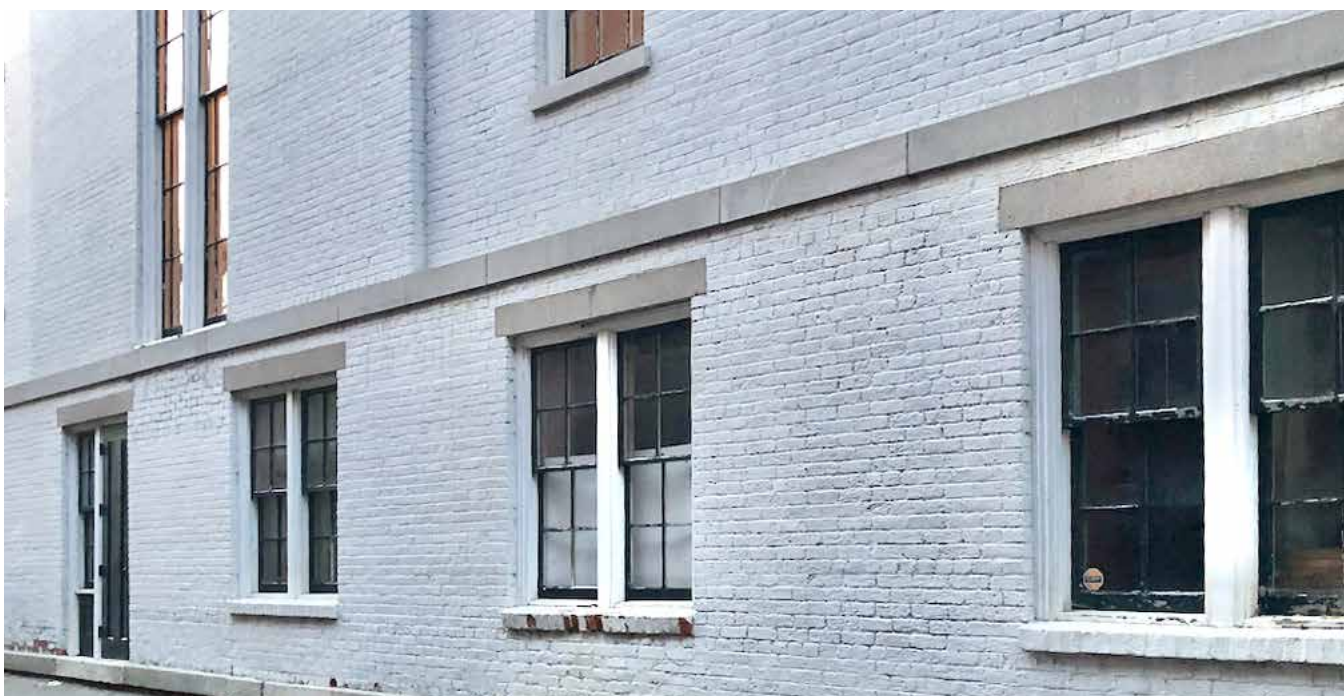
*View down the east alley side (west is similar) showing original openings infilled with double windows and brick.*

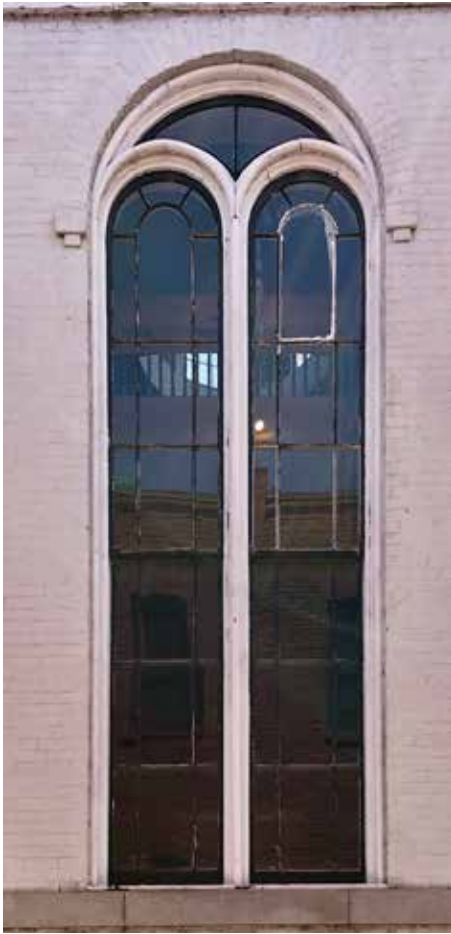
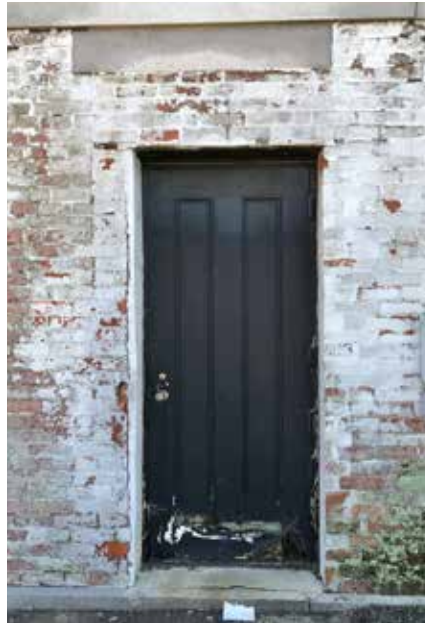
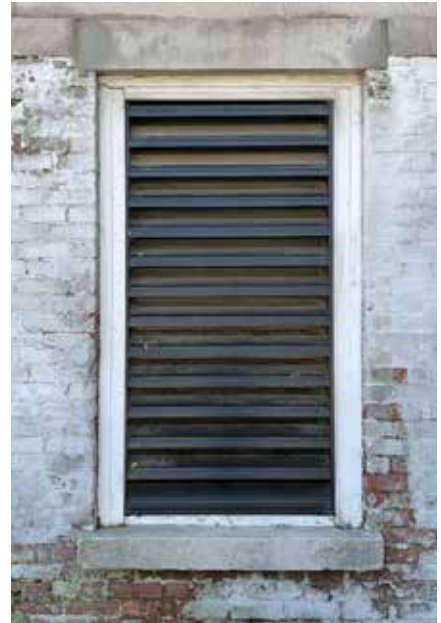
*Image of condition of tall arched windows (left), Historic window infilled with door (center), Historic window infilled with louvers (right)*

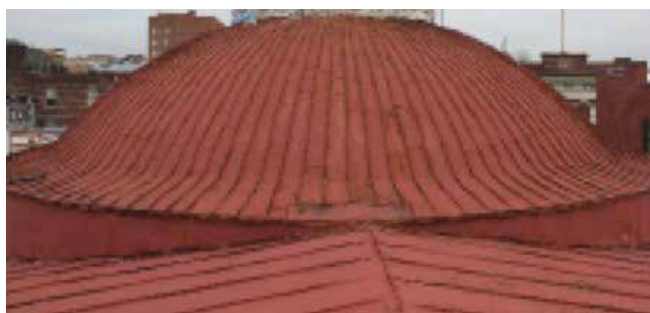
*Views showing general condition of the roof. Dome panels appear to be original but other larger roof areas have been replaced with continuous panels that lack the ability to adequately deal with thermal expansion and therefore show considerable oil canning which contributes to the deterioration of surface coatings. As the roof was always a tin roof with copper gutters, a new painted copper roof will provide the best quality replacement with the look and fabrication of the original roof.*

- 1) The dome roofing should be considered for restoration rather than replacement since it is a primary character defining element of the building and its roof and the tapered short panel roofing may be original to the building's construction. This portion of the roof should be evaluated with historic roofing professionals during stabilization work to determine the best approach to restoration and if that is not feasible, to matching its construction, in-kind, if replaced.

- 2) The existing metal roofing should be removed and replaced with a new copper roof painted to match the original color (note that an attempt will be made to find the original roof color when paint analysis is undertaken). All decking will be inspected for deterioration and replaced in-kind and new step flashing and crickets will be installed at all penetrations and access hatch curbs.\*

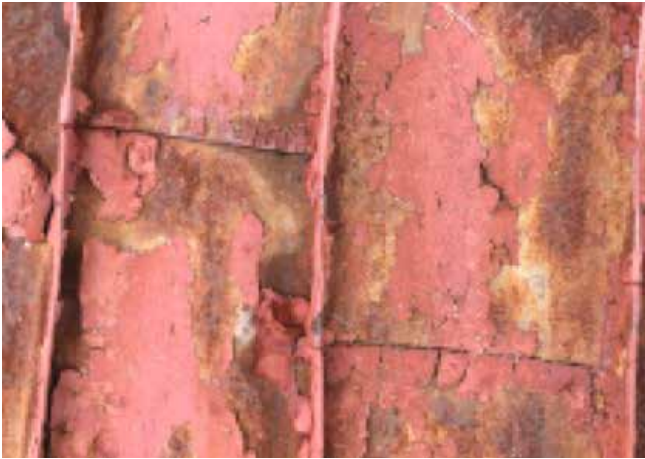
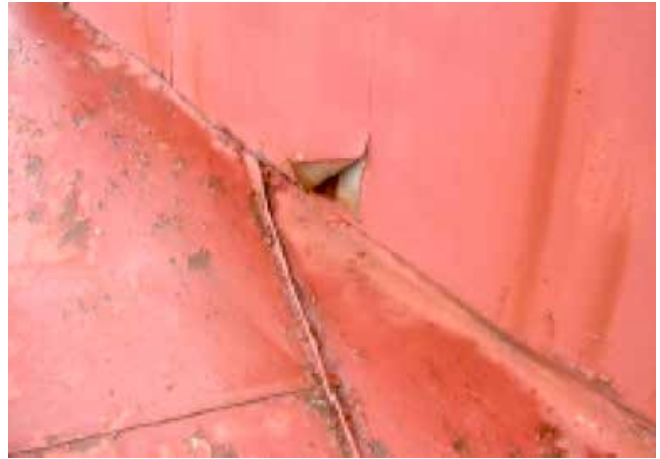
*Details of surface conditions on existing roof.*

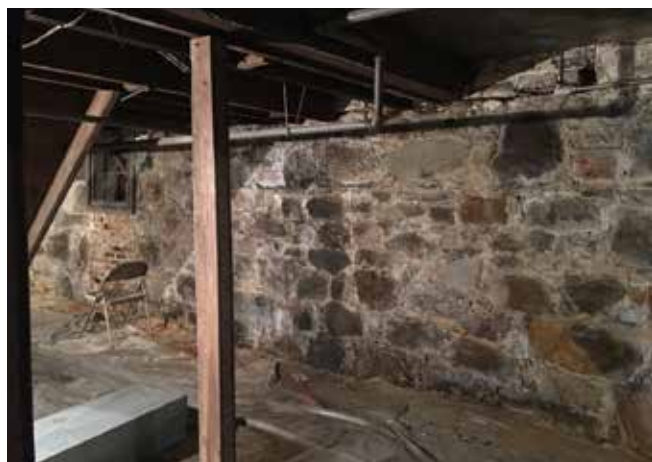
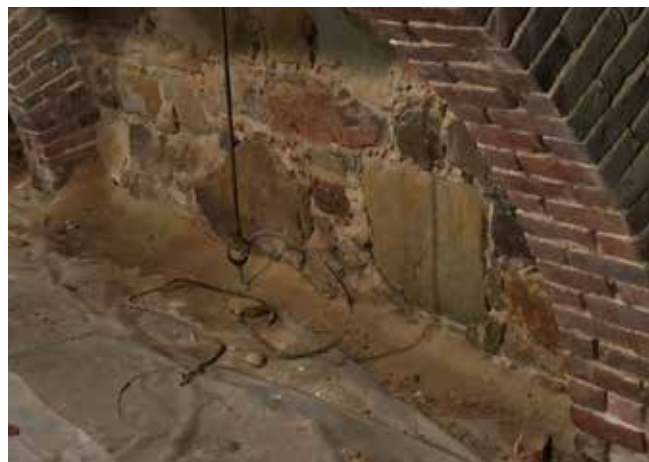
- A range of temporary supporting conditions exist as interim repairs for rotting Ground Floor joists at their bearing in the exterior masonry walls due to moisture in the walls.
- The primary building foundation structure including brick and stone exterior foundation walls and the two center brick arched walls are in generally good condition.
- Footings were placed at four steel columns installed to shore up four of the dome's supporting columns. No attempt to "right" the deflection was made at the time, therefore, the deflection visible on the interior is not a sign of continued movement, just fixed as it existed when the new support posts were installed.

*Basement views showing temporary 4x4 supports (left) and powdering mortar from both the stone and brick wall areas (right).*

- 1) Careful repointing of unsound mortar at all basement walls and supports.
- 2) Repair all deteriorated joist bearing conditions.
- 3) Repair existing structure in order to remove temporary shoring.
- 4) Eliminate water and moisture in the basement (see previous section on water infiltration).

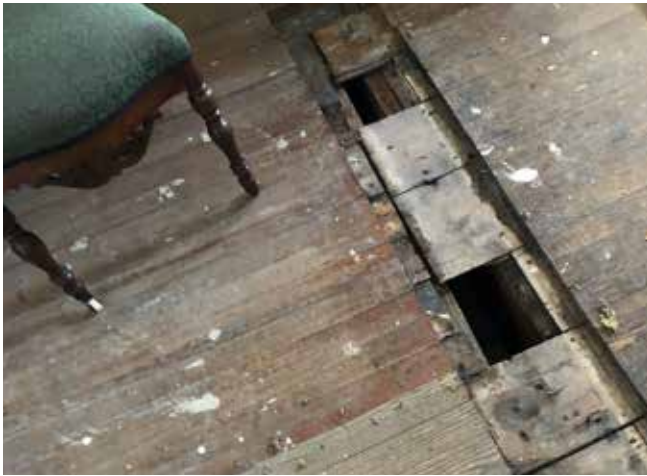
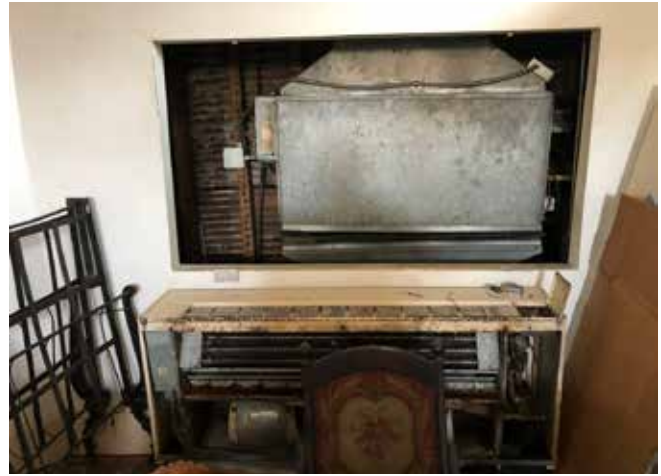
The damage and failure of floor framing in the southeast corner of the building is documented in the 2013 report and notes that a significant amount of flooring and First Floor ceiling plaster will need to be removed in order to make the repairs. The floor in this room has been sagging for years as evidenced by the floor dropping away from the baseboard along the curved wall that separates the southeast room from the mezzanine walkway. In addition to the engineer's evaluation, we feel that water is also playing a role in the deterioration of 1) joist bearing conditions at the southeast exterior wall, and 2) condensation from HVAC units concealed in the wall along this portion of the curved walkway have kept conditions wet and have possibly contributed to rot or deterioration in concealed wall and floor areas. Investigative work was undertaken in these areas, we assume for the engineering report, but the work was not careful and not easily repairable to its previous appearance.

*Images of investigative demolition at the southeast room on the Second Floor (left) and mechanical equipment inside corridor walls (right).*

- 1) The removal of existing flooring and plaster ceiling should be kept to a minimum as the full extent of the joist/girder failure is assessed. No removal of historic materials should be authorized without the review and approval of the project's historic architect and the Virginia Department of Historic Resources.
- 2) Although column settling has occurred in the past, They appear to have been stabilized by the installation of the four steel posts under the columns that had dropped. We recommend the ongoing monitoring of the column elevations for the life of the building.

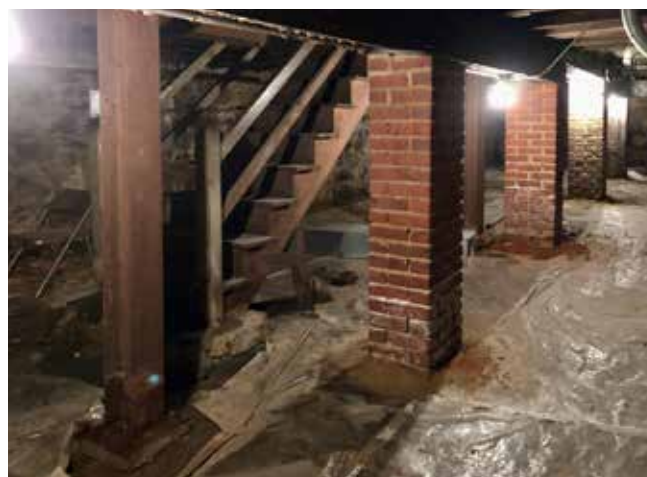
The two stairs down from the Ground Floor show significant signs of deterioration and rot due to the ground staying wet where the stringers land at grade.

*Basement views showing stairs from Ground Floor and brick piers deteriorating at their base.*

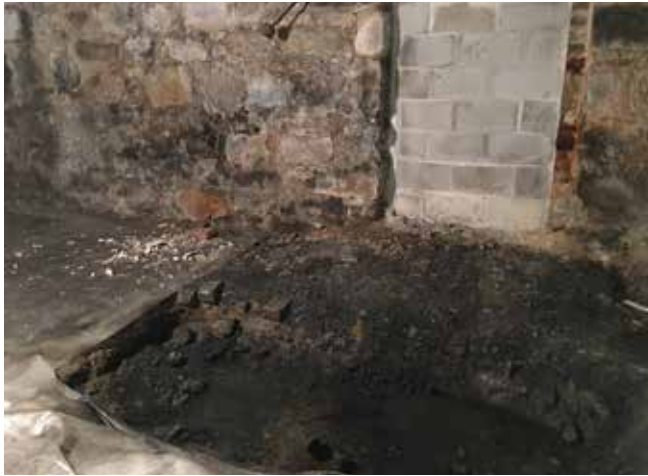
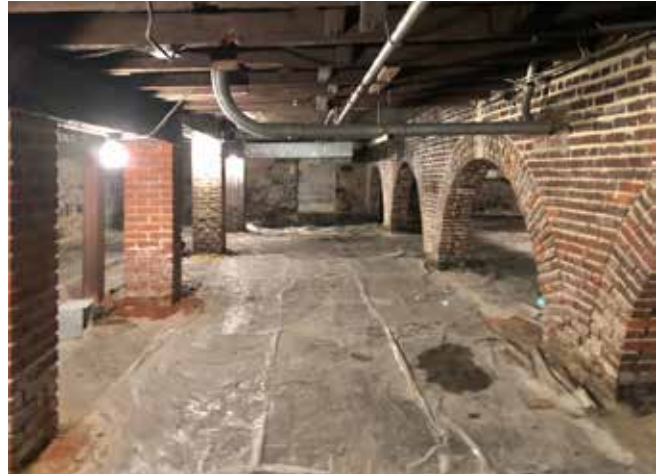
*Basement views - original brick floor revealed at filled in northwest bulkhead (left), view toward northwest bulkhead entry, beyond, now filled in (right)*
