# *The* PETERSBURG EXCHANGE BUILDING

## *A Historic Structure Report*

*24 November 2021*

**PREPARED BY:**  
*Studio Ammons Inc. &  
Landmark Preservation Associates*

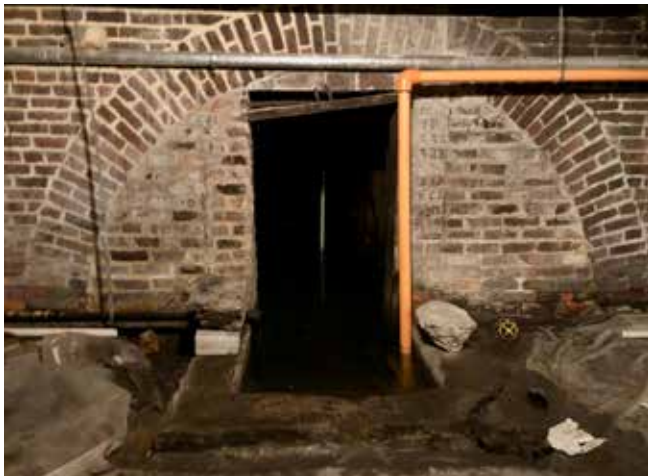
The basement has a brick floor that is covered by 2-3 inches of dirt in most locations and was most likely destroyed in the northeast quadrant of the building when systems were upgraded. The Boiler Room often floods and has standing water for long periods of time causing most of the wood framing in the room to deteriorate and rot. In the 1970's renovation a new Mechanical/boiler Room and Stair was located above this area and the original Ground Floor floor system removed and replaced with a poured concrete floor.

*View of the entrance to the boiler room in the northeast corner of the Basement (left), and view of mold on Ground Floor joists and subfloor (right).*

- 1) Moisture remediation - see previous recommendations in this report.
- 2) Thorough cleaning of all basement surfaces to remove the presence of mold and mildew.

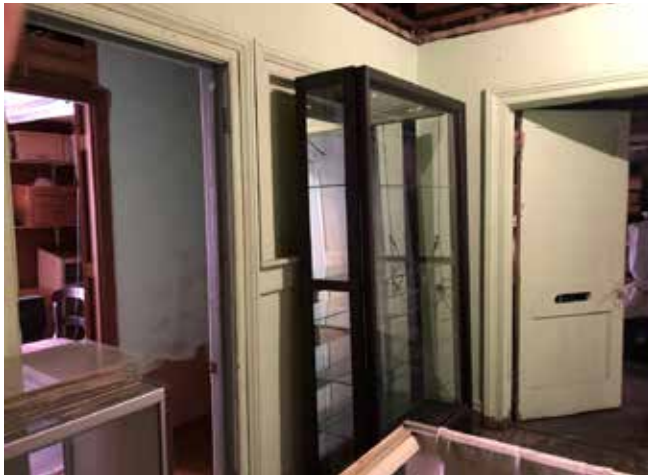
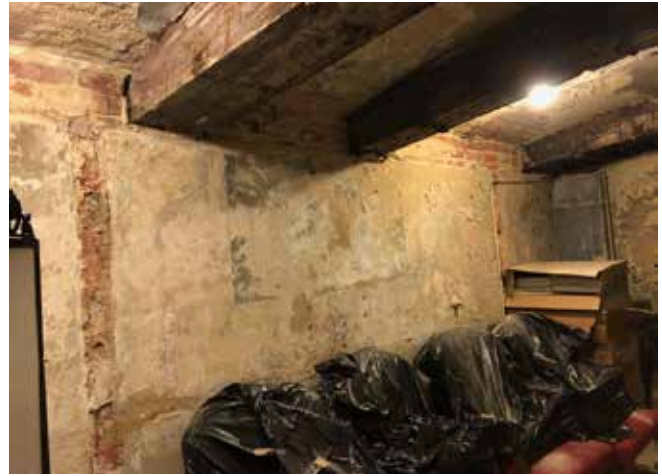
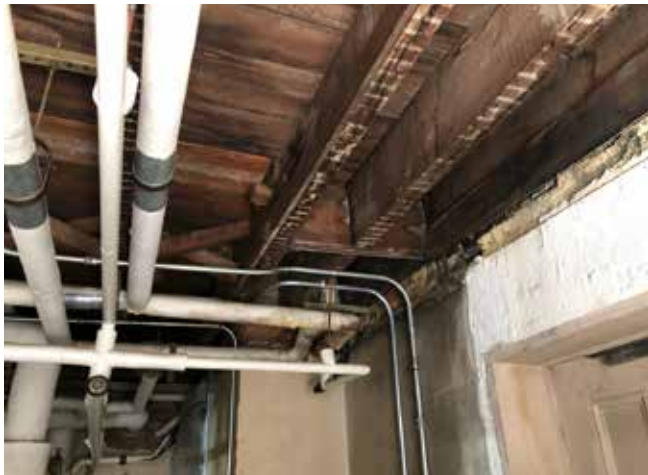
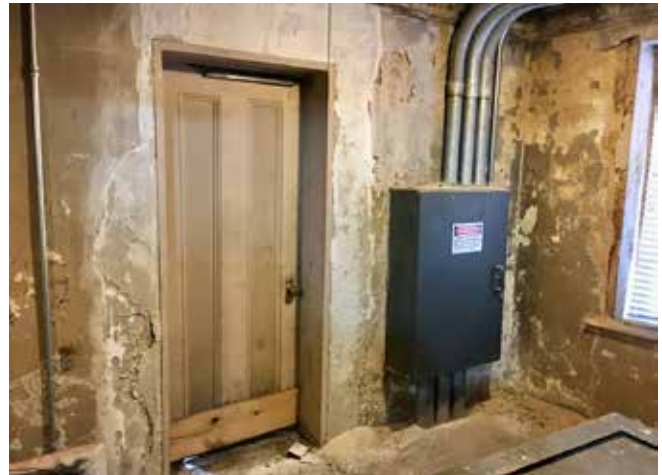
*Unimproved areas on the Ground Floor where early or original finishes still exist.*

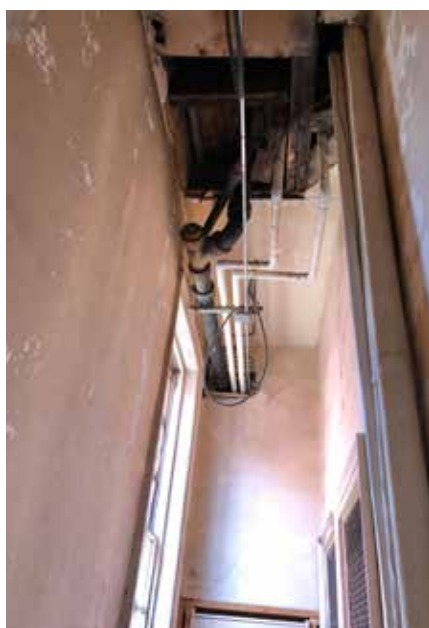
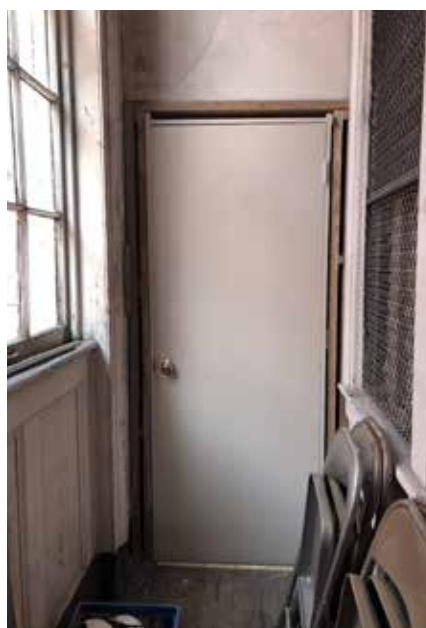
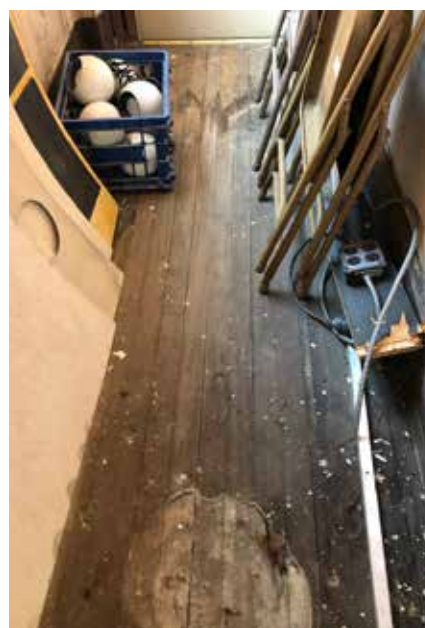
*Views of the back hallway on the west side of the building where early or original finishes still remain.*

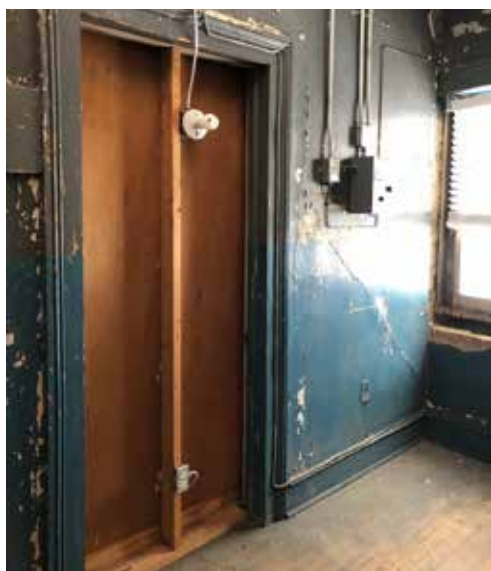
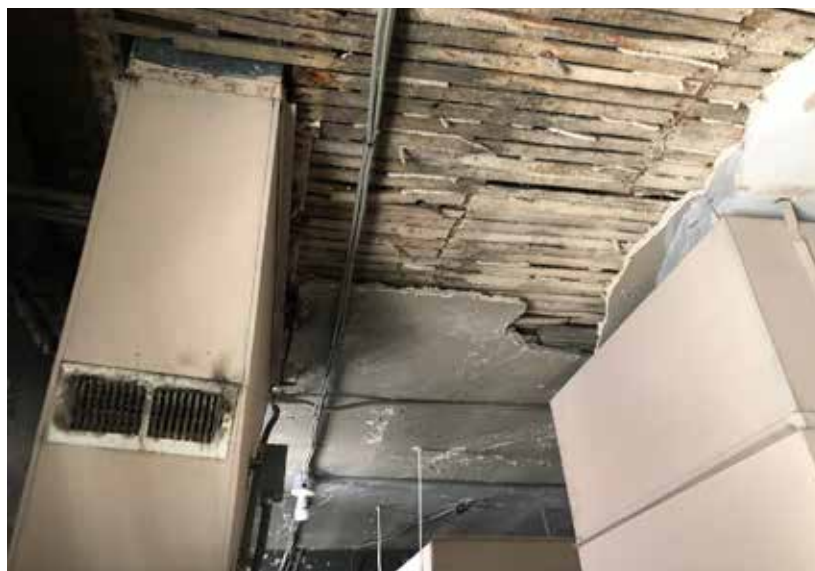
*Views into the Mechanical Room showing evidence of early or original finishes in an area that has had little maintenance over the years.*

- 1) Water damage at walls and ceilings from mechanical systems and roof leaks should be repaired and coordinated with any new or upgraded systems.
- 2) Mechanical Room finishes should be protected until they can be fully analyzed to determine the date of the finishes and how these spaces will be used in future programming.
- 3) Prioritize structural floor repairs in the southeast room. Bring the room back to usable condition with repairs to walls and floor. Repair associated damage to baseboard and wall finishes in the gallery.

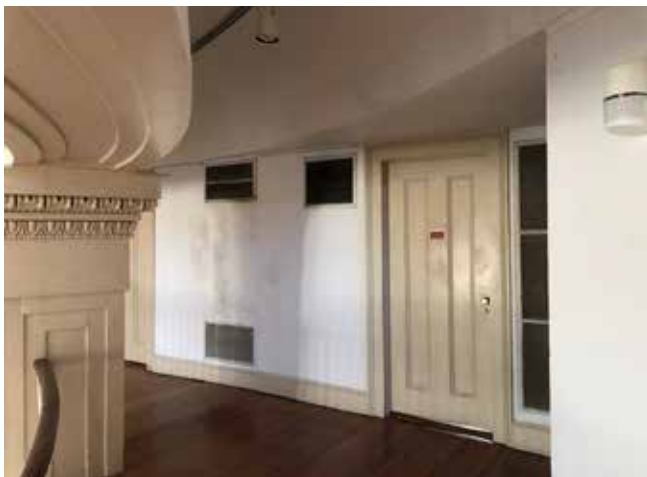
*Views of moisture damage in the areas around mechanical grills and concealed ductwork around the Second Floor gallery.*

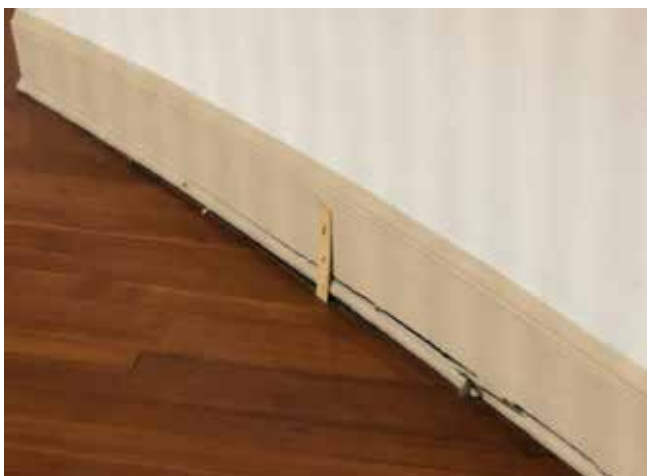
*Southeast gallery location where floor has dropped and structural framing repairs are necessary (left), and moisture damage to arched plaster gallery ceiling (right).*

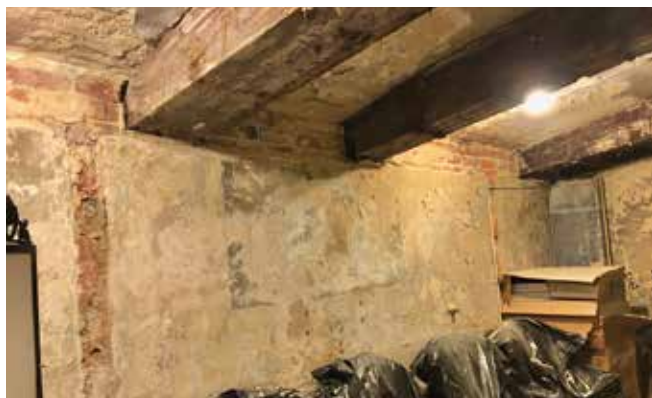
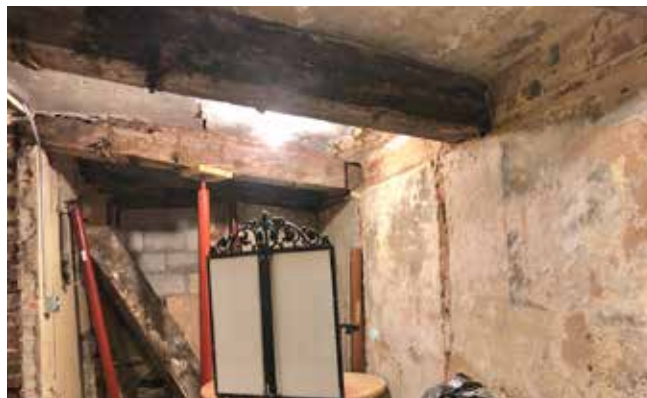
*Views of the east room below the Front Portico showing curved wood beams and vaulted brick ceiling along with the remains of plaster finishes. The CMU infill of the original east doorway can be seen in the photo on the right.*

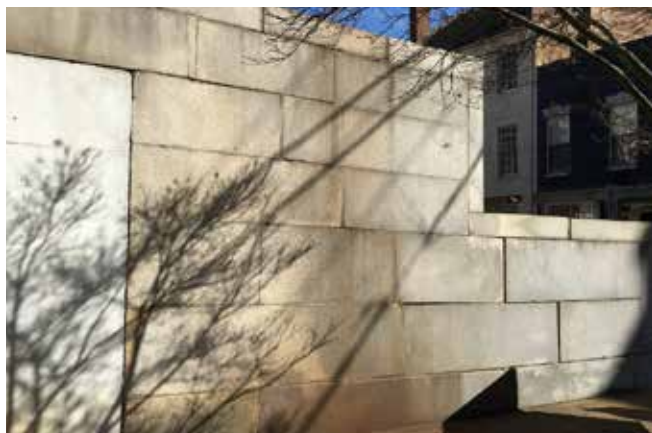
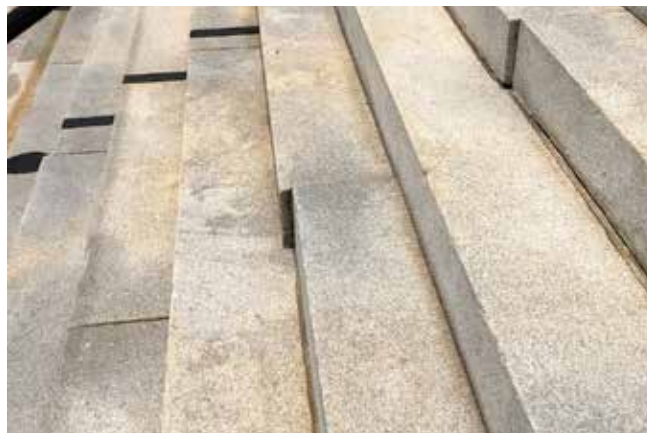
Some settling has occurred in the steps and cheek walls causing the large granite steps to appear to have "slid out and down" opening up gaps where the horizontal and vertical surfaces of the slabs meet. It's not known whether the stone steps are set on masonry or sand. This settlement is also evident at the cheek walls where the dressed stones appear to have dropped towards the street with the concrete sidewalk poured up to the wall as it has settled. It's not known whether there is still any active settling or if the visible drop toward the street happened a long time ago and has stabilized since then. This shifting is allowing water into the cheek wall mortar joints, Portico floor joints and the joints between the granite steps causing continued shifting and settlement as well as the rotting of the wood beams holding up the vaulted floor structure below.

*Views of the Front Portico west cheek wall with probable original infill in lighter stucco (Left) and granite steps detail showing settling and shifting (Right).*

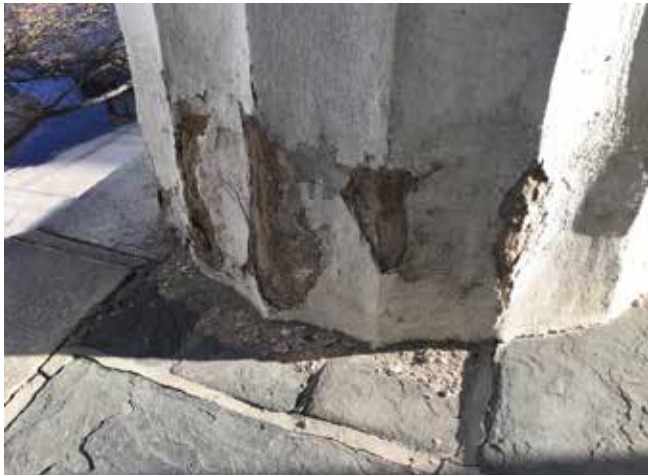
*Views of flagstone floor and stucco on brick Doric columns showing deteriorated finishes..*

- 1) Portico floor stones should be repointed and repaired where damaged.
- 2) Portico columns should be inspected for structural soundness prior to repairing stucco fluting on columns and painting.

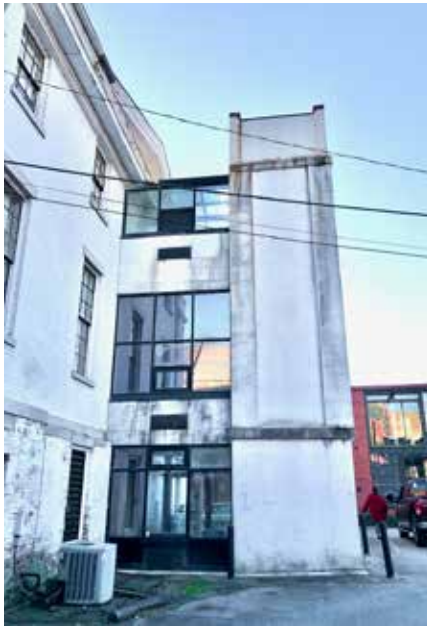
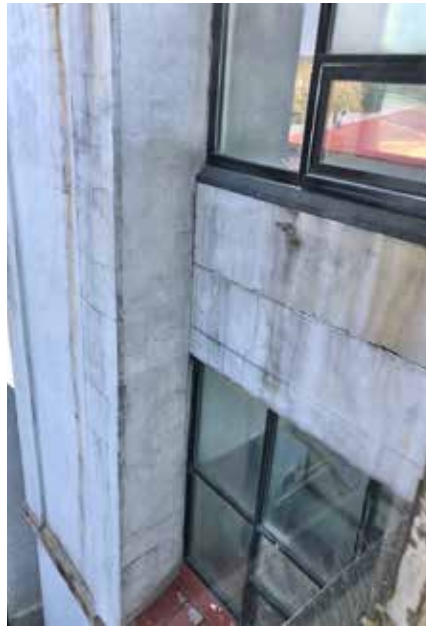
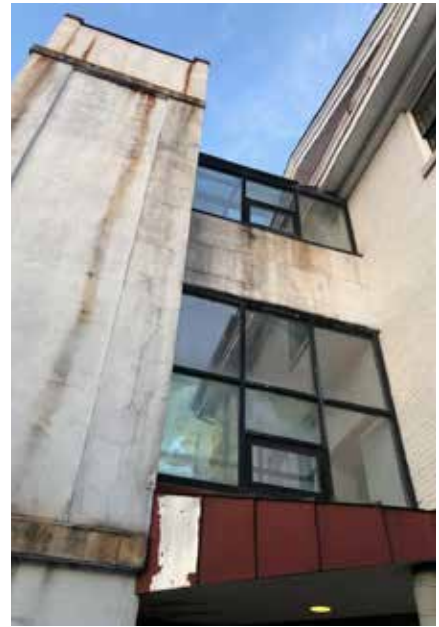
The elevator tower appears to have had little maintenance since its construction in the 1970's renovation. The exterior stucco finishes have cracked and water is infiltrating the walls. There is no longer a seal at grade and ground water is infiltrating the foundation. Although no visible sign of settlement is apparent, there has been no monitoring of this condition. The insulated windows, set in a bronze anodized storefront system, show signs of broken seals causing fogging and condensation build-up inside the windows reducing clarity and visibility through the glass. The roof and entrance canopy are a modern, prefinished, standing seam roof. The prefinished roof coating is peeling exposing the metal underneath.

*Exterior views of the elevator tower added in the 1980's museum conversion.*

- 1) Until a decision is made about the scope of future restoration/renovations to the building, where the elevator tower might be removed, the elevator must remain operational and the tower and connector weather-tight.
- 2) The installation of gutters and downspouts on the tower roof will help control water and moisture infiltration at the ground.
- 3) Windows should be kept water tight until a final decision is made regarding the fate of the tower.
- 4) The elevator tower should be removed and a new elevator installed as part of a future Rear Portico addition. [Long Term]

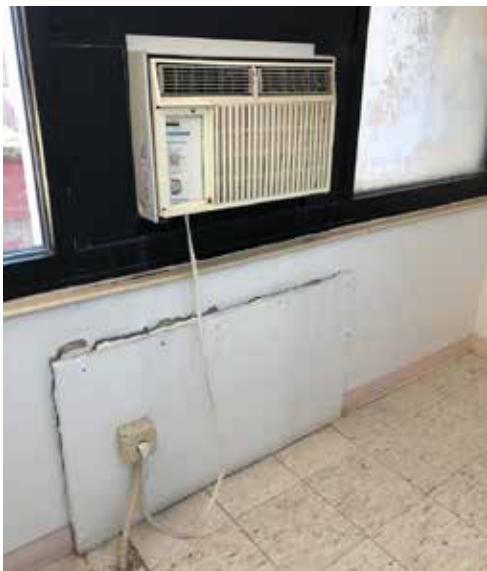
*Interior views of the Second Floor of the elevator tower connector showing the condition of the glass and lack of integrated HVAC systems.*

The elevator tower is served by fan-coil units that do not appear to be operating properly as a window air conditioning unit has been carefully installed for additional cooling. (see Elevator Tower photos in previous section)

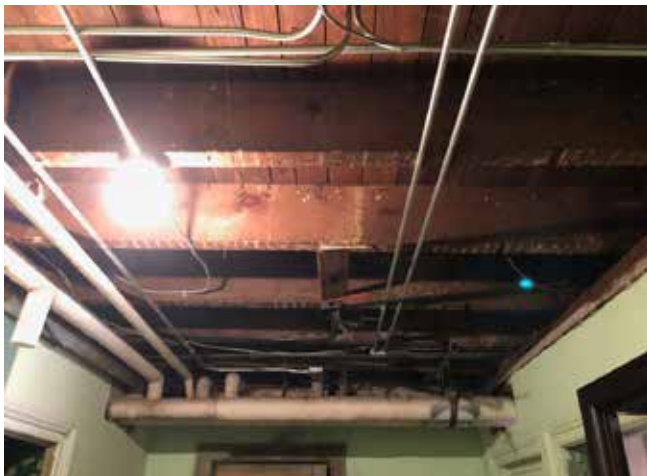
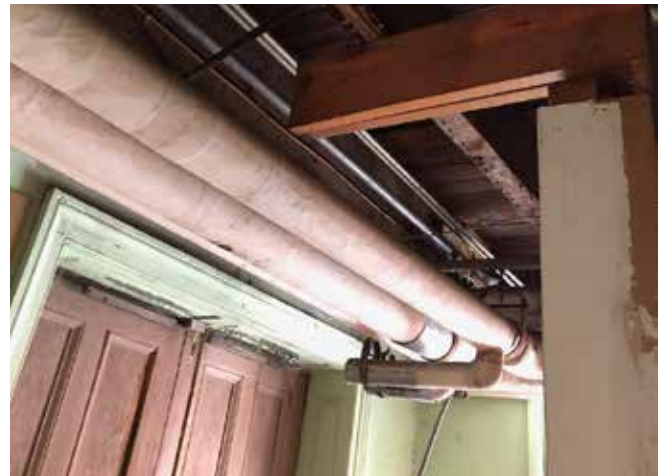
*Mechanical piping running through the southwest rooms on the west alley side of the Ground Floor.*

- 1) Existing systems should be kept operational until new systems are installed at some point in the future. Where there is visible evidence of condensation, piping and ductwork should be insulated to reduce dripping and moisture build up. All in-wall units should be inspected and maintained to prevent condensation and moisture build up. All filters should be kept clean.
- 2) New systems should be installed throughout the building with museum level humidity controls. [Long-term]
- 3) A new fire suppression system should be installed throughout the building, sensitively installed to reduce negative impacts on existing historic fabric.
